SAND2009-1630

Pedestrian and Traffic Safety in Parking Lots at SNL/NM: Audit Background Report

This report supplements audit 2008-E-0009, conducted by the ES&H, Quality, Safeguards & Security Audits Department, 12870, during fall and winter of FY 2008. The study evaluates slips, trips and falls, the leading cause of reportable injuries at Sandia. In 2007, almost half of over 100 of such incidents occurred in parking lots. During the course of the audit, over 5000 observations were collected in 10 parking lots across SNL/NM. Based on benchmarks and trends of pedestrian behavior, the report proposes pedestrian-friendly features and attributes to improve pedestrian safety in parking lots. Less safe pedestrian behavior is associated with older parking lots lacking pedestrian-friendly features and attributes, like those for buildings 823, 887 and 811. Conversely, safer pedestrian behavior is associated with newer parking lots that have designated walkways, intra-lot walkways and sidewalks. Observations also revealed that motorists are in widespread noncompliance with parking lot speed limits and stop signs and markers.

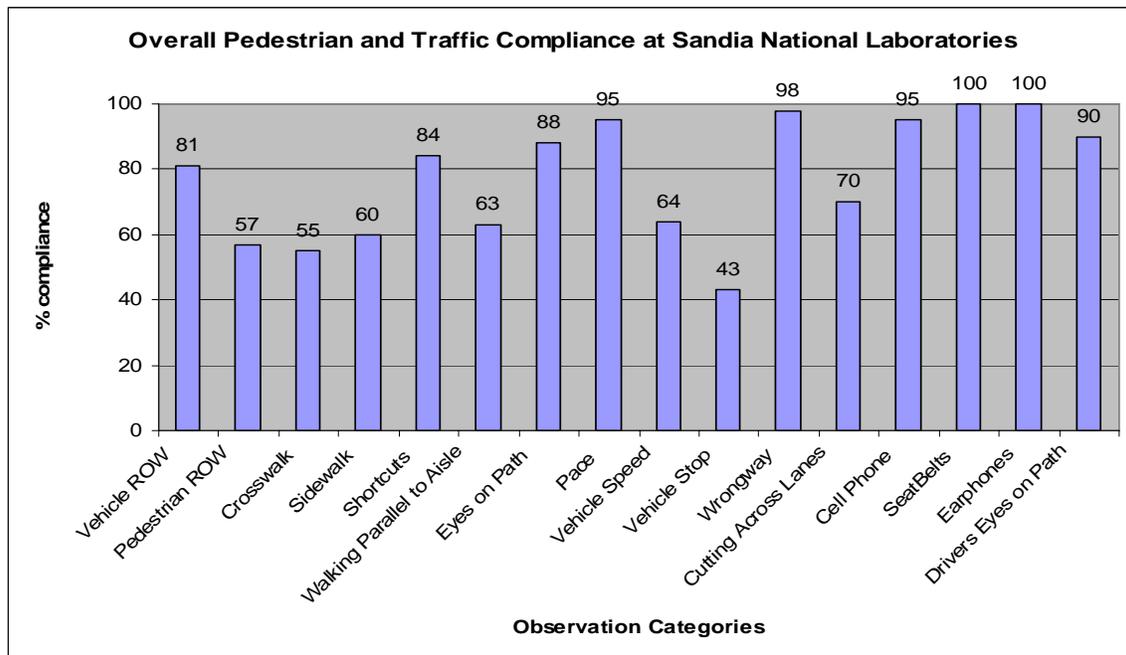
Auditors recorded observations of pedestrians and motorists walking and driving in 10 parking lots across SNL/NM.¹ Figure 1 graphs the overall results for the 16 pedestrian and motorist behaviors observed as part of the study. While the combined data identify overall trends, auditors noted that important differences among parking lots affected pedestrian and motorist behavior. These differences included parking lot design and size, pedestrian-friendly features, such as designated crosswalks and walkways, and traffic signs.

Figure 1: Cumulative percent compliance for pedestrian and motorist behaviors.

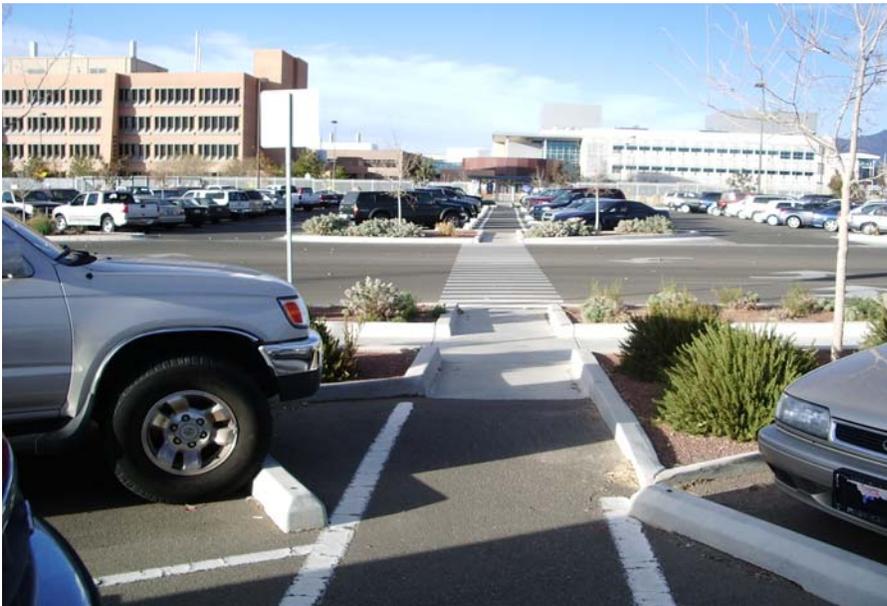
Counting the marked crossings only at building 897, the compliance rate for safe behavior by pedestrians was 90% (Appendix C, Table C3). Crosswalk usage is noticeably greater in parking lot 897 where an intralot walkway and lot layout naturally funnels pedestrians directly to a crosswalk and toward the pedestrian's destination (Figure 2). Compliance was 54% at unmarked crossings in the building 897 parking lot (Appendix A, Diagram A6).

Figure 2: Example of marked crosswalk and intralot walkway, features associated with highly safety-compliant behavior in the building 897 parking lot.

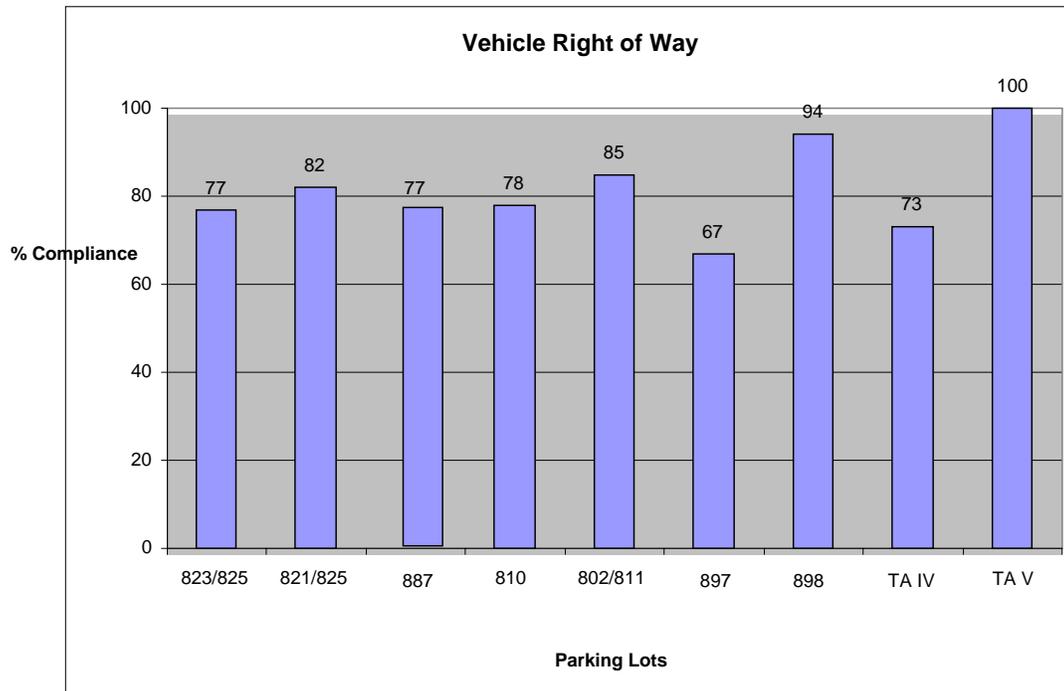
Table C1: Vehicle Right of Way (254 Observations)

⁷ At parking lot 810, results are biased by observations at Gate 17 where pedestrians crossed at a stop sign situated at the gate. Vehicle right of way at stop sign is 83 %.

⁸ At parking lot 897, results are 76% measured at marked crosswalks compared to un-marked crosswalks alone (67%).

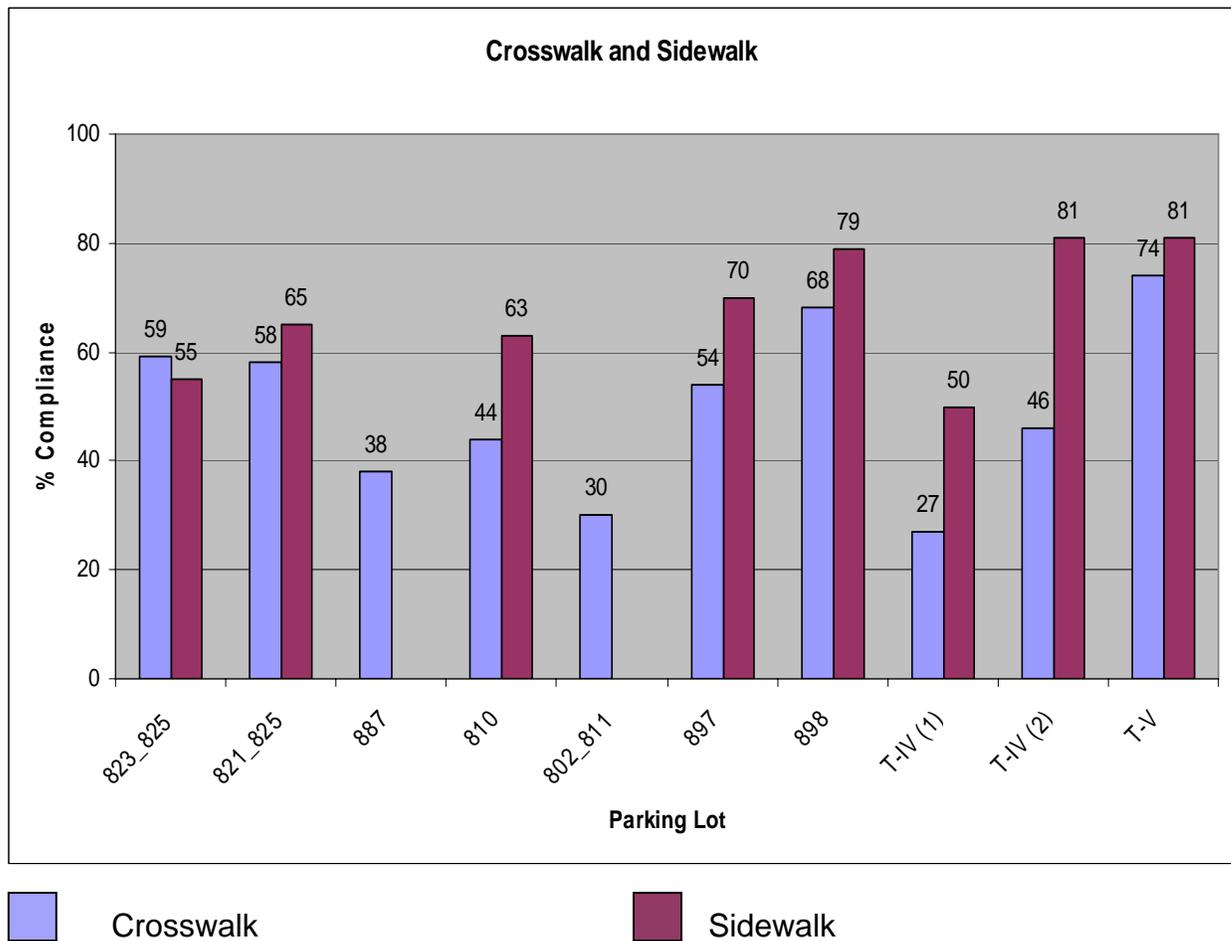
Table C4: Sidewalks¹² (328 Observations)

¹² There are no sidewalks at parking lots 887 and 802/811.

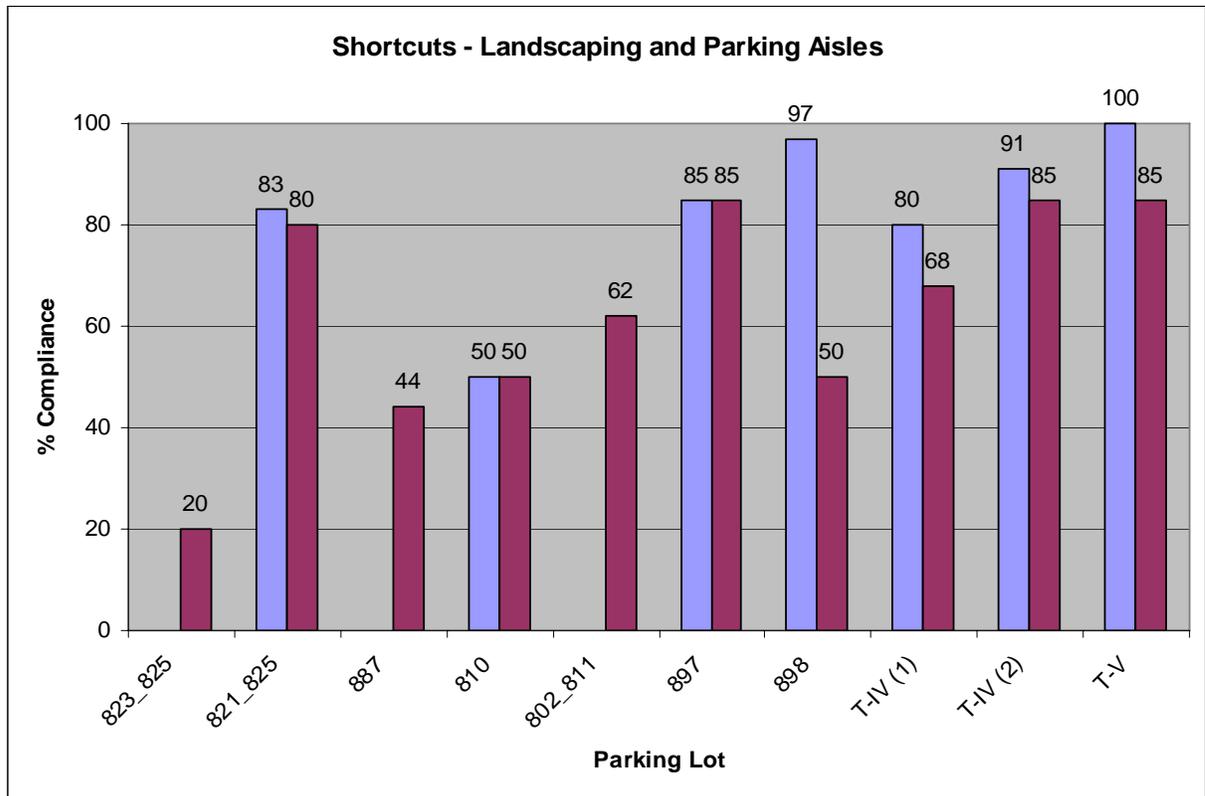
Table C5: Shortcuts (541 Total Observations)

NOTE: Shortcuts include those taken across landscaping and parking aisles.

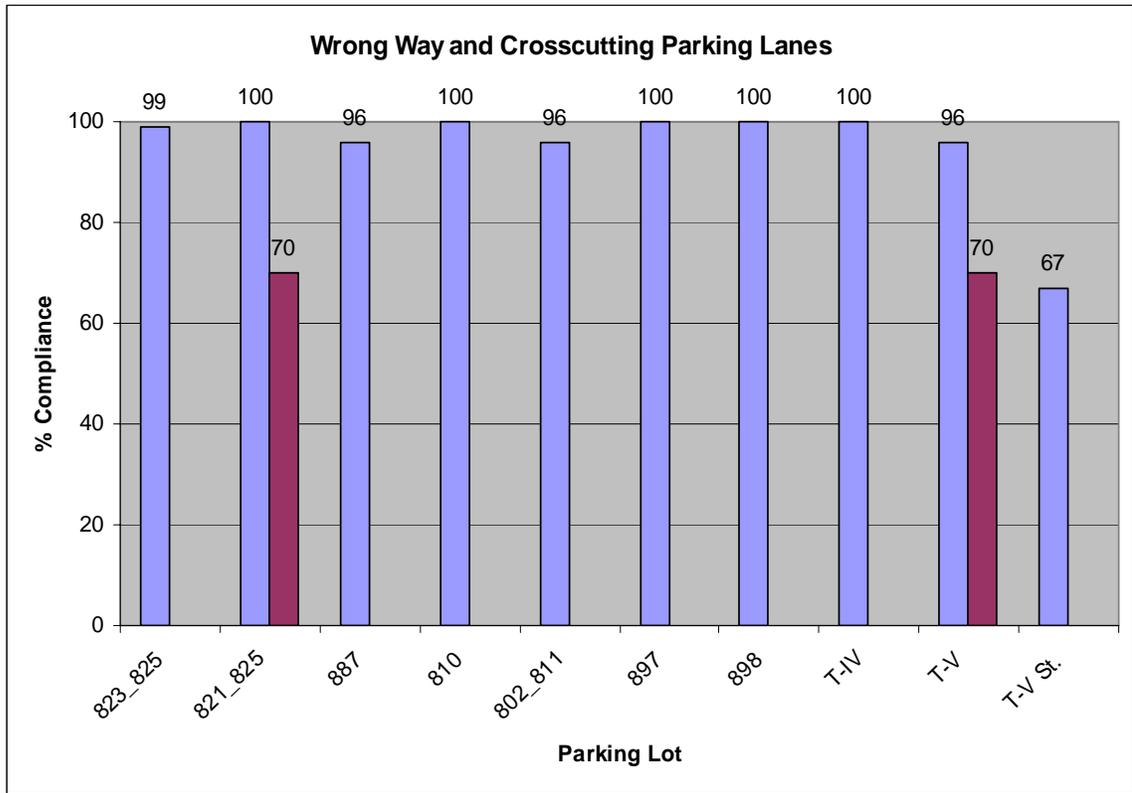
Table C10: Wrong Way (including Tech Area V Street) (444 Observations)¹⁴

¹⁴ Wrongway for parking lots, except Tech Area V, where 67% drove wrong way in street to avoid speed turtles (close call observed). Cutting across parking aisles is not applicable to parking lots with bumpers. Only applicable to south of Building 825 and Tech Area V.
