SAND2011-1539

## **Report on Accelerated Corrosion Studies of Electrical Components**

S. Jill Glass, Curtis D. Mowry, and N. Robert Sorensen

Sandia National Laboratories (SNL) conducted accelerated atmospheric corrosion testing for the U.S. Consumer Product Safety Commission (CPSC) to help further the understanding of the development of corrosion products on conductor materials in household electrical components exposed to environmental conditions representative of homes constructed with problem drywall. The conditions of the accelerated testing were chosen to produce corrosion product growth that would be consistent with long-term exposure to environments containing humidity and parts per billion (ppb) levels of hydrogen sulfide ( $H_2S$ ) that are thought to have been the source of corrosion in electrical components from affected homes. This report documents the test set-up, monitoring of electrical performance of powered electrical components during the exposure, and the materials characterization conducted on wires, screws, and contact plates from selected electrical components. No degradation in electrical performance (measured via voltage drop) was measured during the cour

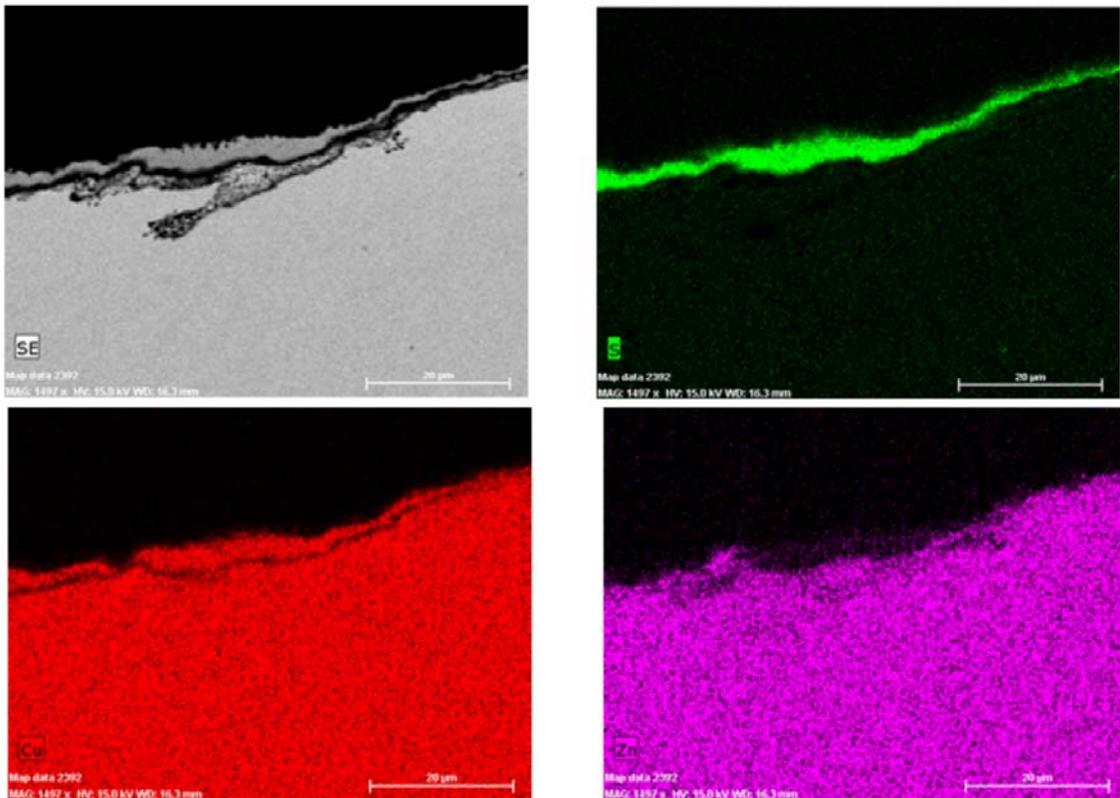
1-RS-HSP2\_map1

<b>Part</b>	<b>Figure Number</b>	<b>Comments</b>	<b>Thickness (microns)</b>
1-RS-HSP2	Figure 12, Figure 13	Void below corrosion film. Measure depth from perpendicular	15.3
1-RS-HSP2	Not shown		12
1-RS-HSP2	Not shown	At inside curvature of part	36.6
1-RS-HSP2	Not shown	Separation of outer layer, possible fill underneath	52
1-RS-HSP2	Not shown	Wide view with layers and pits	25

Figure 12 shows SEM images of a cross section of the hot screw plate from the rocker switch. Figure 13 and 14 present the elemental data obtained from EDS analysis of the cross section shown in Figure 12. In Figure 13A, a thin layer of corrosion product is visible on the surface of the contact plate. There is evidence of voids below the corrosion product layer, consistent with the sulfidation process. The elemental maps also show Cu and Zn (Figure 13C-D), elemental constituents of the substrate (brass). The sulfide layer is clearly visible on the surface. As seen in Figure 14, the corrosion product layer also contains chlorine and oxygen.

Figure 13. SEM image (top left) and elemental maps using EDS of HSP2: sulfur (green), Cu (red), and Zn (purple).

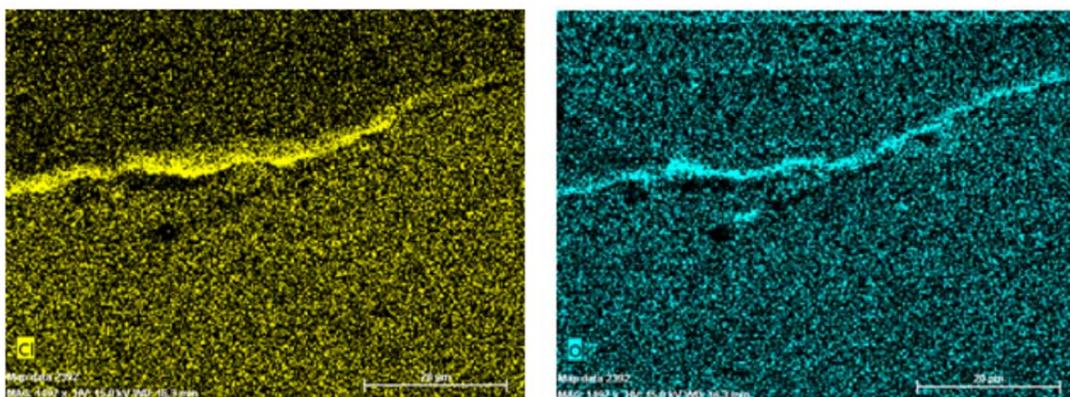
Figure 14. Elemental maps using EDS of HSP2, showing chloride (yellow), and oxygen (blue).

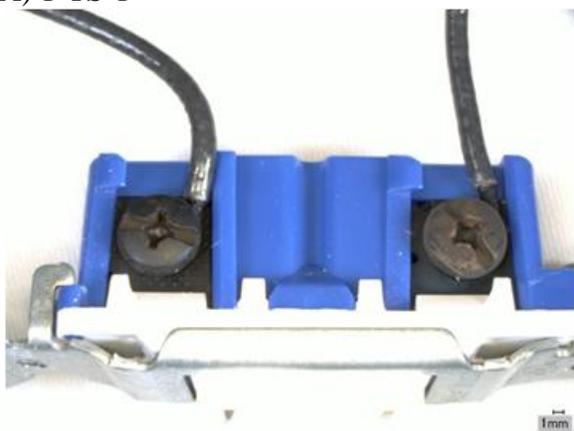
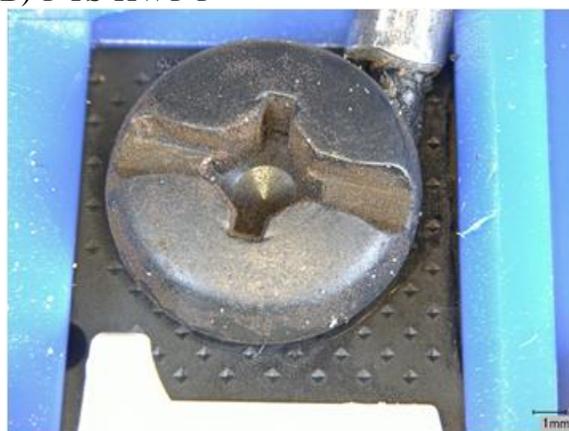
Figure 15 shows optical images of the toggle switch from Circuit 1. The metal contact surfaces exhibit sulfidation. Tarnishing of the wires, contact plates, and screws was observed.

Figure 15. Photographs of toggle switch from Circuit 1.

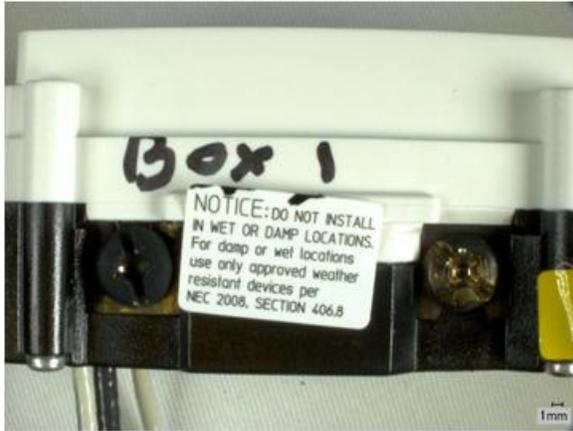
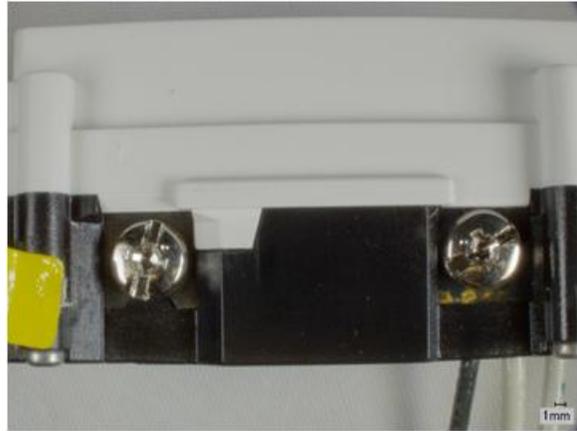
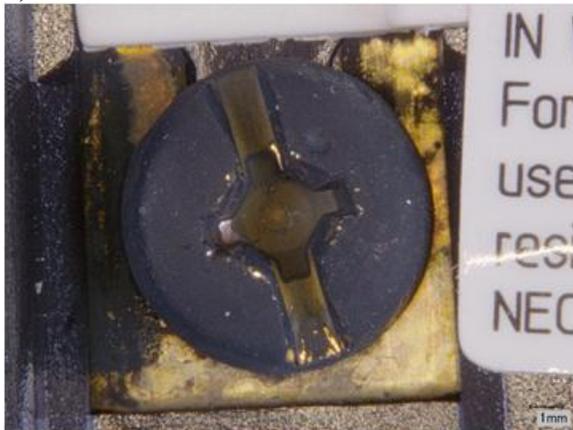
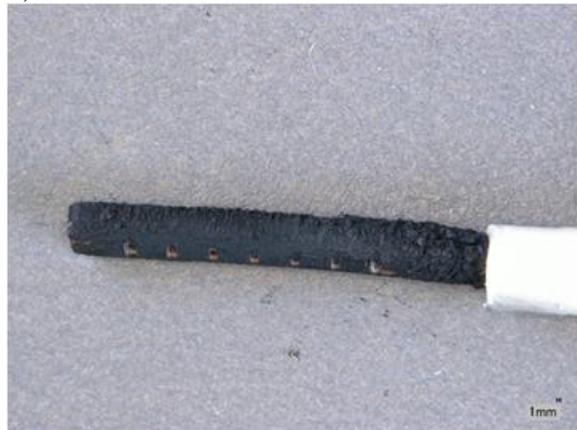
Optical images of the GFCI receptacle from Circuit 1 are given in Figure 16 and Figure 17. Corrosion of the contact surfaces was observed. The screws presented in (B) do not exhibit significant attack. Their color indicates that they are not brass screws, so they are considerably more resistant to sulfidation. Interestingly, the push-in wire (D) exhibits the presence of an extensive layer of corrosion product. This indicates that the gas permeated the receptacle itself. This is supported by the images in Figure 17, which show the insides of the GFCI. Clearly, the receptacle case presents little or no impediment to the corrosion gas. It is interesting to note that many of the internal components were corroded during this test (Figure 17D). Note that the majority of the contact is tarnished, with the real contact area (the spot near the center) exhibiting considerably less corrosion. During the test, one of the load lamps arced, resulting in tripping of

Figure 16. Photos of outside of GFCI receptacle from Circuit 1.

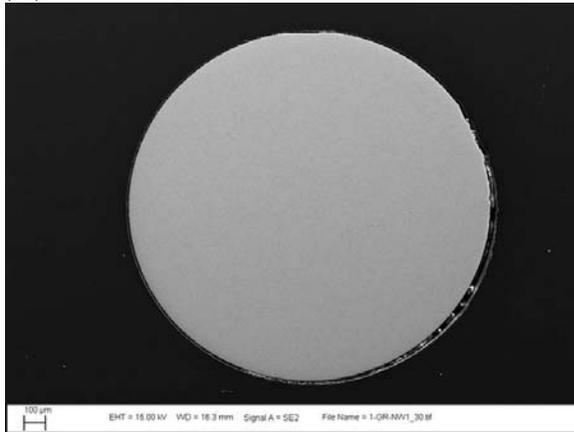
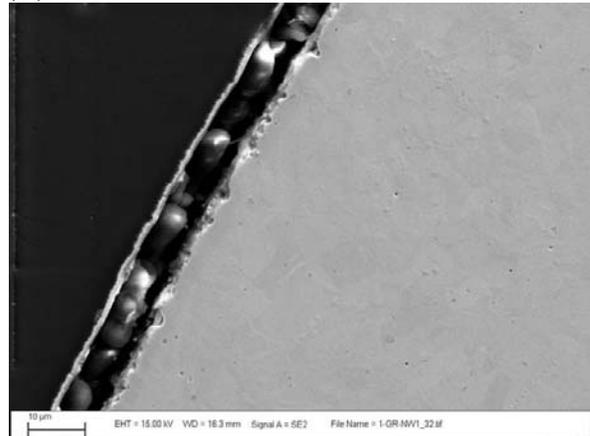
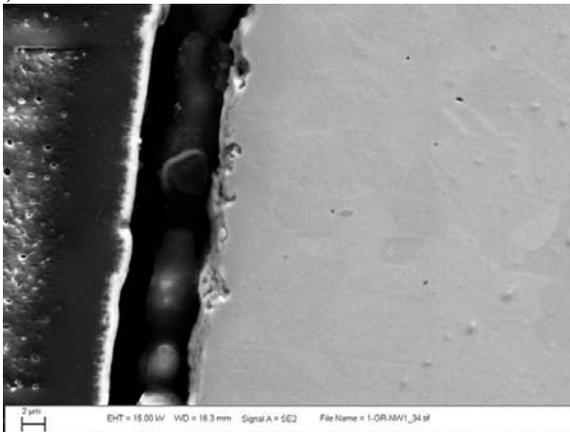
The neutral wire from the GFCI receptacle was cross sectioned for analysis. The SEM images are shown in Figure 18. A thin corrosion product layer can be seen covering the wire surface. A very conservative estimate of the decrease in cross section of the wire can be calculated based on the SEM images. As given in Table 2, the corrosion product thickness was 11 microns. If we assume that the thickness is uniform, and that the corrosion product thickness equals the loss of metal, the cross sectional area of the wire at the conclusion of the test is 98% of the original cross section. In reality, the area decrease is considerably less (the corrosion product thickness is less than the thickness of lost). Thus, attack of the wire did not result in a significant decrease in cross sectional area and does not affect the current carrying capabilities of the wire.

Figure 18. SEM images of cross section of neutral wire 1-GR-NW1.

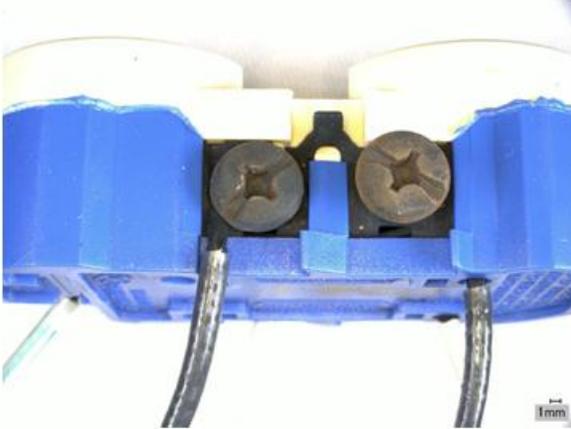
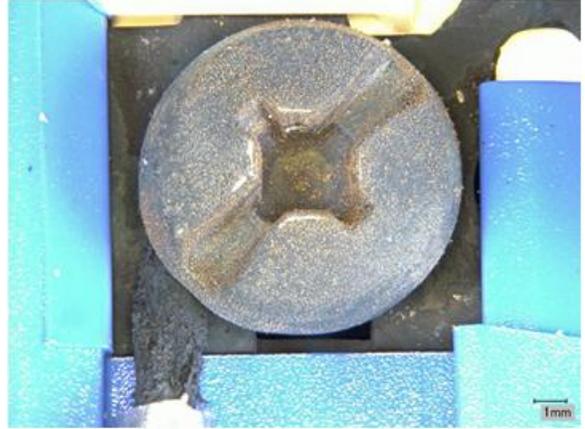
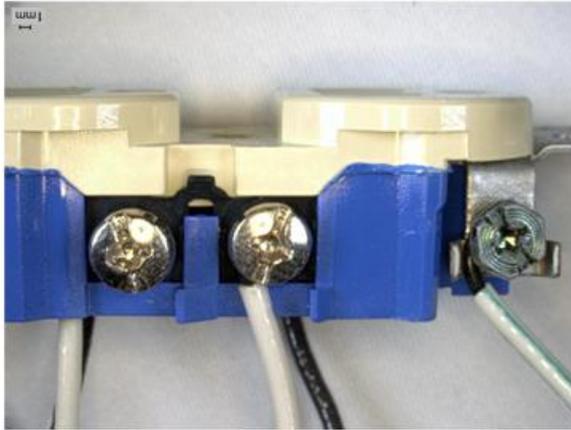
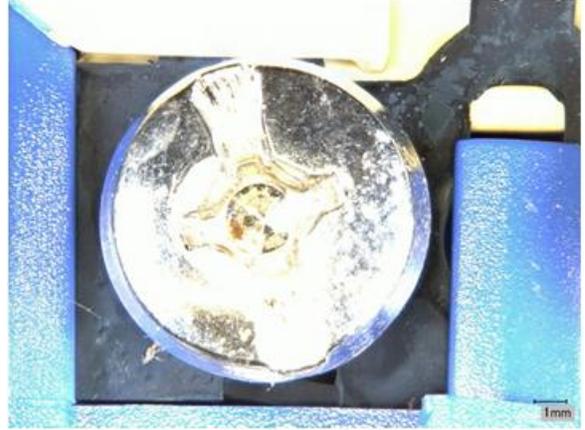
Analysis of the receptacle from Circuit 1 included optical images and SEM analysis of the hot wire. Optical images are presented in Figure 19 and Figure 20. They show corrosion of the Cu base materials. Very little attack of the neutral screws or the ground screw was observed. The wires exhibited significant attack, but were essentially untouched in two locations: where the wire was in intimate contact with screws, and where the wire contacted the pressure plate.

Figure 19. Optical photographs of receptacle from Circuit 1. The image in (A) shows the side view of hot wires; (B) hot screw and contact plate; (C) side view of neutral wires; and (D) neutral screw and contact plate.

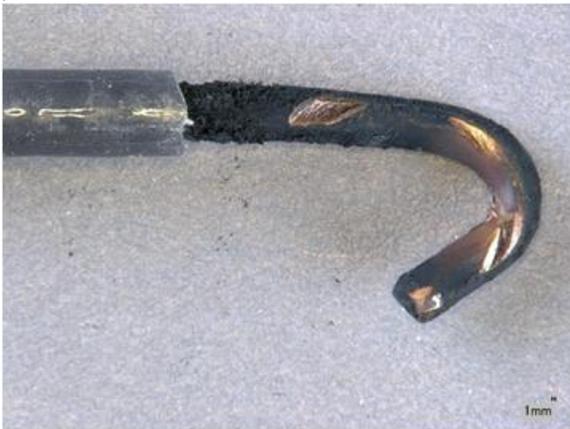
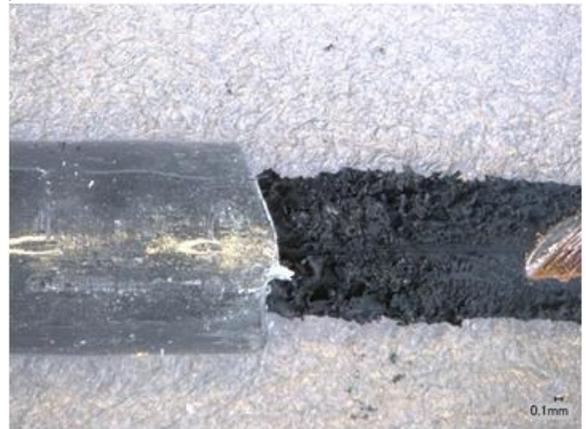
Figure 20. Optical photographs of hot wire removed from receptacle from Circuit 1.

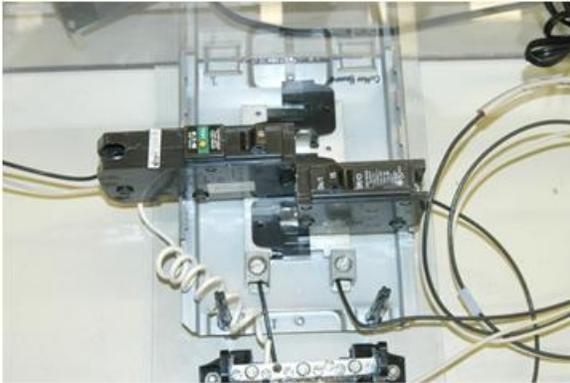
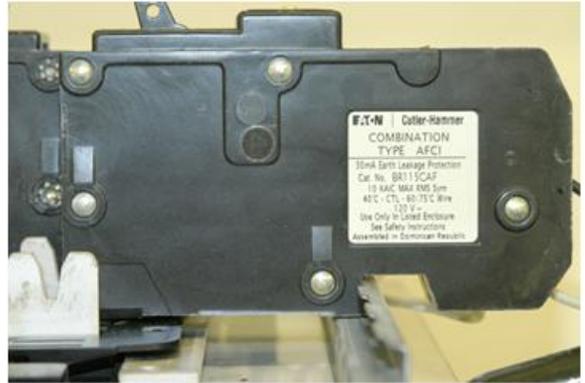
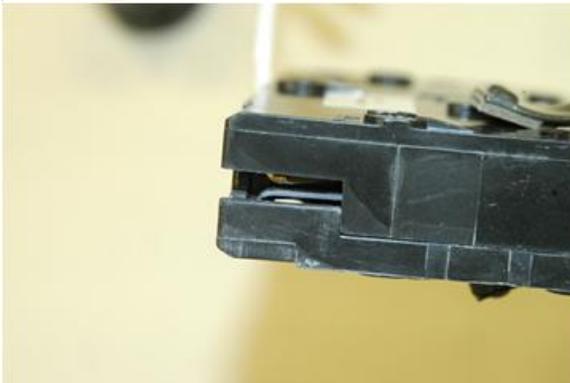
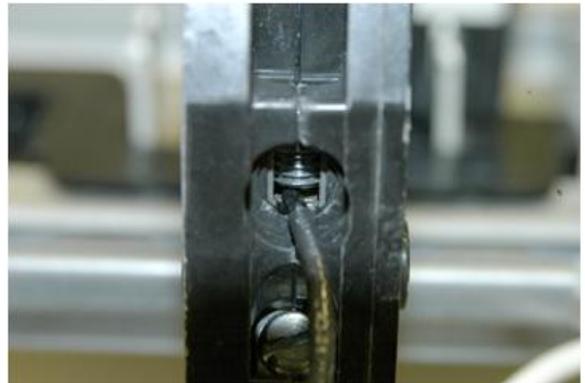
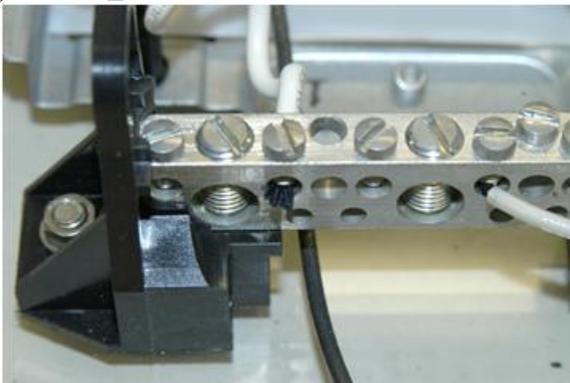
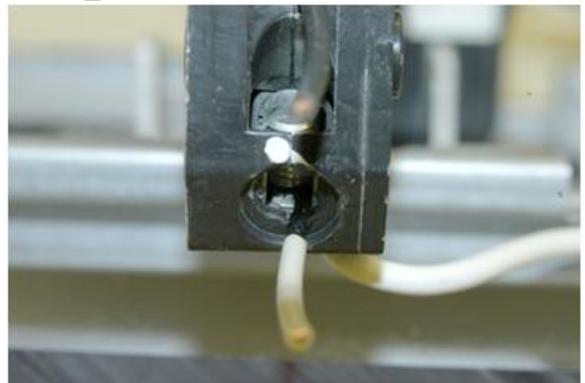
Figure 24 shows optical images of the AFCI from Circuit 1. The output from the standard circuit breaker provides the input to the AFCI. In addition, the neutral feed is connected to the neutral input, and the neutral sense wire is connected to the load center bus. Sulfidation of the contact surfaces can be seen. Both the neutral and hot wires exhibit corrosion, as well as the stranded neutral sense wire (where it is connected to the load center bus—lower left image).

Figure 24. Optical images of the load center and AFCI for Circuit 1.

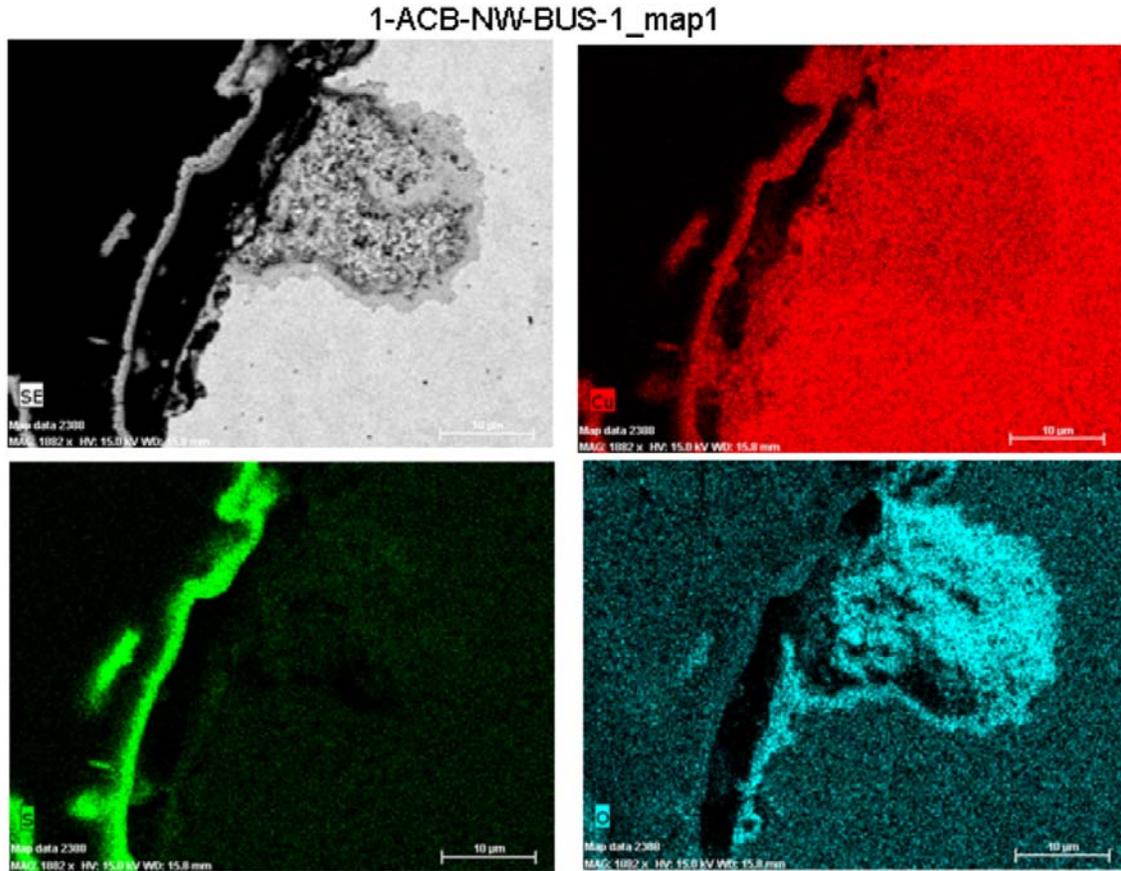
<b>Part</b>	<b>Figure Number</b>	<b>Comments</b>	<b>Thickness (microns)</b>
1-ACB-NW-BUS-1	Figure 26	Stranded wire Large pit	26.7
1-ACB-NW-BUS-1	Not shown	Stranded wire Flaked off layer + tight layer	6.3
1-ACB-NW-BUS-1	Not shown	Stranded wire “divot” growth	6
1-ACB-NW-BUS-1	Not shown	Stranded wire Wide pit with upper layer that appears to have growth under it	21.7
1-ACB-NW-BUS-1	Figure 27	Stranded wire Wavy layer with wide pit	8.5
1-GR-NW-1	Figure 18	Outer layer with what appears to be growth underneath	11.4
2T-RS-HW1	Not shown	Blister growth	16.4
2T-RS-HW1	Not shown	Blister growth	25.7
2T-RS-HW1	Not shown		26.2

Elemental maps for the neutral wire are shown in Figure 26 and Figure 27. A continuous sulfide film can be seen, with subsurface attack of the base metal which is typical of copper sulfidation reactions. In the void formed in the base metal, oxidation has occurred, filling the cavity with copper oxide and/or copper sulfate.

Figure 26. EDS map of wire cross section showing oxygen in “pocket. The elemental maps for Cu (red), S (green), and oxygen (blue) are shown.

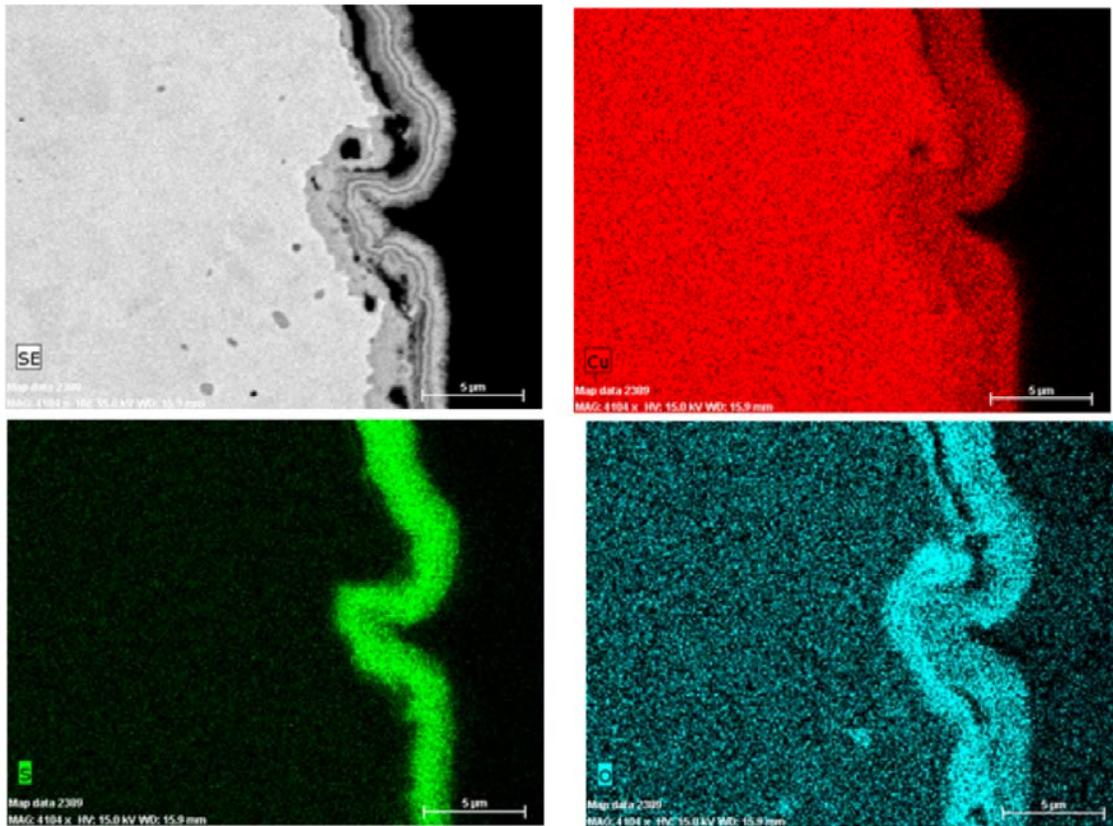
1-ACB-NW-BUS-1\_map2

Figure 27. Elemental maps taken on cross section of the neutral wire from the arc-fault circuit breaker from Circuit 1. The image at the top left is an SEM image of the area being analyzed. The elemental maps for Cu (red), S (green), and oxygen (blue) are shown.

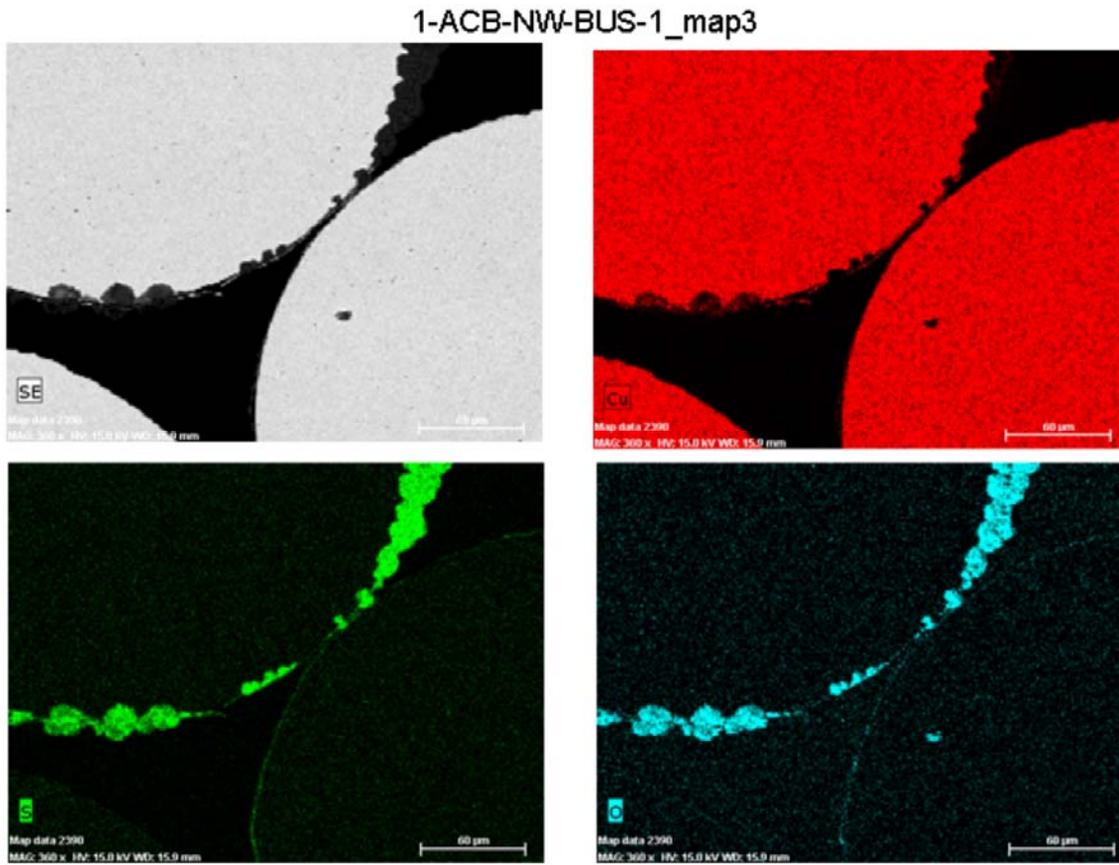
Figure 28 shows elemental maps taken on the stranded wire from the AFCI that was attached to the load center bus. All of the strands of wire are covered with a sulfide layer.

Figure 28. Elemental maps taken on cross section of the neutral wire from the arc-fault circuit breaker from Circuit 1. The image on the left is an SEM image of the area being analyzed. The elemental maps for Cu (red), S (green), and oxygen (blue) are shown.

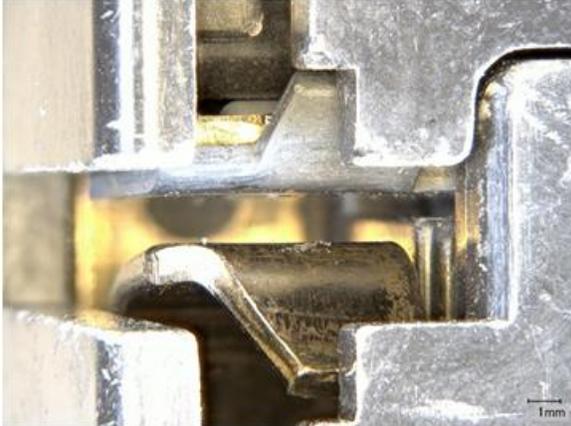
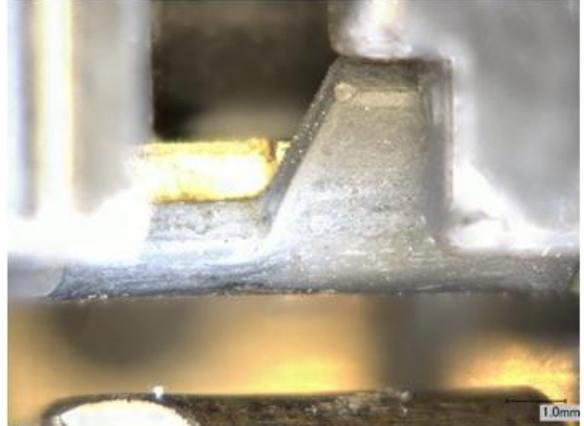
Figure 29 shows optical images of the contact surfaces of the standard circuit breaker from Circuit 1. Corrosion of the upper contact is visible. The lower contact appears to be plated, or constructed of a different material. It did not exhibit extensive corrosion.

Figure 29. Optical images of the contacts in the standard circuit breaker in Circuit 1.

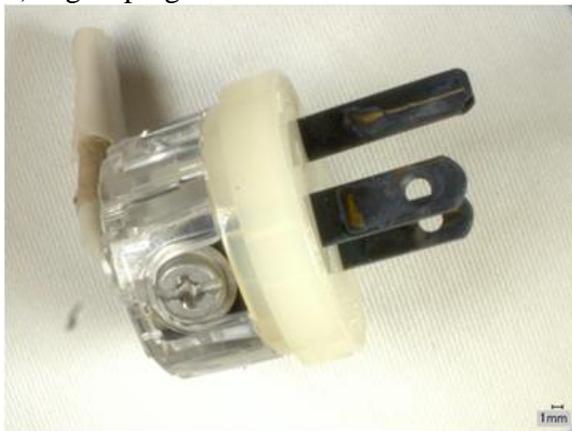
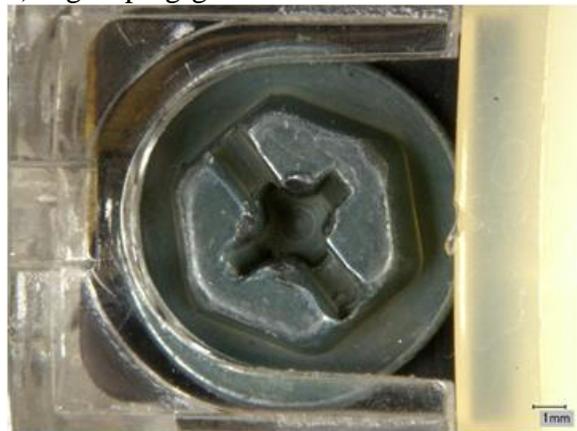
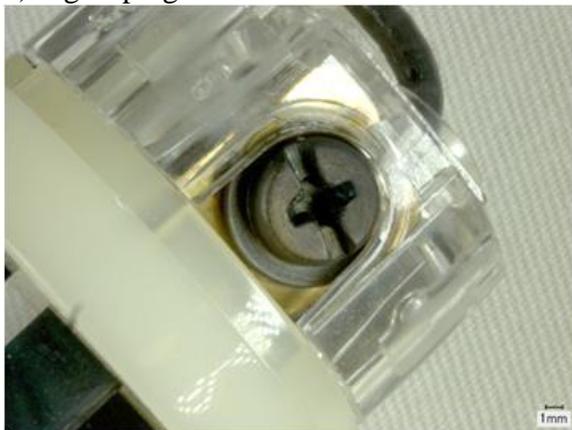
Figure 30 shows images of the plug used to connect the standard receptacle to the GFCI receptacle in Circuit 1. Note that the contact surfaces exhibit corrosion, even when inserted into the socket. Also, note that there are areas of contact that prevented or reduced the attack of the base metal.

Figure 30. Optical images of the plug used to connect the standard receptacle to the GFCI receptacle in Circuit 1. The prongs and screws are blackened relative to those on a new, as-received, unexposed plug.

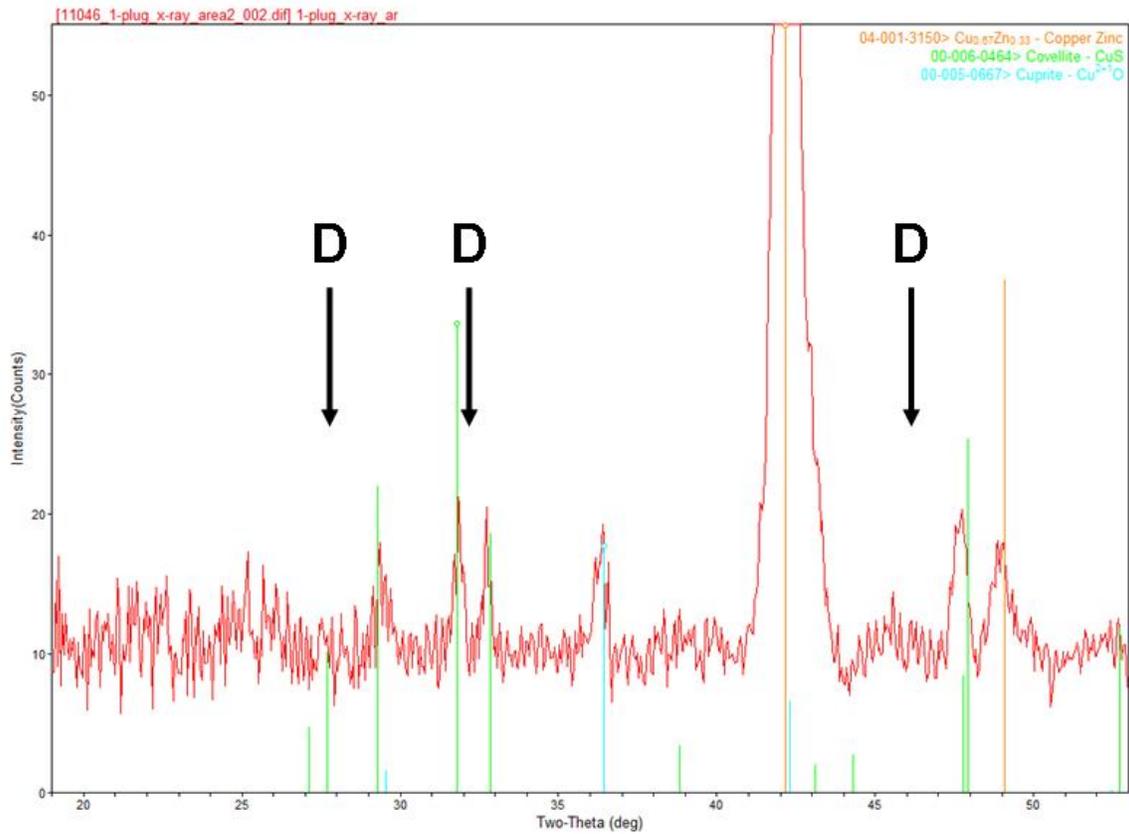
Corrosion product was scraped from the “hot” prong of the plug and analyzed by XRD, and an *in situ* spot was analyzed by  $\mu$ XRD. These tests detected that the base metal is a copper-zinc alloy and revealed the presence of a covellite ( $\text{CuS}$ ) copper sulfide phase. Additional phases detected only by XRD include: copper sulfate hydroxide hydrate and copper zinc sulfate hydroxide hydrate (Ktenasite), whereas, only cuprite  $\text{Cu}_2\text{O}$  was detected by  $\mu$ XRD. Lack of full cross-validation of XRD and  $\mu$ XRD is expected due to the differences in counting statistics and sampling area. The  $\mu$ XRD spectrum is shown in Figure 31 and illustrates the peaks attributable to the covellite, cuprite, and copper-zinc alloy. The figure is also labeled with the approximate locations where a digenite copper sulfide phase would be detected.

Figure 31.  $\mu$ -XRD data for ground prong of plug from Circuit 1, showing cuprite (blue), covellite (green), and copper/zinc (orange) peaks observed and labels where digenite (D) peaks would occur, if present.

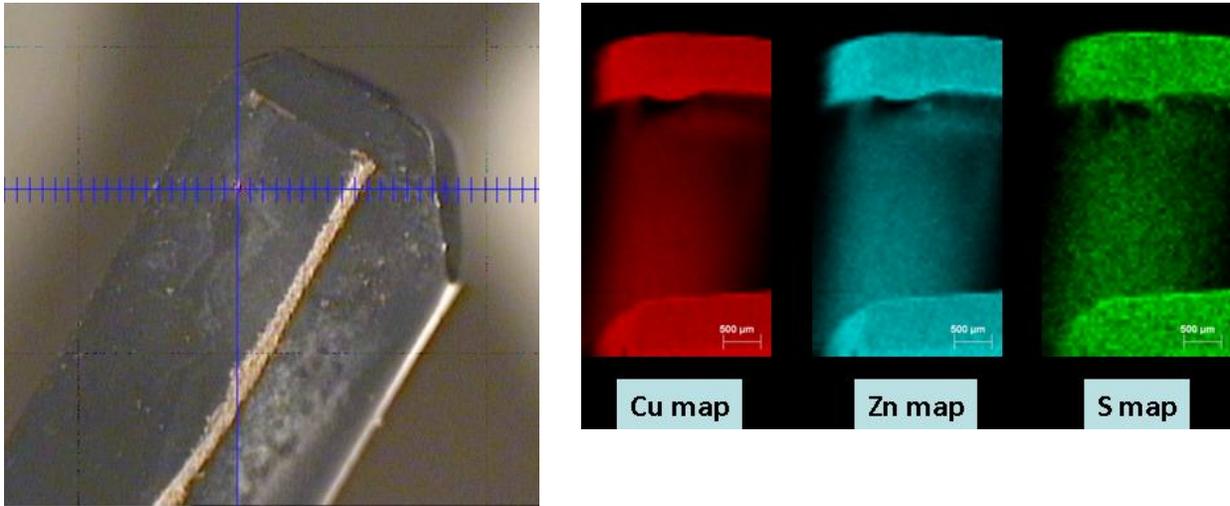
A copper-zinc alloy was detected for the ground prong of the plug by XRF analysis, and the elemental map, Figure 32, shows that the sulfur coverage is uniform within the tested length (approximately 2.5 mm) near the prong end.

Figure 32. Photo of one side of ground prong and XRF element maps of ground prong of grounded plug. XRF images taken “end-on” of full prong.

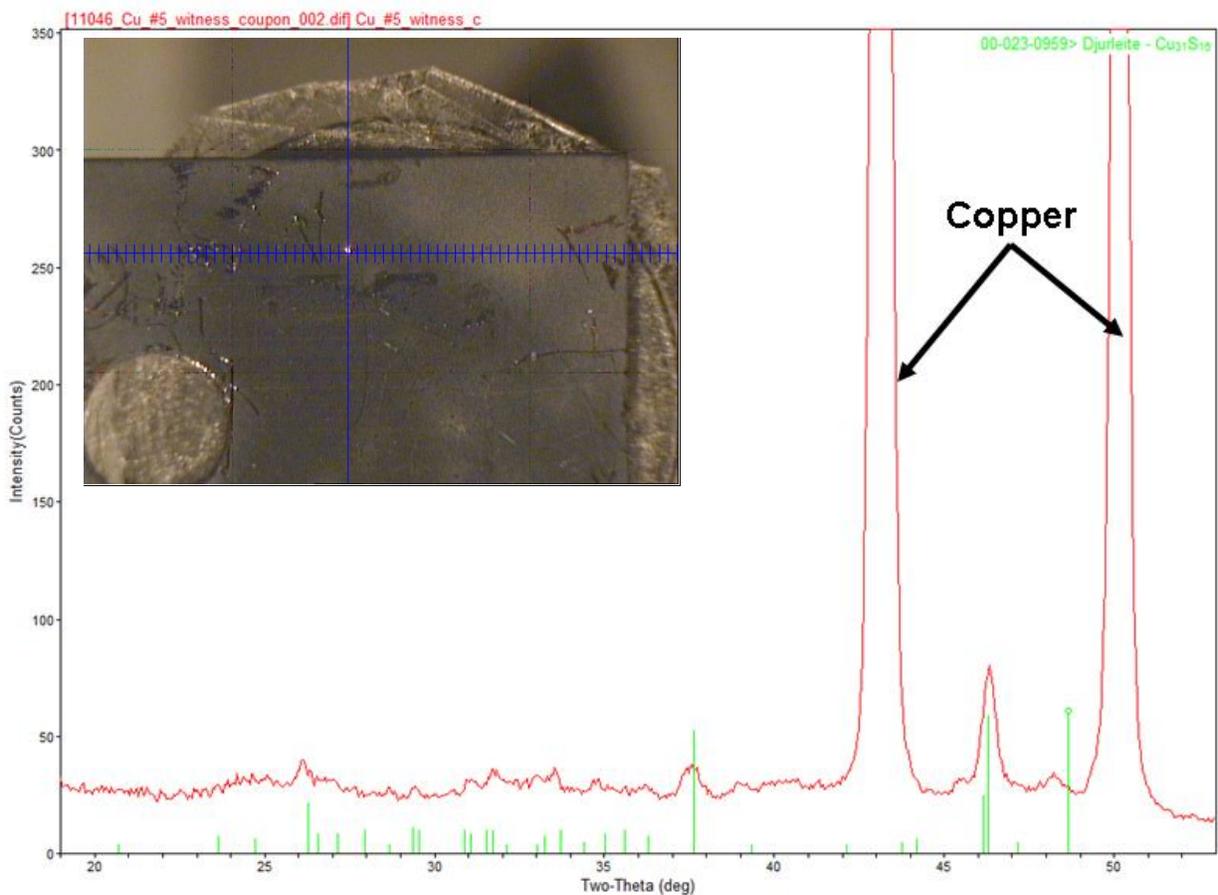
XRD of scraped powder and *in situ*  $\mu$ XRD both detected the copper sulfide phase known as “djurleite” ( $\text{Cu}_{31}\text{S}_{16}$ ) as the predominant corrosion product observed on copper witness coupon No. 5. Data for the  $\mu$ XRD, along with the image indicating the location of the analysis, are shown in Figure 33. The image shows the copper witness coupon (which has a small hole for mounting, which was not used in these tests) on top of the metal instrument sample holder. The grey to bluish-black appearance of the sample is consistent with the appearance of djurleite. Both XRD and  $\mu$ XRD techniques verify also that the witness coupon is pure copper.

Figure 33. Video image (inset) showing location of  $\mu$ XRD analysis and  $\mu$ XRD data for witness coupon No. 5, showing labeled copper and djurleite peaks (green).

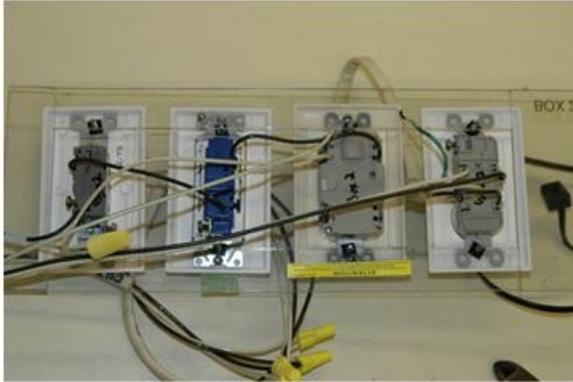
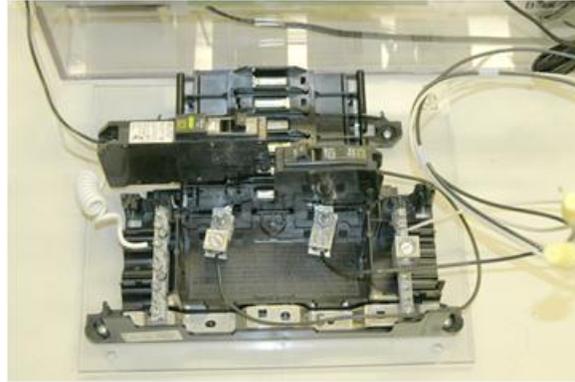
Figure 34 shows optical images of the load center and the back side of the components for Circuit 2. Parts from the rocker switch and the GFCI receptacle were selected for cross section SEM and X-Ray analysis (see Table 5).

Figure 34. Photographs of the electrical components tested in Circuit 2. The view from the bottom (left image) shows how the system was wired electrically. The image on the right shows the load center.

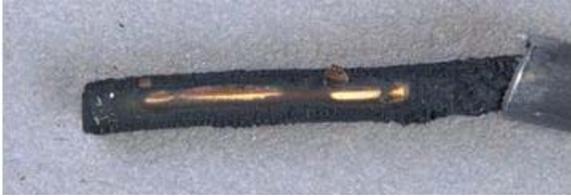
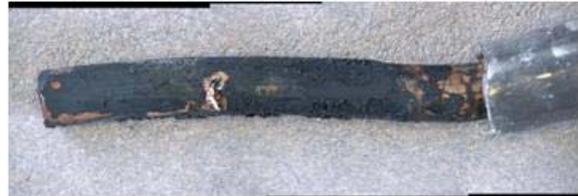
Optical images of the hot wires from the rocker switch in Circuit 2 are shown in Figure 35. The wire on the left was connected using a screw contact, while the wire on the right is from the push-in contact. Note that both exhibit corrosion across the majority of the surface, with contact areas where the surface was shielded, showing little or no attack.

Figure 35. Optical images of wires from the rocker switch in Circuit 2. Both the standard wire connection and the push-in connection are shown.

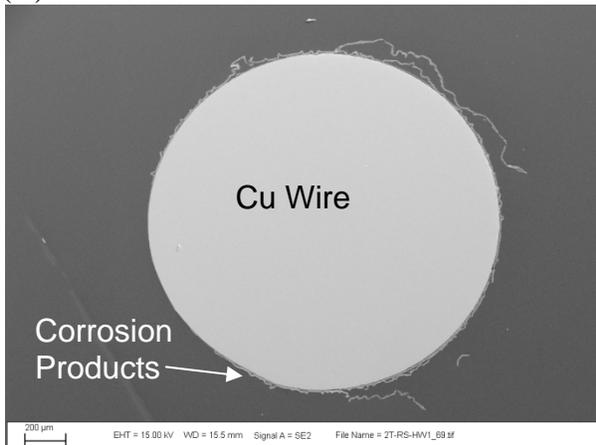
(A) 2T-RS-HW1-69

Figure 36 shows SEM images of the hot wire (screw connected) from the rocker switch. As with other components, there is evidence of film growth and rupture. It is important to note that the thickness of the corrosion product film is very small relative to the diameter of the wire. In other words, copper sulfidation under these conditions is a surface phenomenon and does not result in significant reduction in the cross sectional area of the conductor. As such, the corrosion process will have no effect on the current carrying capabilities of the wire.

Figure 36. SEM images of the cross section of the rocker switch hot wire from Circuit 2. The image on the left shows a low magnification image of the wire, with a high magnification image showing details of the corrosion product layer presented in the figure on the right.

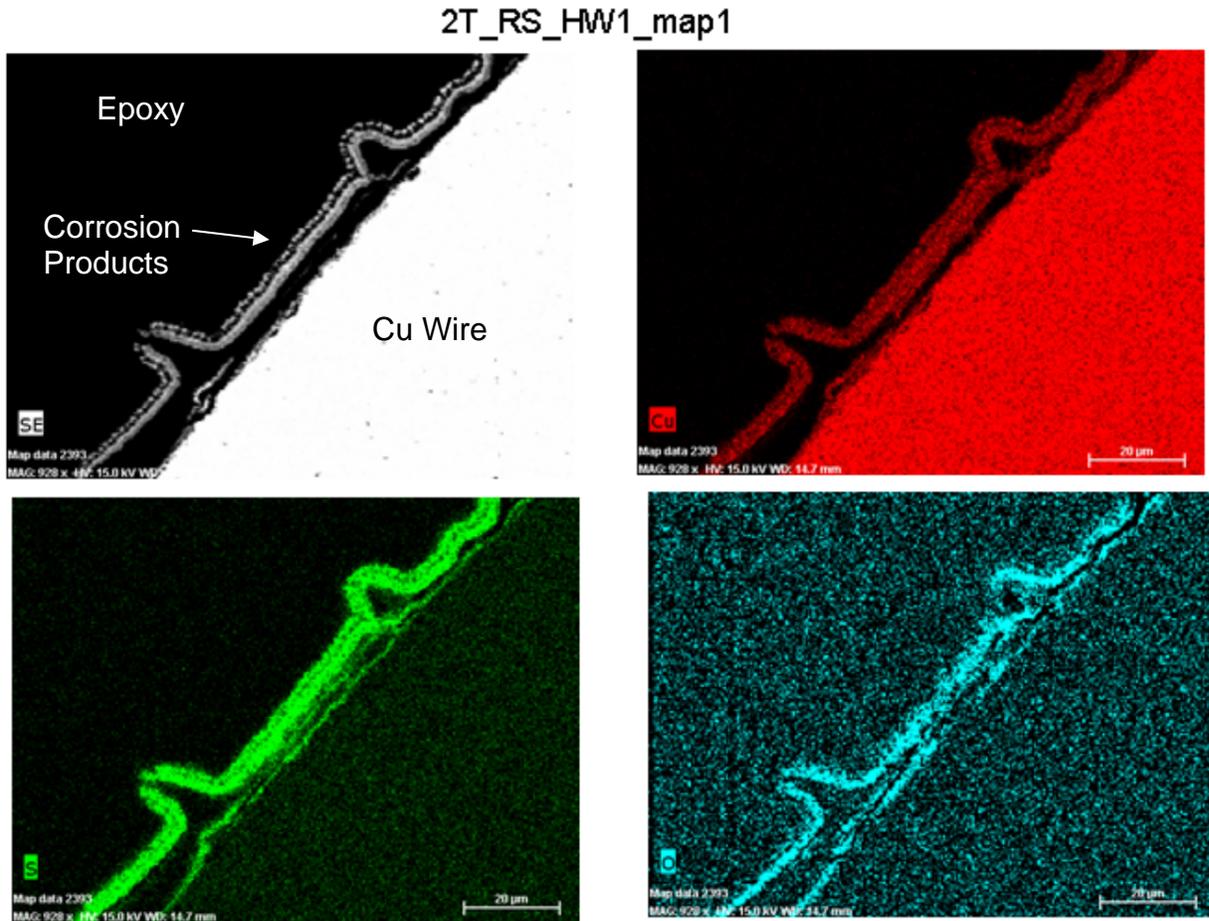
Figure 37 shows the elemental maps of the wire shown in Figure 36. The corrosion product consists of a layer of copper sulfide, with a thinner layer of either copper oxide or possibly copper sulfate.

Figure 37. Elemental maps from the rocker switch hot wire (cross sections) in Circuit 2. The upper left image is an SEM image identifying the area being analyzed. Three maps are shown for Cu (red), S (green), and oxygen (blue).

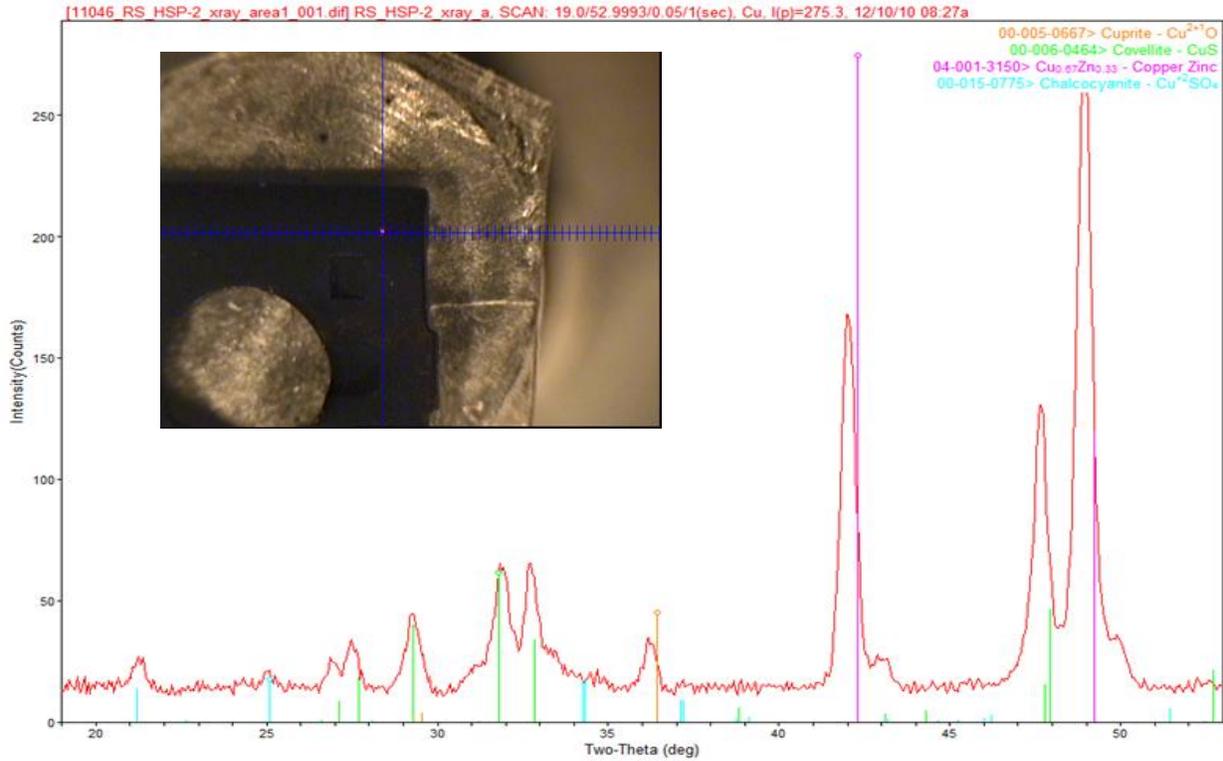
XRD analysis of scraped powder from this contact plate detected the same phases that were detected in the powder scraped from the Circuit 1 plug: covellite, copper sulfate hydroxide hydrate, Cu-Zn sulfate hydroxide hydrate (Ktenasite), and a copper-zinc alloy (as the  $\text{Cu}_{0.67}\text{Zn}_{0.33}$ ).  $\mu\text{XRD}$  analysis was also consistent with that of the Circuit 1 plug, detecting cuprite, covellite, and copper-zinc alloy. Additionally a chalcocyanite phase ( $\text{CuSO}_4$ ) was detected *in situ* on this part. The location of sampling and  $\mu\text{XRD}$  data are shown in Figure 38. The large metal piece behind the sulfidated (black) part is the instrument sample holder.

Figure 38. Video image (inset) and  $\mu\text{XRD}$  data for 2-RS-HSP-2 (contact plate), showing cuprite (orange), covellite (green), and copper/zinc (purple), and chalcocyanite ( $\text{Cu}^{2+}\text{SO}_4$ -light blue) peaks observed.

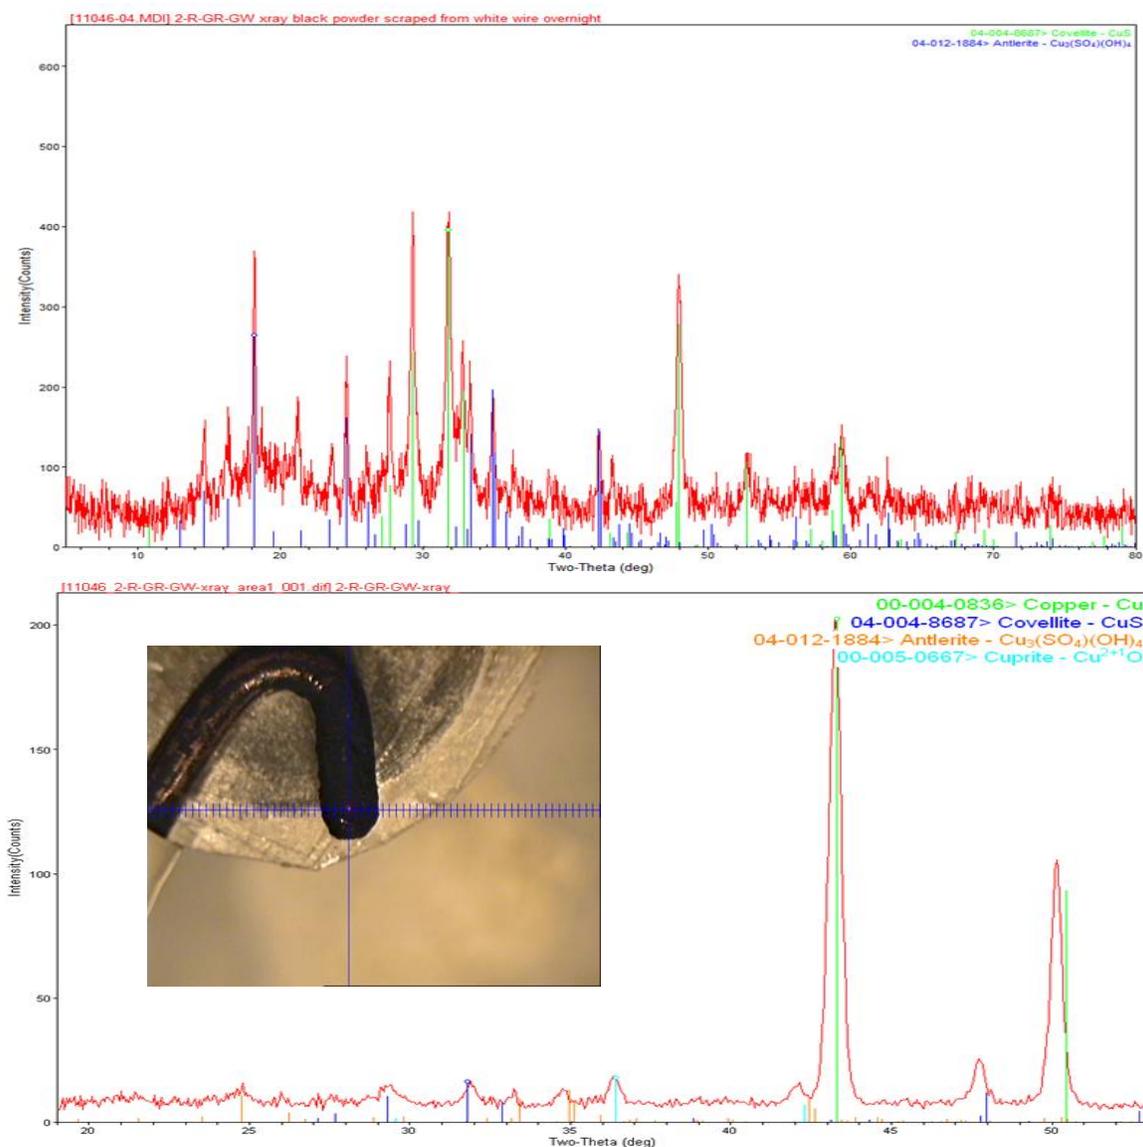
XRD analysis of black powder scraped from the wire surface (top, Figure 39) and  $\mu$ XRD *in situ* of the ground wire (bottom, Figure 39) of the GFCI component of Circuit 2 detected covellite ( $\text{CuS}$ ) and the antlerite copper sulfate hydroxide phase ( $\text{Cu}_3(\text{SO}_4)(\text{OH})_4$ ). In addition, the  $\mu$ XRD data shows copper oxide (cuprite) and copper metal.

Figure 39. XRD data (top) for powder scraped from wire 2-R-GR-GW showing covellite (green) and antlerite (blue), and  $\mu$ -XRD data (bottom) showing antlerite (orange), cuprite (light blue), covellite (dark blue), and copper (green) peaks.

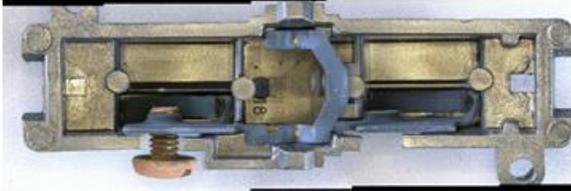
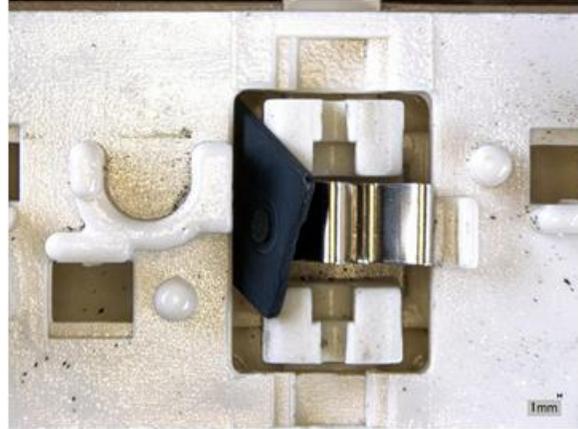
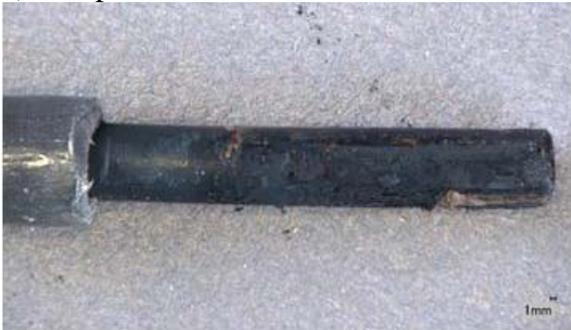
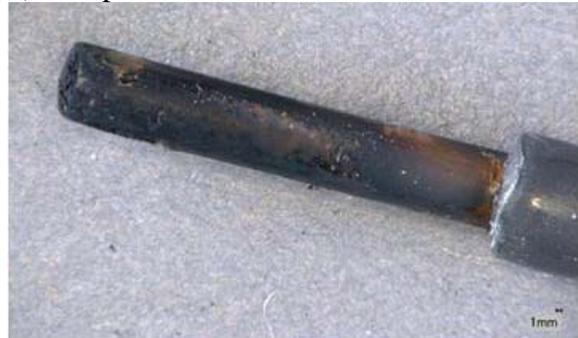
Figure 40 shows optical images for the rocker switch from Circuit 3. The case was removed to reveal the interior components. As with other components, it appears that the case provides little or no protection against the corrosive gasses. Both interior and exterior components exhibit corrosion. The bottom two images show both sides of the hot wire. In this case, the wire was connected to the push-in contact. Corrosion of the wire surface was less nonuniform, but it essentially covered the entire surface other than the contact point.

Figure 40. Optical images of the rocker switch and hot wires from Circuit 3.
