SAND2011-1539

## **Report on Accelerated Corrosion Studies of Electrical Components**

S. Jill Glass, Curtis D. Mowry, and N. Robert Sorensen

Sandia National Laboratories (SNL) conducted accelerated atmospheric corrosion testing for the U.S. Consumer Product Safety Commission (CPSC) to help further the understanding of the development of corrosion products on conductor materials in household electrical components exposed to environmental conditions representative of homes constructed with problem drywall. The conditions of the accelerated testing were chosen to produce corrosion product growth that would be consistent with long-term exposure to environments containing humidity and parts per billion (ppb) levels of hydrogen sulfide ( $H_2S$ ) that are thought to have been the source of corrosion in electrical components from affected homes. This report documents the test set-up, monitoring of electrical performance of powered electrical components during the exposure, and the materials characterization conducted on wires, screws, and contact plates from selected electrical components. No degradation in electrical performance (measured via voltage drop) was measured during the cour

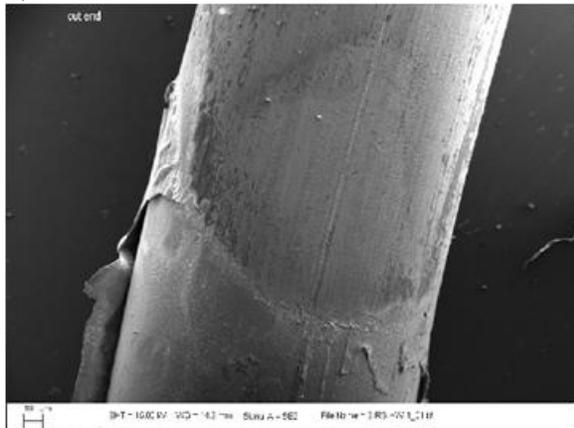
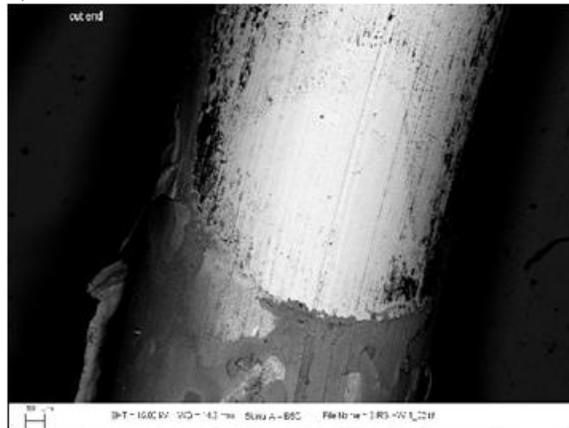
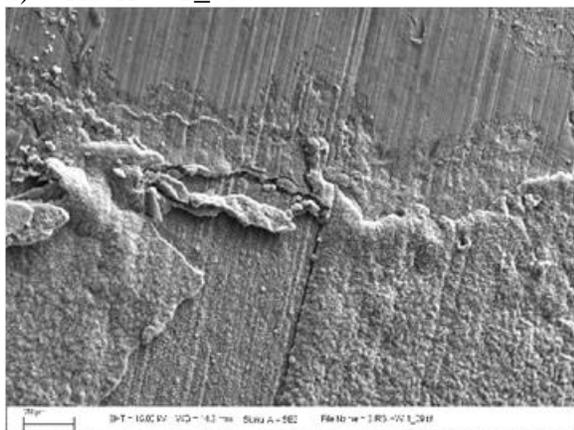
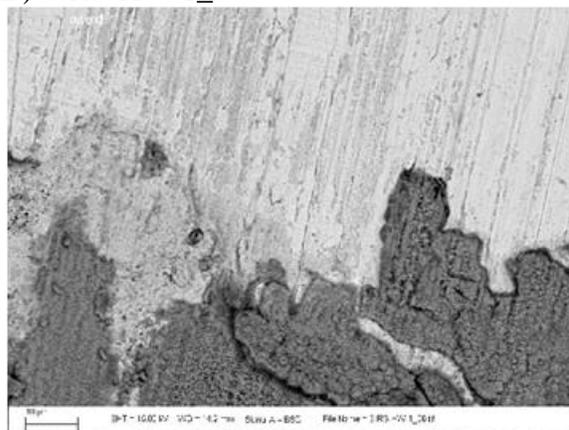
Figure 41 shows SEM images of the hot wire from the rocker switch. The figures on the left are secondary electron images that show topography. In this case, the insulation was removed next to the corroded area. The images on the right are back-scattered electron images. In these images, brightness is a function of the atomic number of the element on the surface. The bright area in the top of the image represents bare copper exposed by the removal of the insulation; the lower portion of the picture is darker and represents the sulfide layer (*i.e.*, copper has a higher/larger atomic number than sulfur). These images show that sulfidation of the copper stops where the insulation protects the underlying copper. Figure 42 shows the elemental maps associated with this location. Clearly, the insulation protected the underlying copper from sulfidation because the top of the elemental maps showing the region of the wire that was covered with insulation shows no sulfur.

Figure 41. SEM images of the hot wire from the rocker switch in Circuit 3. The figures on the left are secondary electron images, which show topography. The images on the right are back-scatter images. In these images, brightness is a function of the atomic number, with higher brightness indicating elements of higher atomic number.

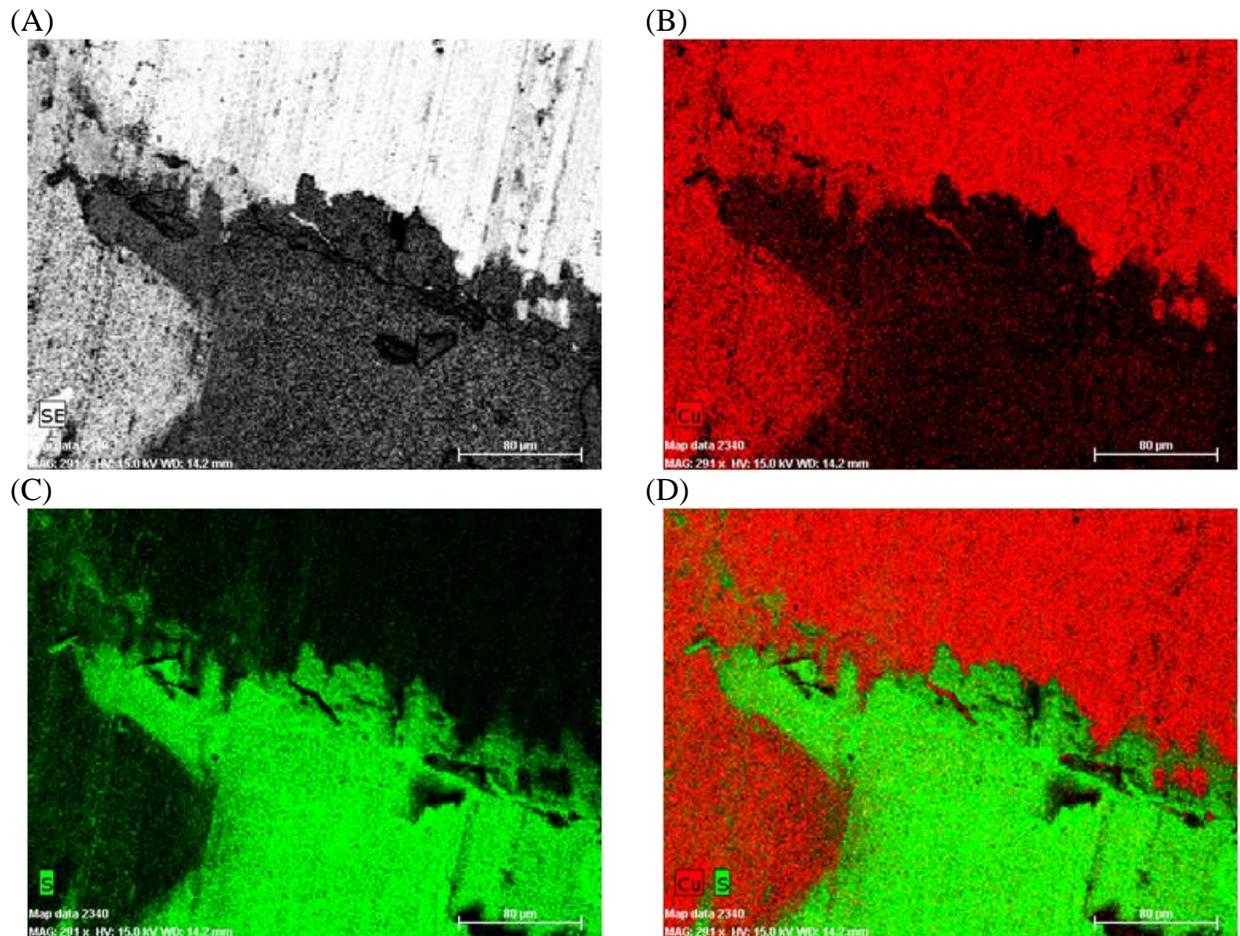
Figure 42. EDS elemental maps of the hot wire from the rocker switch in Circuit 3. Images include A the SEM image, (B) a copper map (red), (C) a sulfur map (green), and (D) a combined copper/sulfur map (red and green).

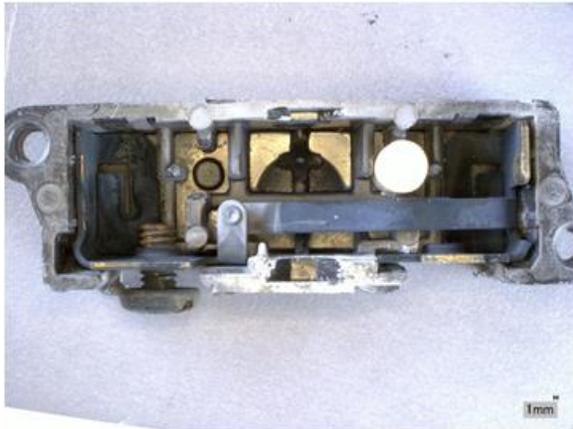
(A) 3-TS-insides-1

Optical images of the toggle switch from Circuit 3 are shown in Figure 43. As with previous components, sulfidation was universal, except where the surface was shielded (contact points).

Figure 43. Optical images of the toggle switch in Circuit 3. The figure on the left shows the inside of the switch. Note the extensive corrosion product on some of the components. The image on the right is of the hot wire connected to the toggle switch (screw side).

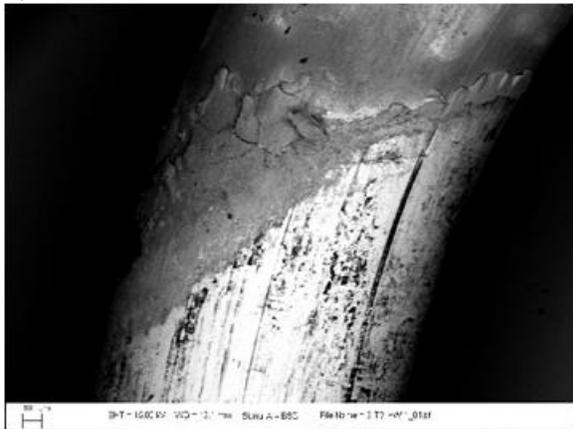
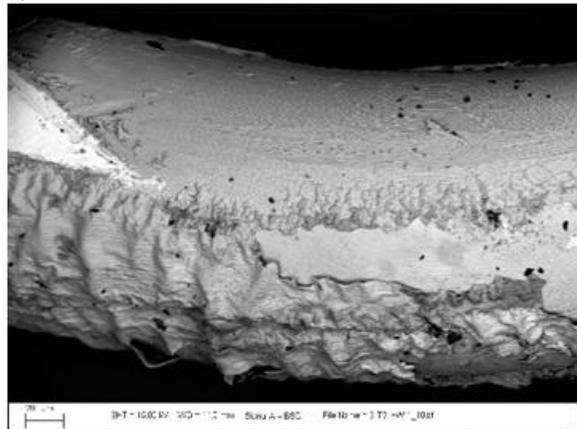
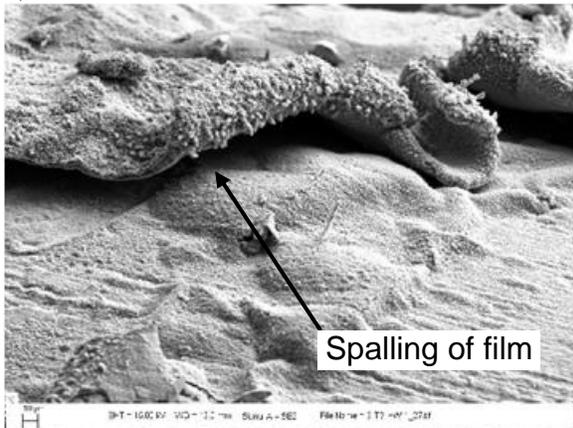
Figure 44 shows SEM images of the hot wire from this component. The top two images are back-scattered electron images and show the presence of bare Cu at a contact point (light region). The corrosion product film structure/morphology is similar to that found on other components, exhibiting layering, buckling, and spalling.

Figure 44. SEM images of the hot wire from the toggle switch in Circuit 3. Note the spalling of the corrosion product film. The contact areas can be seen in the upper two images (bright areas) where the contact shielded the surface from the corrosive gasses.

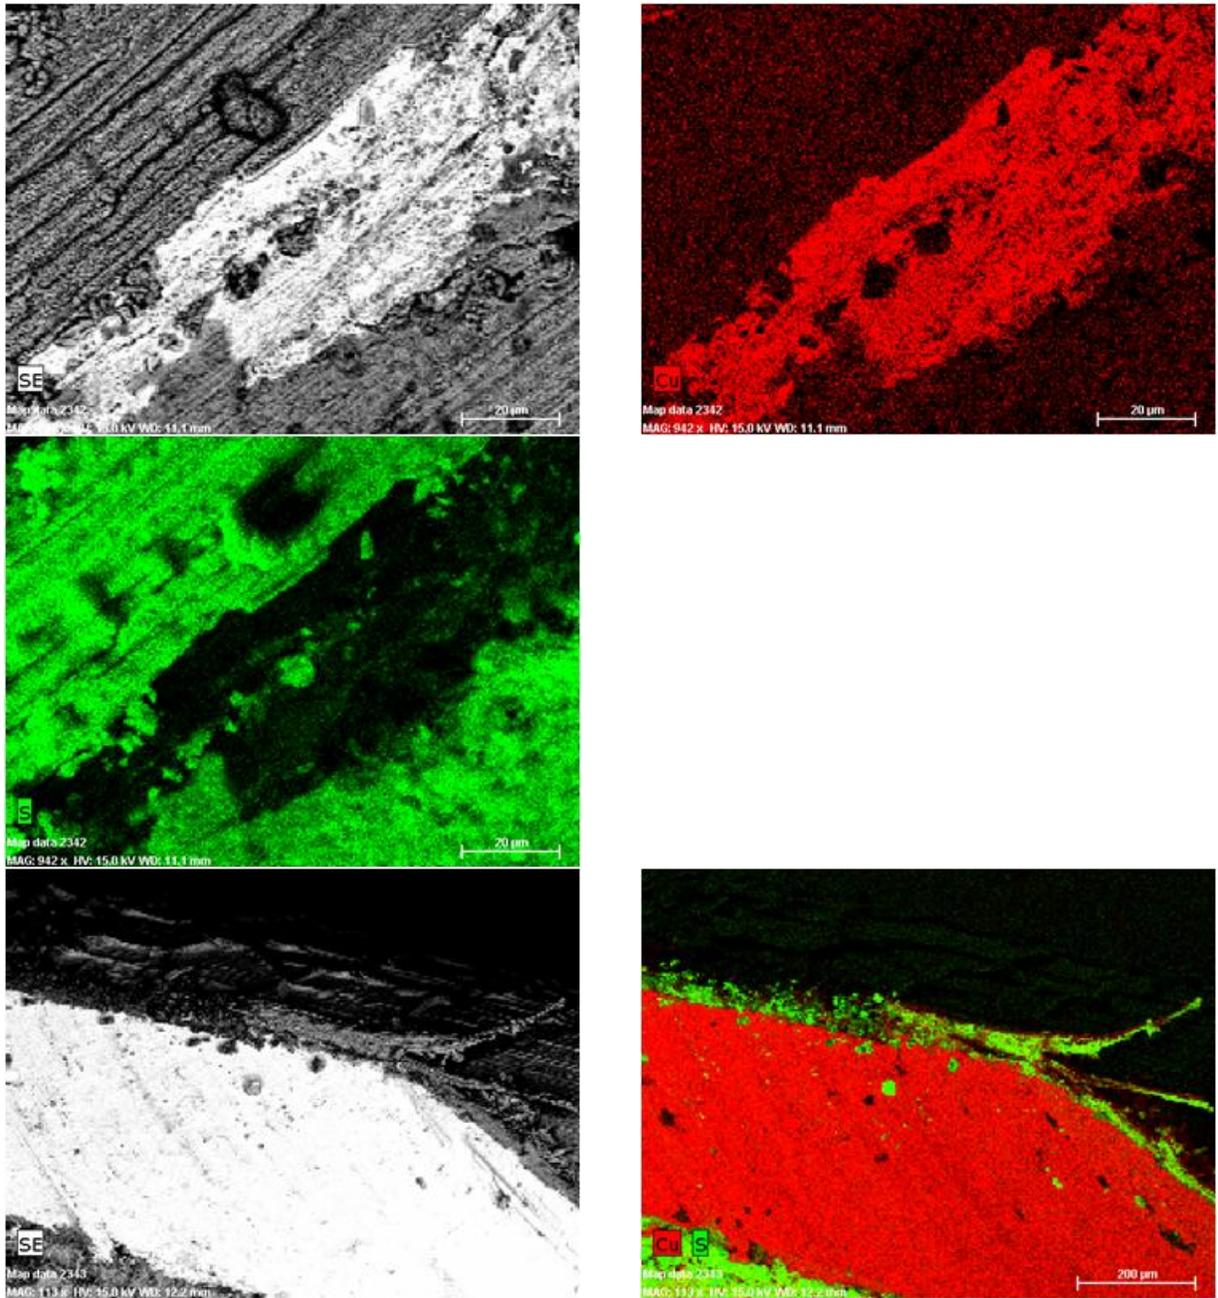
Figure 45 shows EDS elemental maps of two areas of the hot wire from the toggle switch. Copper is shown in red, and sulfur is shown in green. These images are consistent with the SEM images and show the presence of bare Cu at the contact points.

Figure 45. SEM images and EDS elemental maps of the hot wire from the toggle switch in Circuit 3. Sulfur is shown in green, and copper is shown in red.

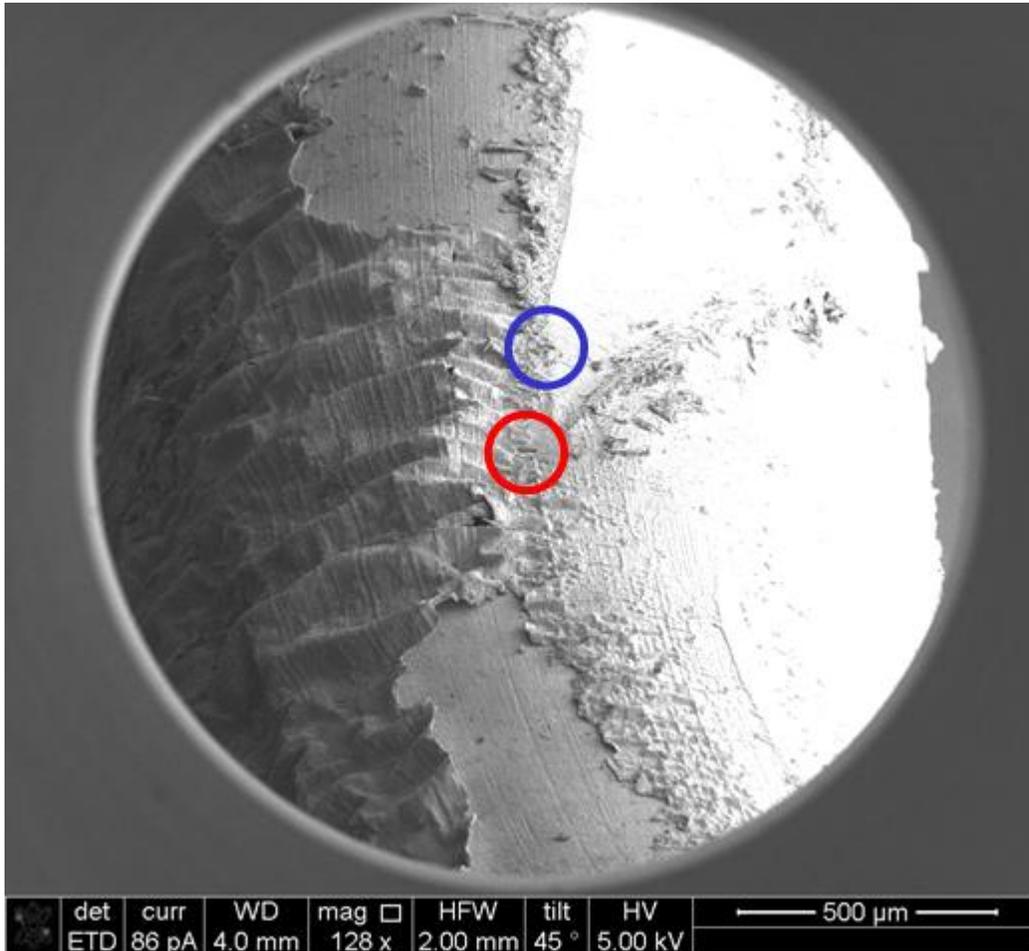
potentially less damaging to the surface layers; however, it is time consuming; therefore, only limited FIB analyses were performed. Figure 46 shows a low magnification view with circles indicating locations of two FIB cuts. Since this is a very low magnification, the instrument aperture is observed as the wider circle. The bright area in the upper right, is the area where the screw made contact with the wire and appears to be free of corrosion product.

Figure 46. Low magnification FIB image of hot wire from toggle switch (3TS-HW-1), showing location of FIB cuts (red designated as “Section 1” and blue designated as “Section 2”) into corrosion product film.

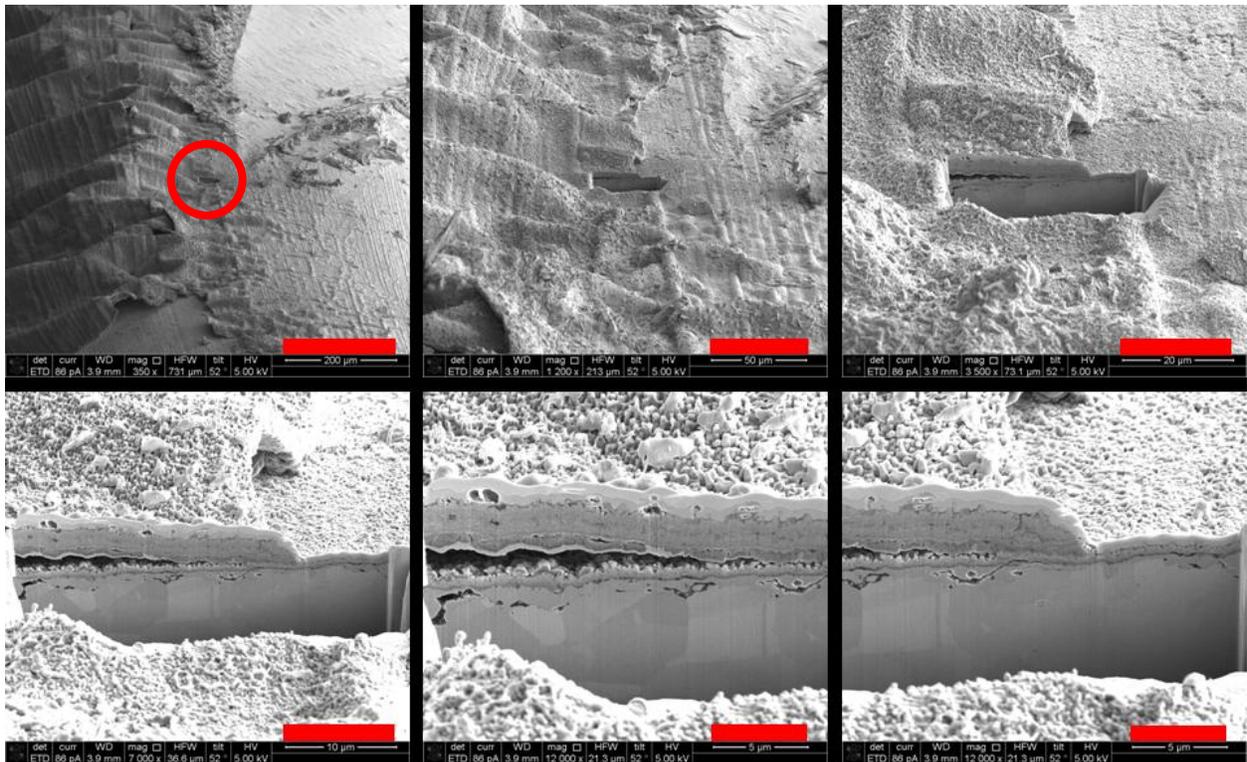
Figure 47 shows SEM images of the FIB cut designated as “Section 1,” indicated by the red circle in the previous figure, at increasing magnifications (350 to 12,000X magnification). This FIB cut is approximately 50 microns from the nearest portion of the wire contacted by the screw. The middle top image illustrates wavy features of the corrosion product observed in SEM cross sections of other samples. The right top and lower left images illustrate an abrupt edge of the wavy growth that appears to have smaller features, suggesting flaking and regrowth of the corrosion product. The middle lower and right lower images show closer views of the corrosion layer and the varying gap between the wire and corrosion product. This is consistent with crosssection observations of other wires.

Figure 47. FIB cuts into 3-TS-HW-1 “Section 1” (see Figure 46) with scale bars at 200 (350X), 50, 20, 5, and 5 (12,000X) microns, respectively.

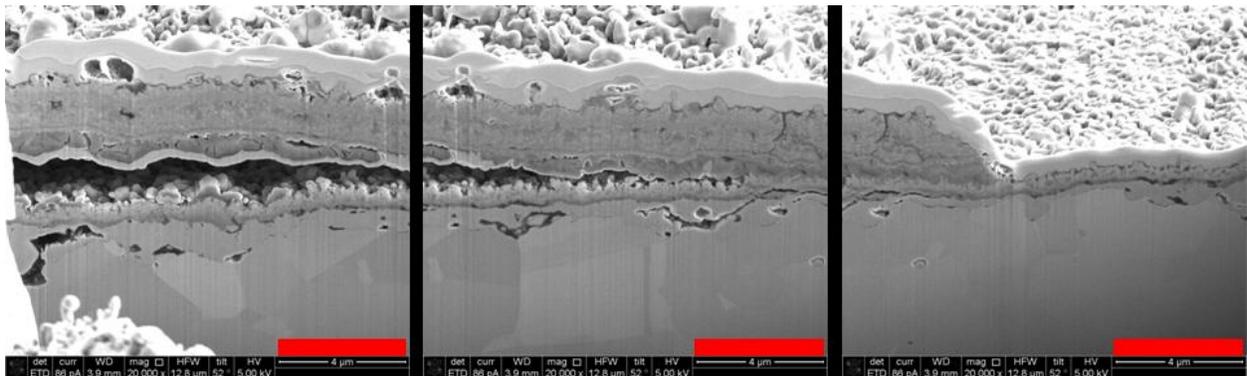
Figure 48 shows three images at the same magnification (20,000X) of the edge of the FIB cut. The copper wire is at the bottom, the varying contrast areas are consistent with solid copper. Some pitted areas are observed along with roughened product growth underneath the upper layer of corrosion. The bright white top layer is the platinum layer deposited on the sample to preserve features.

Figure 48. FIB cuts into 3-TS-HW-1 “Section 1” (see Figure 46) with scale bars at 4 microns each.

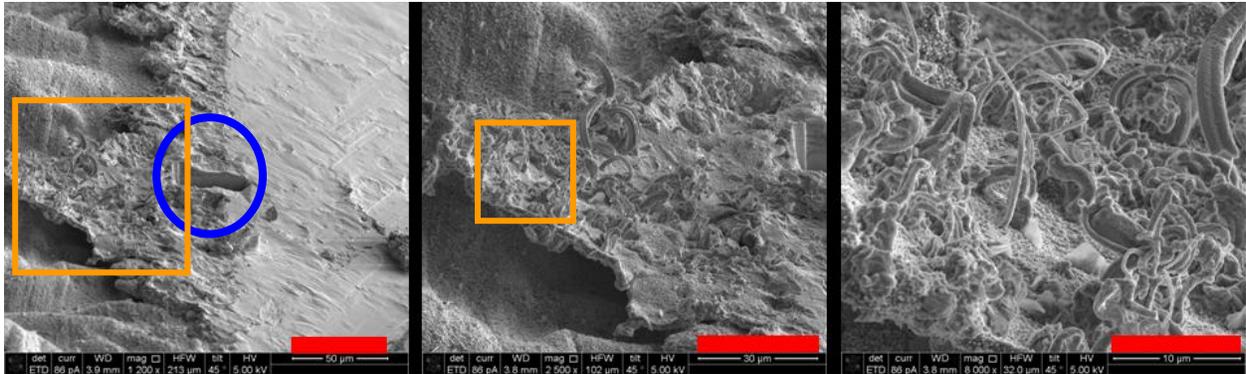
Interesting growth morphologies were seen in all samples, which included needles and other features. One example, with needle and spiral-like growths, observed near the FIB cut is shown

in Figure 49 at various magnifications. On the left is a wider view of “Section 2,” indicated with the blue circle. The orange box indicates the approximate area of the middle image, while the orange box in the middle image indicates the approximate area of the image on the right.

Figure 49. FIB cuts into 3-TS-HW-1 “Section 2” (see Figure 46) with scale bars at 50, 30, and 10 microns, respectively.

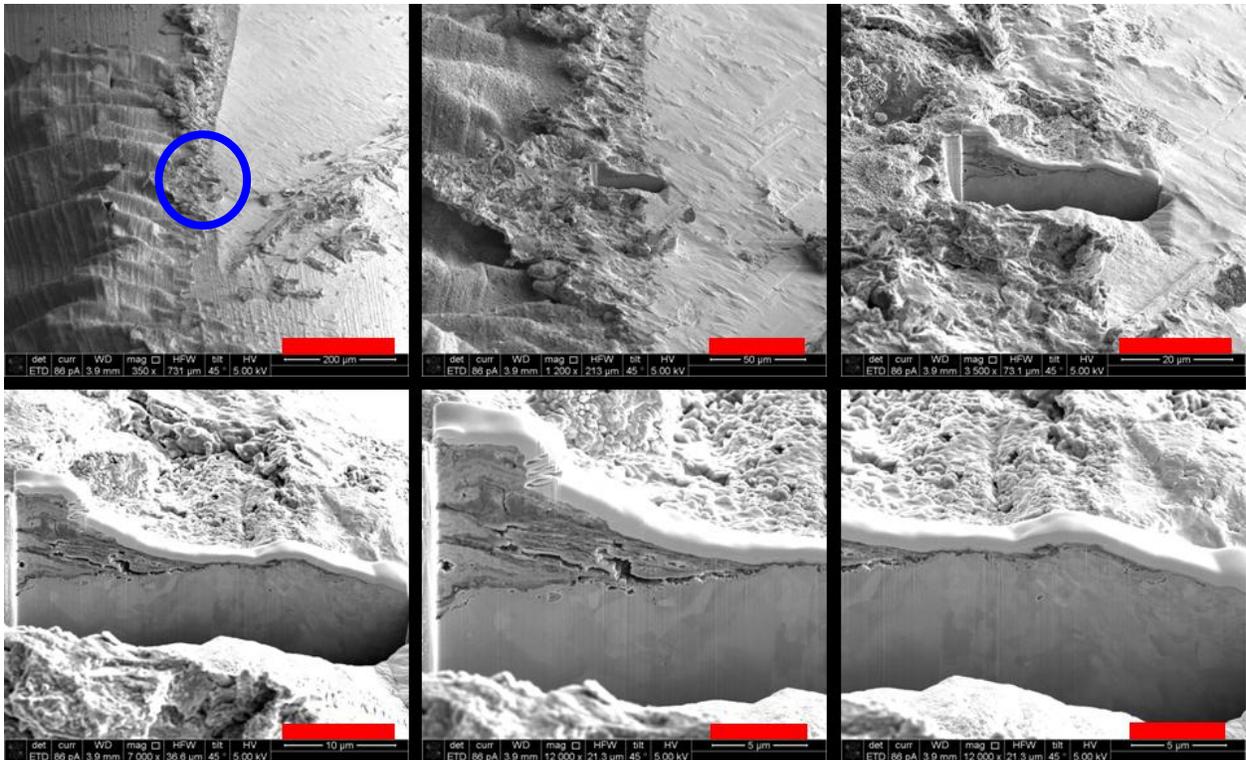
A closer look at the cross section of corrosion growth revealed by the FIB cut designated as “Section 2” is shown in Figure 50. In the top row, a bare copper area is observed to the upper right of the images, the area underneath the screw. The lower row shows higher magnification views of the change in the corrosion thickness from left to right.

Figure 50. FIB cuts into hot wire from Circuit 3 toggle switch (3-TS-HW-1) “Section 2” (see Figure 46) with scale bars at 200, 50, 20, 10, 5, and 5 microns, respectively.

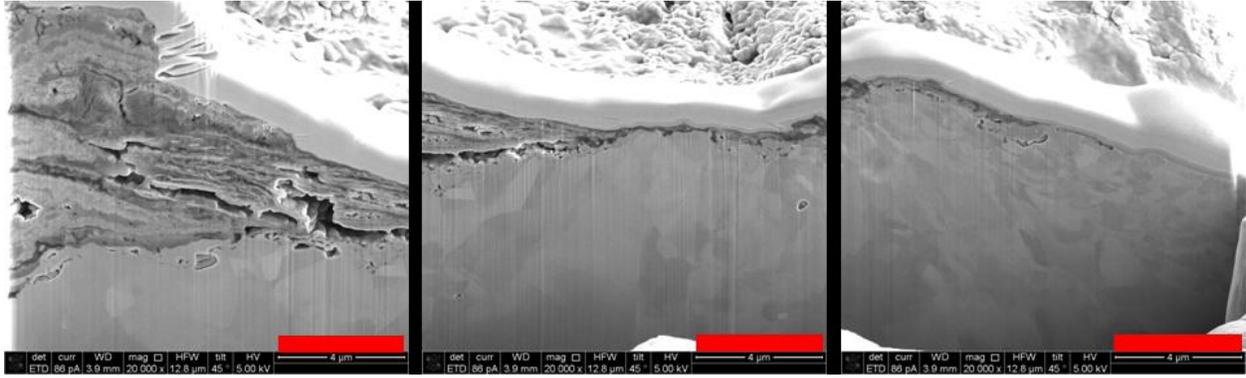
Figure 51 contains a series of SEM images across the FIB cut at 20,000X magnification. Layering and pitting is observed; moving from left to right and closer to the contact point of the screw, the overall corrosion thickness transitions from approximately nine microns to significantly less than one.

Figure 51. FIB cuts into 3-TS-HW-1 “Section 2” (see Figure 46) with scale bars at 4 microns each (20,000X).

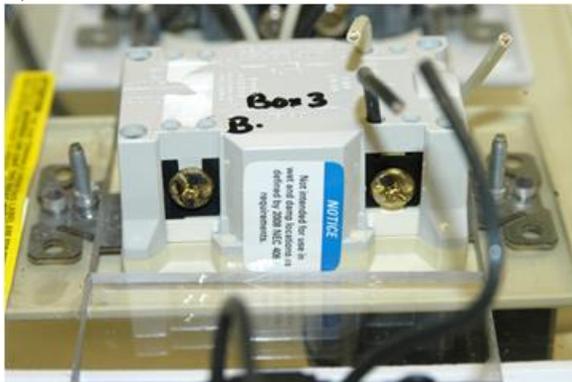
(A) CKT-3\_6957

Figure 52 shows optical images of the GFCI receptacle from Circuit 3. The contact screws showed evidence of minor corrosion on the surface. The contact plates below the screws were corroded extensively. As seen in the figure, they were black at the conclusion of the test.

Figure 52. Optical images of the GFCI receptacle. Note the darkening of the normally shiny contact pads and slight corrosion (discoloration) of the screws.

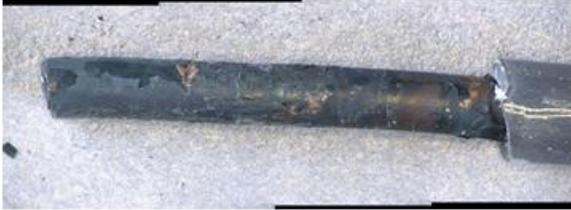
(A) 3-R-PIHW-2

Figure 53 shows optical images of the hot wires (push-in contacts) from the standard receptacle from Circuit 3. These results are consistent with previous samples, showing corrosion product across the surface except where the contact was made.

Figure 53. Optical images of wires from the standard receptacle from Circuit 3. Both the (A) hot and (B) neutral wire are shown. Both are “push-in” type contacts.

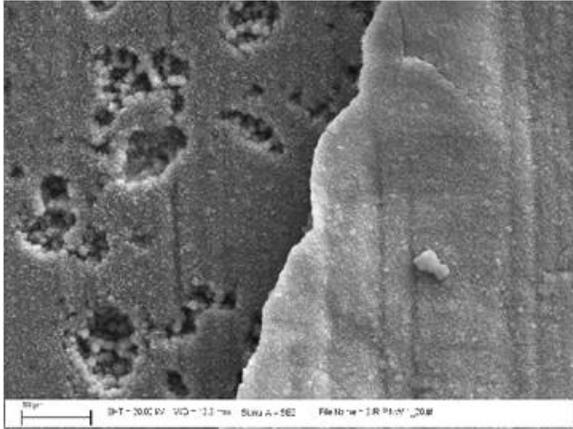
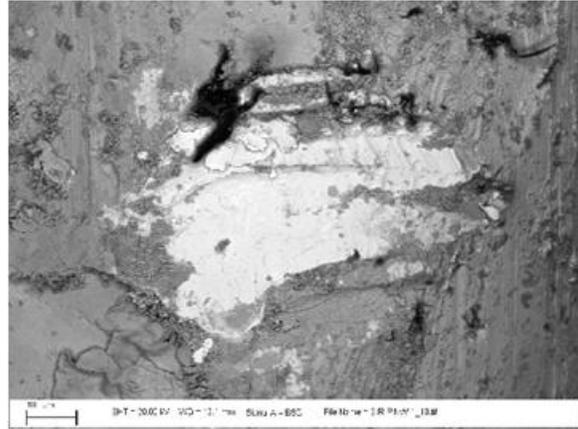
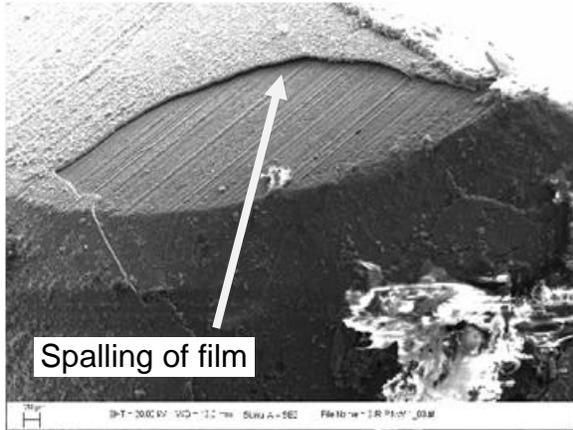
The SEM images shown in Figure 54 show similar features to other samples: multiple layers of the film, spalling, voiding of the metal, and bare metal at the contact point.

Figure 54. SEM images of the surface of the neutral wire from the receptacle in Circuit 3. The connection was a push-in connection. (B) shows the contact point, which is brighter due to the presence of Cu without S. The end of the wire is shown in the lower images at two magnifications. Note the spalling of the corrosion product film. It is believed that the spalling occurred during the test, but is it possible that it occurred after exposure and prior to analysis.

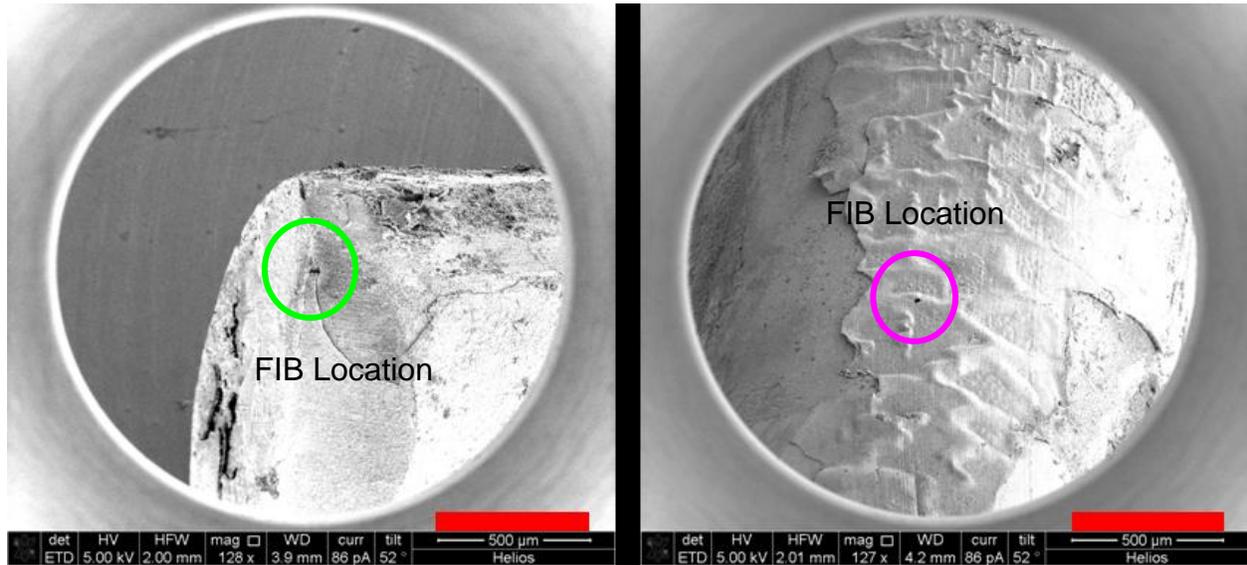
SEM images of two FIB cuts (designated as “Section 3” and “Section 4”) on the neutral wire from the push-in connector of the receptacle are shown below at magnifications of 128x and 127x. The aperture of the instrument is observed as the outer view circle due to wide view and low magnification. “Section 3” (left) was cut at the edge of the corrosion product film. Section 4 (right) was cut into an area surrounded by “wavy” corrosion growth.

Figure 55. FIB cuts into corrosion product on surface of neutral wire 3-R-PINW-1 with “Section 3” (left) and “Section 4” (right) with scale bar of 500 micron.

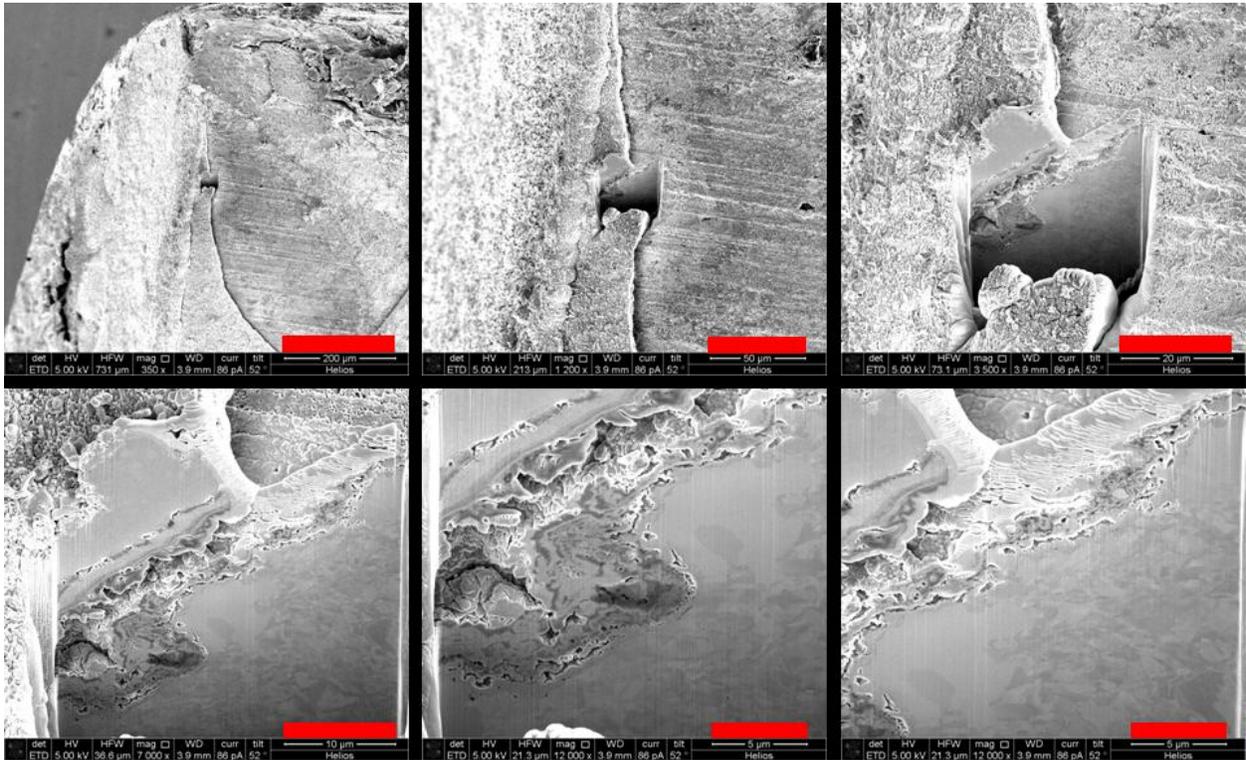
Higher magnification images of “Section 3”, ranging from 350X to 12,000X are presented next (Figure 56) and display varying thickness as well as voiding of the copper below the corrosion product film. The fracture line down the center of the images in the top row shows an area of corrosion product that flaked off.

Figure 56. FIB cuts into neutral wire 3-R-PINW-1 “Section 3” (see Figure 55) with scale bars of 200, 50, 20, 10, 5, and 5 microns.

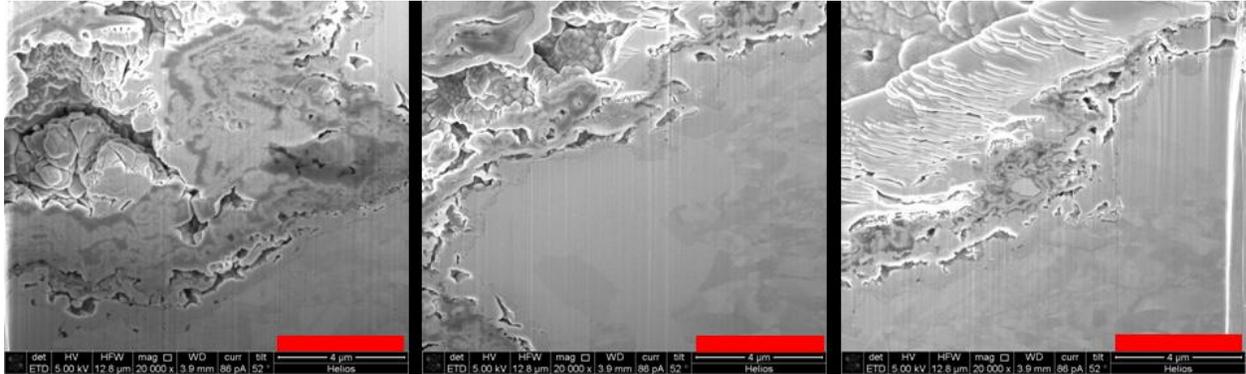
Higher magnification images of the pitting observed in “Section 3” are below (Figure 57); with the thinnest corrosion growth, the platinum FIB coating, and pure copper grains prevalent in the image on the right.

Figure 57. FIB cuts into neutral wire 3-R-PINW-1 “Section 3” (see Figure 55) with scale bars of 4 micron each.

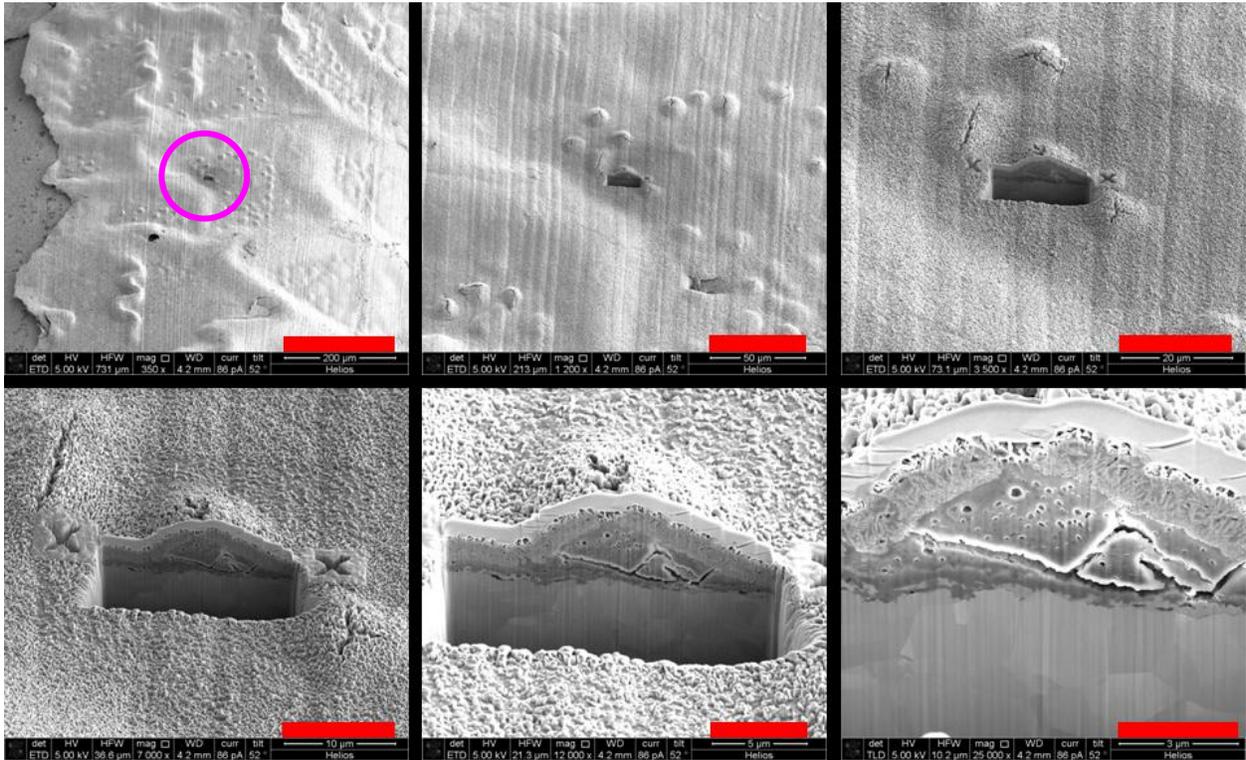
Higher magnification views of “Section 4” are shown in Figure 58 and illustrate an additional morphology seen in some samples—that of a “ bubbling” or blistering of the corrosion product layer. The magnification ranges from 350X to 25,000X. In the lower right image, three different kinds of growth layer are observed—a layer with few voids, a middle layer with multiple voids,

and a third solid layer with what appears to be striated growth. The top-most white layer in the image is the platinum FIB overcoat.

Figure 58. FIB cuts into neutral wire 3-R-PINW-1 “Section 4” (see Figure 55) with scale bars of 200, 50, 20, 10, 5, and 3 microns, respectively.

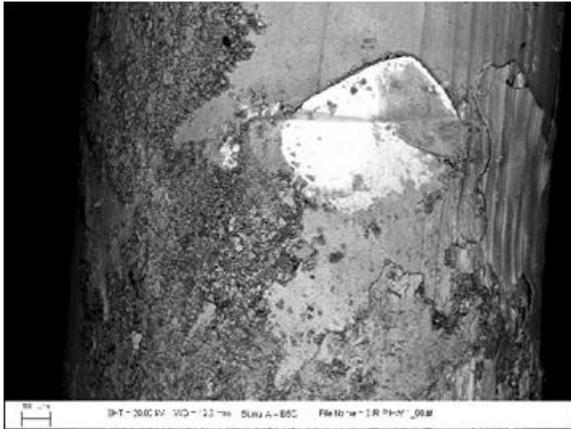
(A) 3-R-PIHW-1\_08

Figure 59 shows SEM images of the push-in hot wire from the receptacle in Circuit 3. The image on the left shows the contact point. It is clear that the intimate contact between the wire and the receptacle contact prevented sulfidation from occurring in the contact area. The image on the right shows the wire at the interface with the insulation. In this case, the insulation was removed to reveal the wire surface directly beneath the insulation. The fact that bare copper is visible in the region shielded by the insulation suggests that the insulation prevents the pollutant gas from contacting the copper wire.

Figure 59. SEM images of the hot wire from the receptacle in Circuit 3. The connection was a push-in connection. The contact point is shown in the image on the left. The image on the right shows a region of a hot wire that was covered by insulation on the bottom.

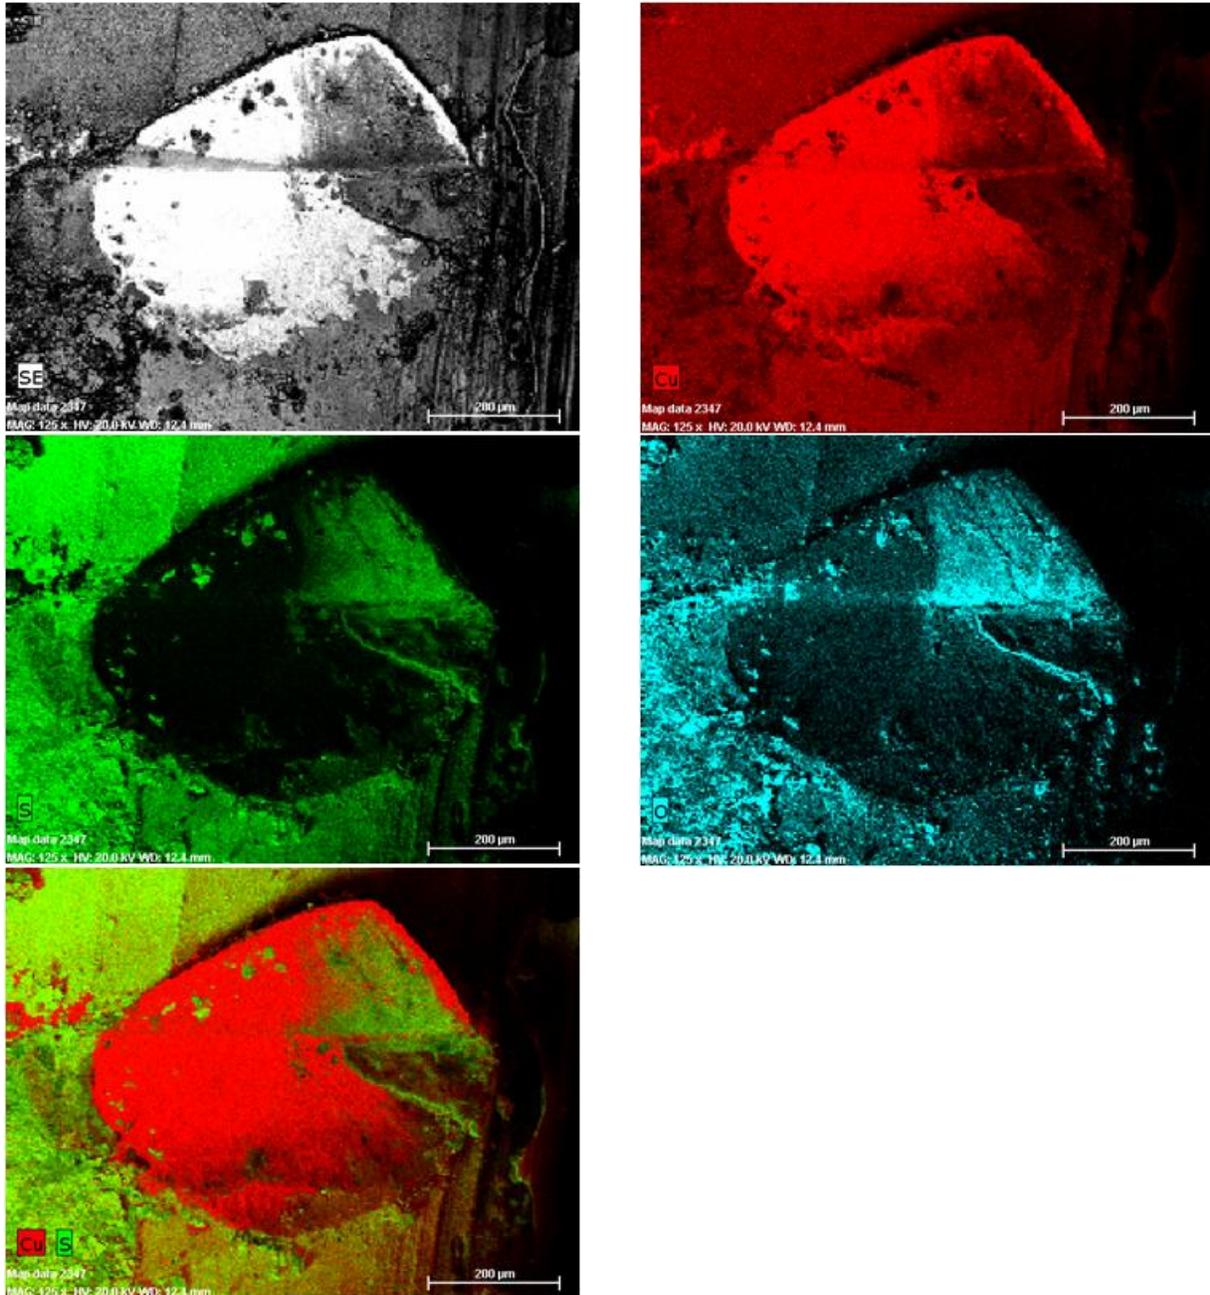
Figure 60 shows the EDS elemental maps from the wire in Figure 59. Copper corrosion products (primarily sulfide with some oxide and/or sulfate) are present on the wire surface, except where the contact was made. In that location, bare copper is visible.

Figure 60. EDS elemental maps of the wire shown in Figure 59. Copper (red), sulfur (green), and oxygen (blue) are shown.

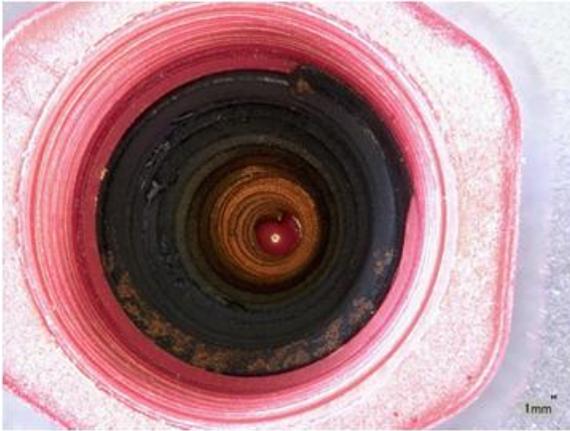
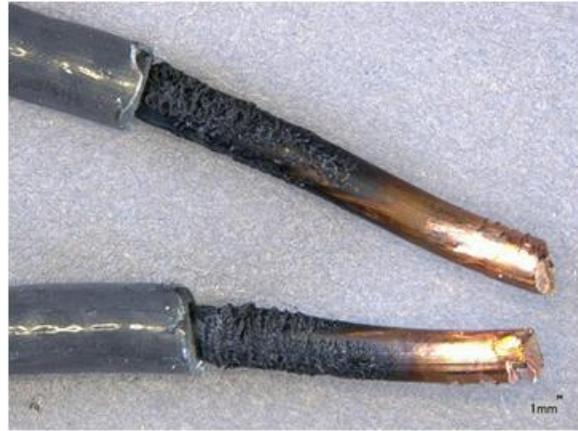
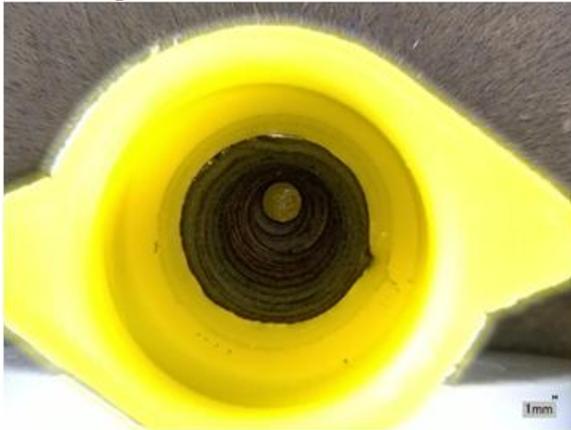
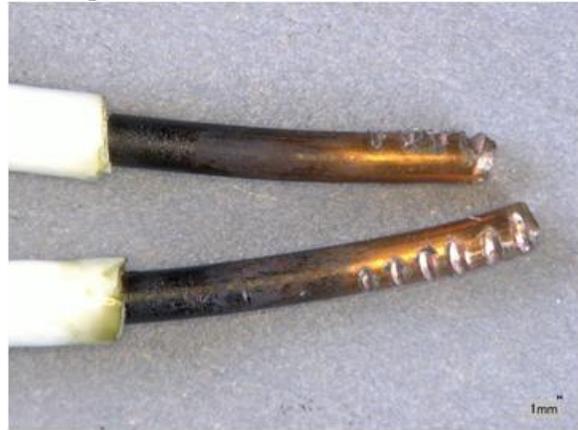
Figure 61 shows optical images of twist-on connectors and the associated wires used to connect component assemblies inside the chamber. Corrosion of both the wires and the twist-on connectors was observed. The extent of corrosion decreased with depth into the twist on connector. A thick corrosion product layer was found next to the insulation. The ends of the wires, where protected by the twist-on connector, exhibit bare copper.

Figure 61. Optical images of twist-on connectors with hot and neutral wires used on the output section of Circuit 2.
