# SANDIA REPORT

SAND2013-3197

## Blade Reliability Collaborative: Collection of Defect, Damage and Repair Data

Thomas D. Ashwill, Alistair Ogilvie, and Joshua Paquette

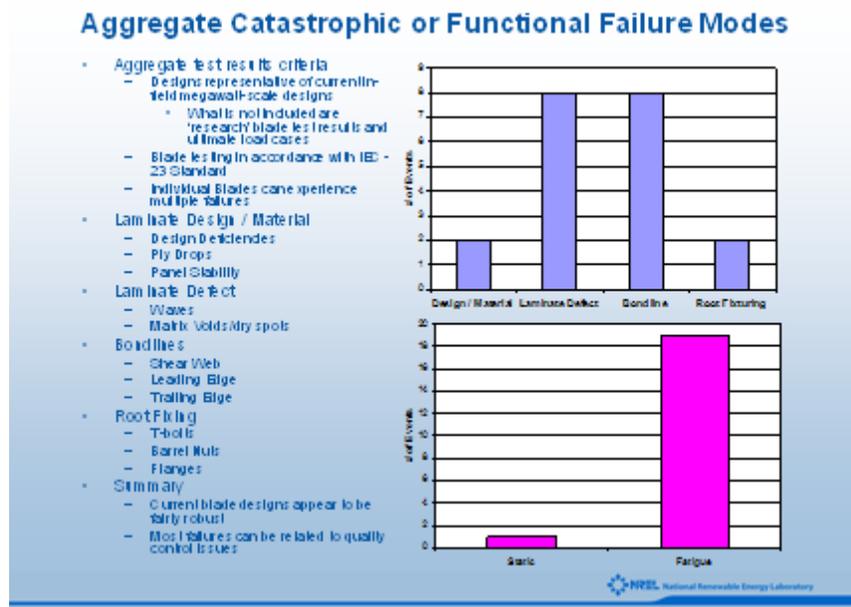
Figure 5: Aggregated Failure Modes

The National Renewable Energy Laboratory (NREL) has tested wind turbine blades for many years in their facility at the National Wind Test Center (NWTC). Scott Hughes, lead blade test engineer at NREL, had an aggregated a set of data on types of failure modes experienced by NREL’s blade testing crew over the years. This was presented at a DNV Wind Energy Blade Damage Tolerance Workshop in March 2008 [6]. Figure 5 shows the results presented under the title of Aggregate Catastrophic or Functional Failure Modes. These results are from blades representative of current (2008) in-field megawatt-scale designs. The failures noted are mostly from the fatigue testing and are broken into four broad areas of failure: laminate design/material, laminate defect, bond lines, and root fixturing. As expected, the largest number of failures occurs due to laminate defects or bond line issues in the shear web, and leading or trailing edges.

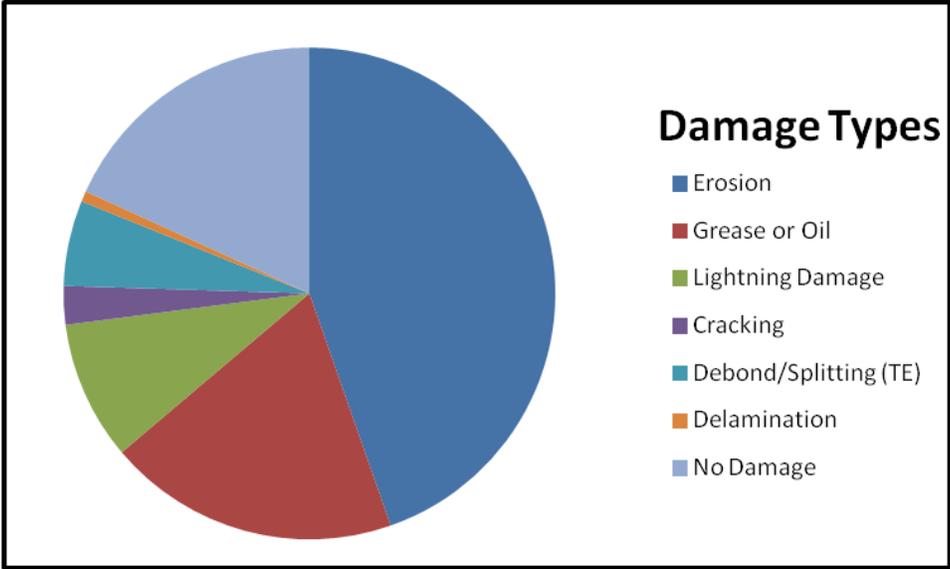
Figure 8: Damage Types

There is large variation seen across plants, operators, technologies, and geographic locations. Almost every data source included blades that had experienced no damage. There were data sources that had not experienced lightning damage, and data sources where every turbine showed some kind of lightning damage. Damage types are plotted in Figure 8.

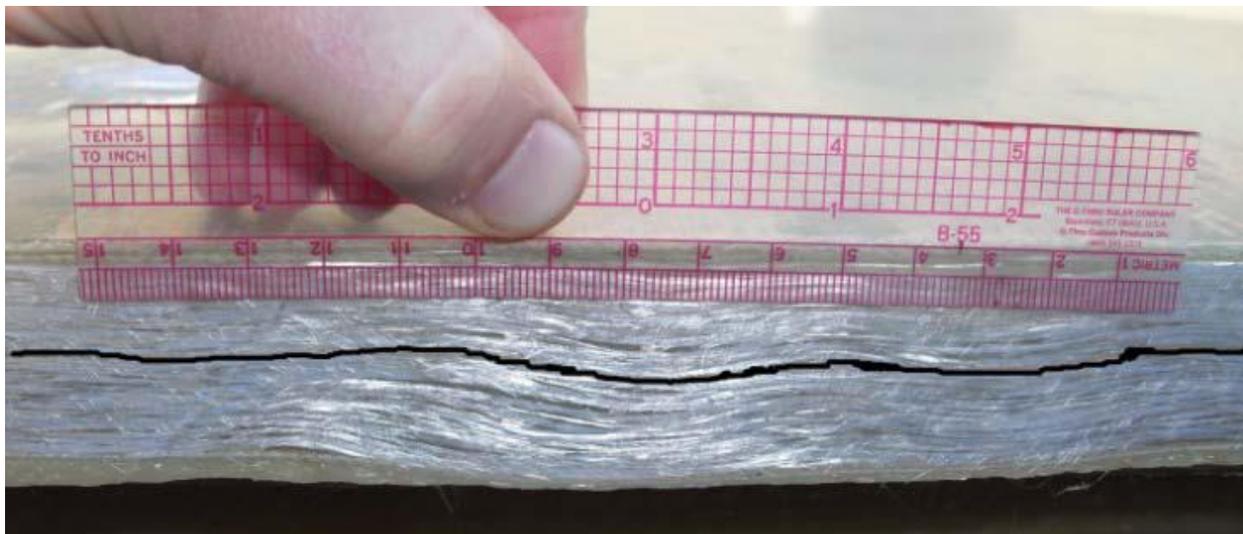
Wave and porosity data were collect from a set of four blades and studied to determine sets of standard wave forms for use in substructure fabrication and companion analysis. Figure 11 shows an image of a wave on a blade section used in the data collection. Waves were discretized (Figure 12), fit with sine wave curves and characterized in terms of wavelength, amplitude and off-axis fiber angle. Further data analysis yields frequency of occurrence of a variety of wave types. Characterization of porosity can be difficult and MSU uses a microscopy technique to identify the location and size of gas inclusion. Figure 13 shows an SEM of a cross-section used to porosity test specimen. Many wave forms were collected as described in Ref. 9 are scaled in order to build coupons with wave variations. Ref. 9 also begins developing a set of criticality and severity parameters for use in the overall analysis tool to be developed. Results of the testing of coupons and companion analysis are detailed in Ref. 10.

Figure 11: Measuring Waviness on a Blade Section

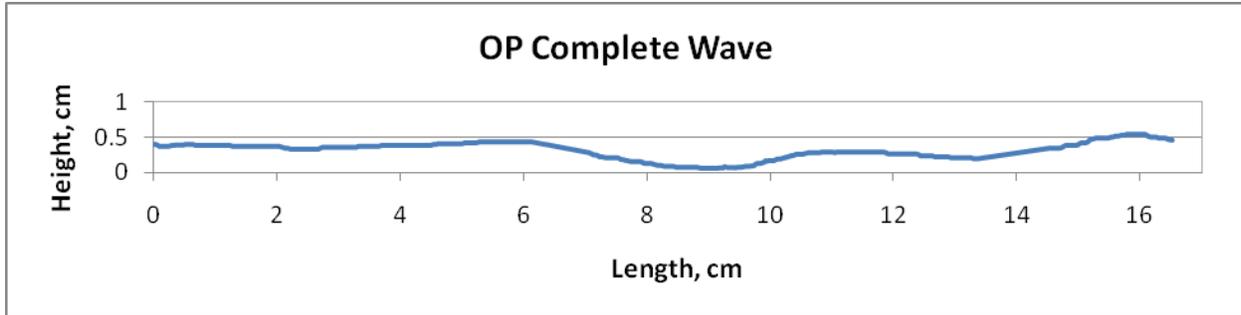
Figure 12: Example of Discretized Out-of-Plane Wave

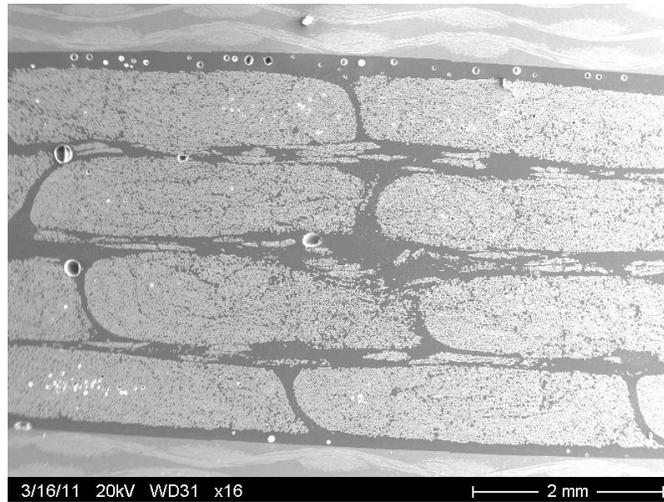
Figure 13: SEM of a Porosity Test Specimen

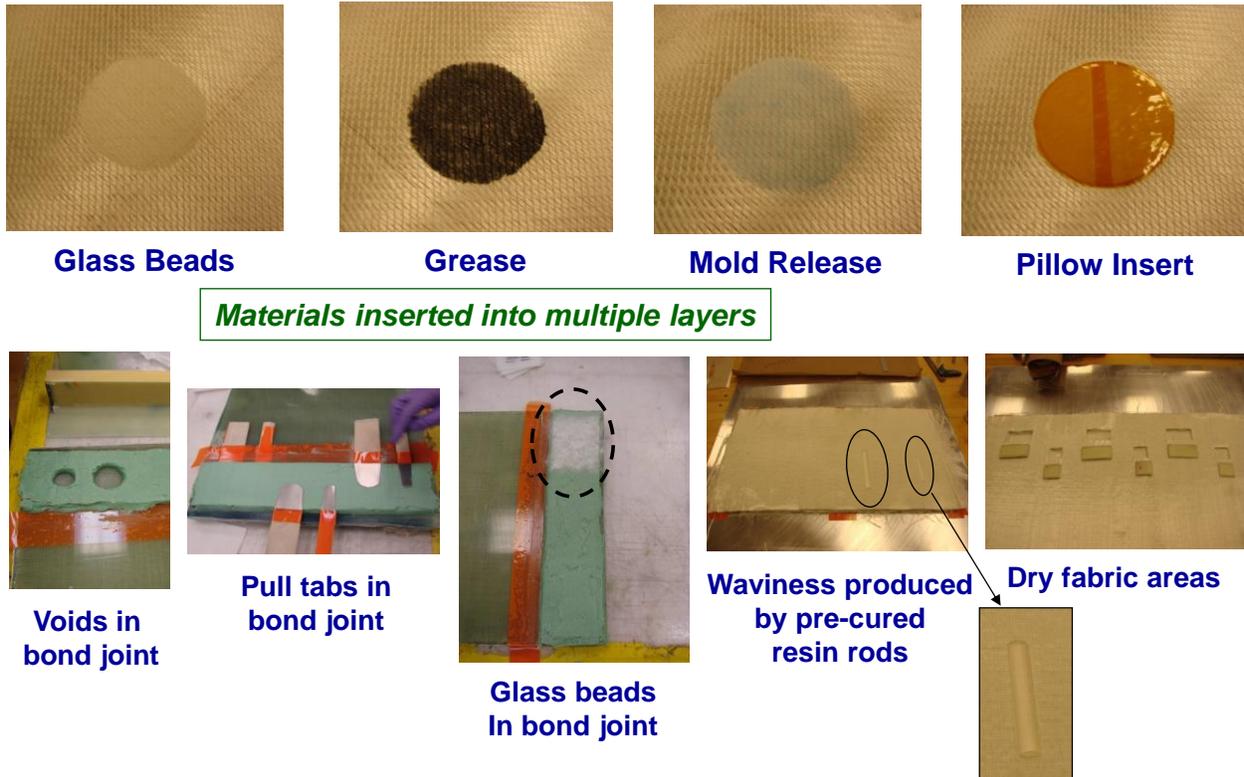
This ongoing work was recently presented at a BRC meeting in July in Albuquerque [11]. This work has started with an initial screening of NDI methods to determine those that show the greatest promise for flaws detection on the manufacturing floor and in the field. Currently, the team has designed and fabricated a variety of flaw types into plates and other substructures. This is followed by the inspection of blades using a variety of NDI methods to understand challenges and ability to detect flaws. Figure 14 shows some of the flaw types engineered into a flat plate and Figure 15 shows shear web and foam core specimens with engineered defects. Types of NDI methods used so far include:

Figure 14: Different Flaw Types Engineered into NDI Feedback Specimens

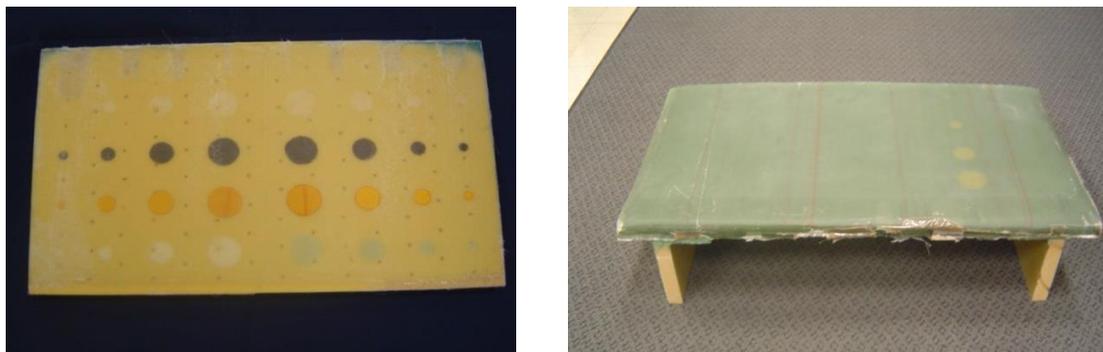
Figure 15: Foam Core with Disbonds and Delaminations (L) and Shear Webs with Waviness and Dry Regions (R)
