SAND2005-3195
Unlimited Release
Printed June 2005

Development of Bonded Composite Doublers for the Repair of Oil Recovery Equipment

Dennis Roach and Kirk Rackow

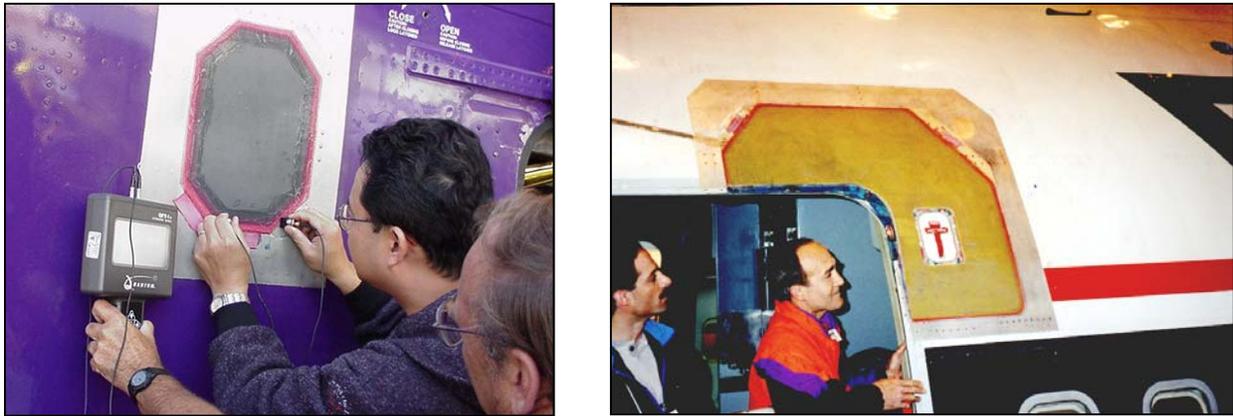
Figure 4: Sample Composite Doubler Aircraft Repairs

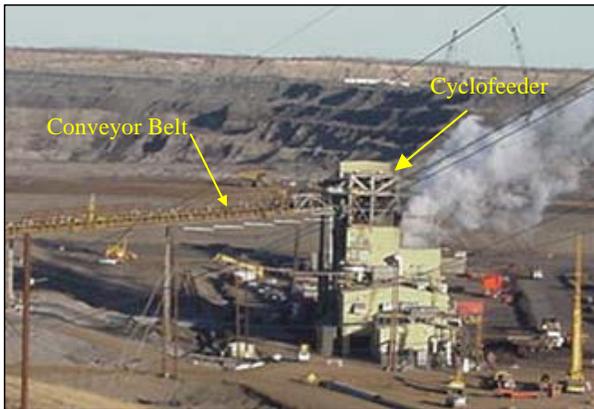
Figure 6: Conveyor Belts Transfer Oil Sands to Cyclofeeder for Hydrotransport

1. Hydraulic and cable shovels – primarily the shovel booms and sticks (see Figures 1-2)
2. Cable shovel revolving frame (body) at window cutout
3. Conveyor belt truss structures (see Figure 6)
4. Mechanical tumbling drums (see Figure 7)
5. Fluid cylinders on tanker trucks
6. Vibrating screens for filtering (see Figure 8)
7. Shovel buckets (see Figure 9 and Section 2.4)
8. Boxes on mining trucks (see Figure 10)
9. Truck frames – stringers and bolsters especially at hinge region (see Figure 11).

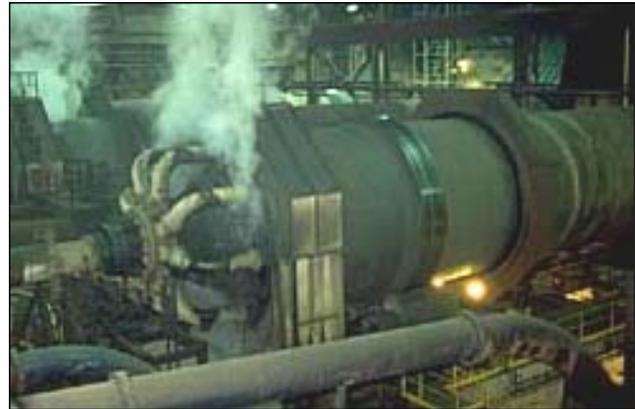
Figure 7: Tumblers Initiate the Separation Process in the Extraction Plant

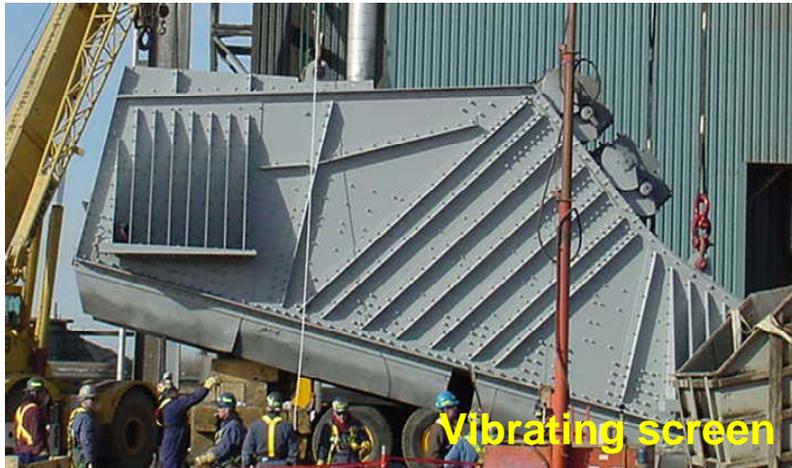
Figure 8: Vibrating Screen for Filtering Initial Mining Products

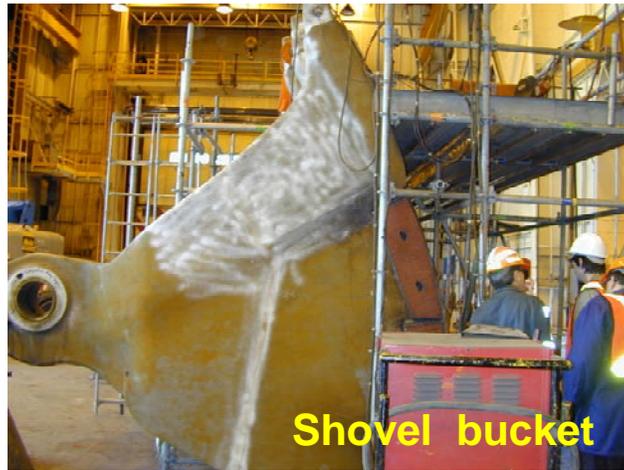
Figure 9: Hydraulic Shovel Bucket

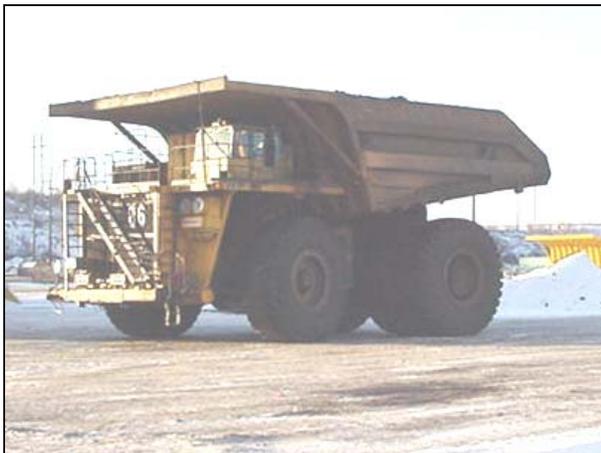
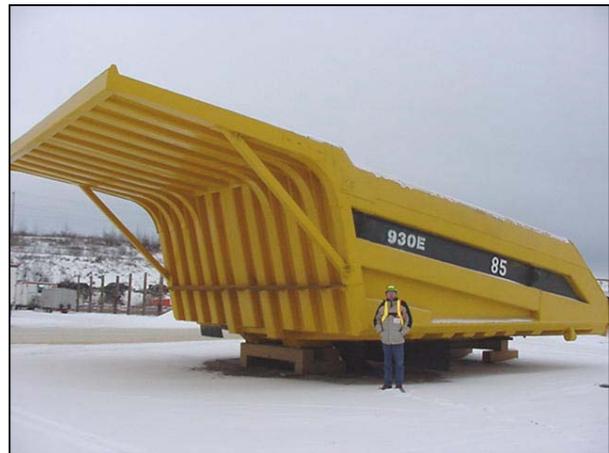
Figure 10: Truck and Truck Box Structure for Oil Sands Mining Operation

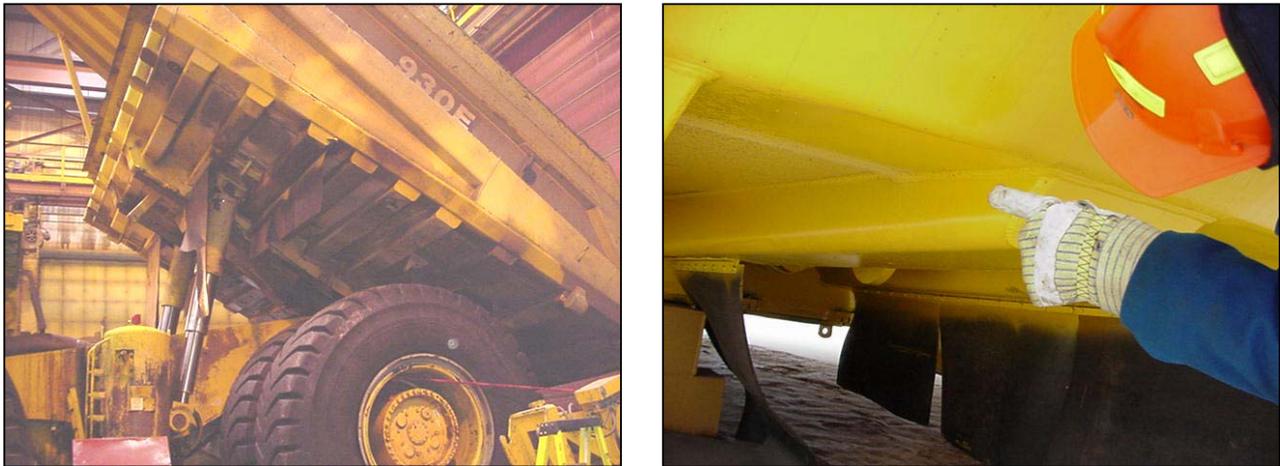
Figure 11: Mining Truck Frame and Crack Area at Bolster-to-Box $\frac{3}{4}$ \" Fillet Weld

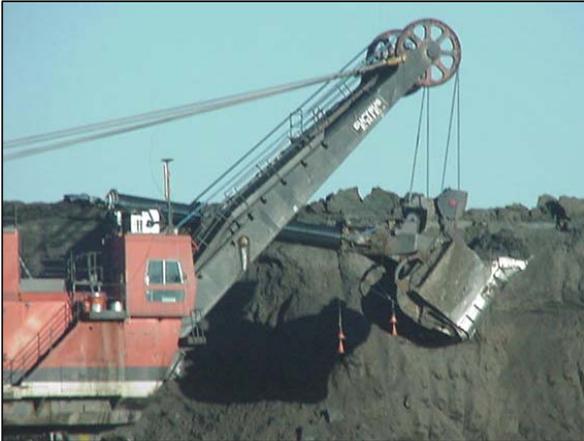
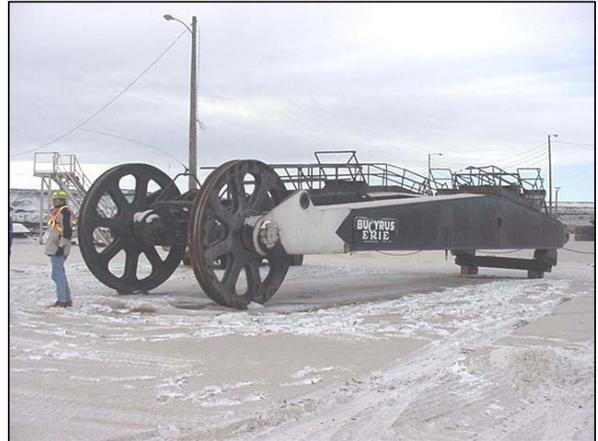
Figure 12: Cable Shovel Boom and Split Boom Removed from Shovel

Cable Shovel Boom – The Bucyrus-Erie 395B cable shovel boom was chosen as the best application for our initial repair. Figures 12 shows two views of the boom mounted and removed from the cable shovel, respectively. It can be seen that this is a split, two pronged boom. The favorable features of this repair include: manageable wall thickness ($\frac{7}{8}$ \" and $1\frac{1}{4}$ \"), good accessibility, relatively low expected stress levels, and no structural impediments (complex geometry). Figures 13 and 14 show close-up photos of regions repaired with fill welds only. Typical cracks found on the shovel boom are pictured in Figure 15. Figure 16 shows the temporary repair process that uses seam-welded fish plates (steel doublers) to quickly repair boom cracks so that the shovel can continue to operate until planned maintenance can complete the more robust fill-weld repair. Multiple plates are applied as the crack continued to grow across the width of the shovel boom. Figure 17 shows a boom plate crack as it propagates out from under the fish plate and around the corner into an adjacent boom plate.

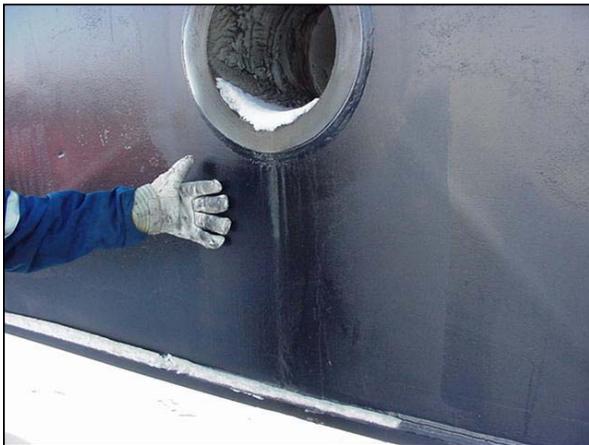
Figure 13: Fill-Weld Repair on Boom Side Plate

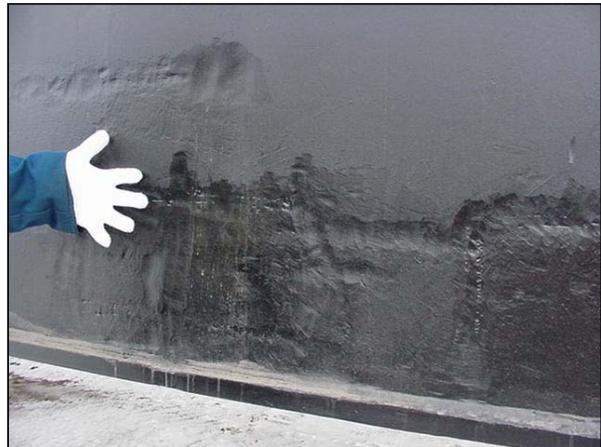
Figure 14: Fill-Weld Repair on Side Plate

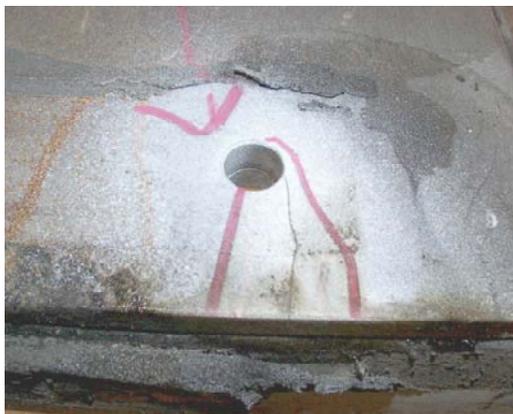
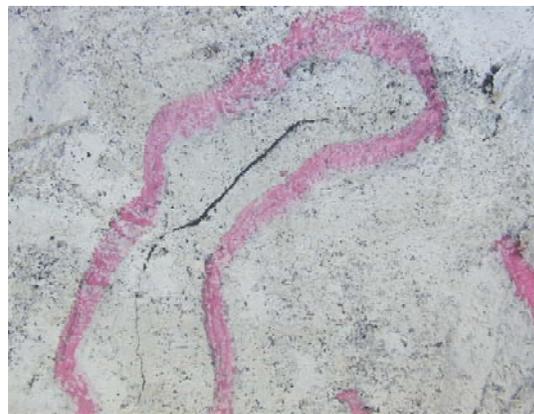
Figure 15: Typical Cracks Found in the Shovel Boom

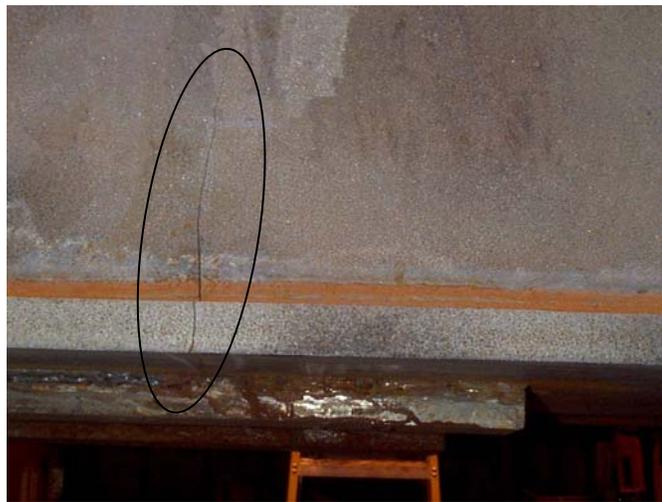
Figure 17: Crack in Boom Plate Emanating Around the Corner from a Fish Plate Welded Repair

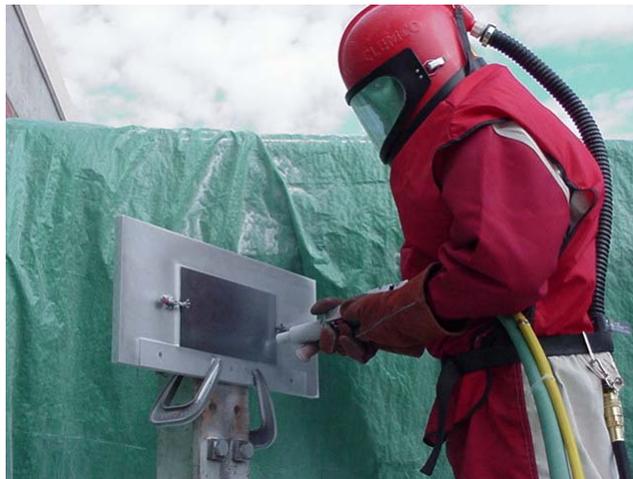
Figure 18: Grit Blast of Steel Surface Using 50 Micron Aluminum Oxide Grit Applied at 60 PSI

The relationship between the grit blast delivery pressure (energy level) and the corresponding surface roughness was determined. It was found that a 60 psi grit blast on carbon steel (ASTM 572) produced a similar surface roughness as a 40 psi grit blast on aluminum (2024-T3) during aircraft repairs. Filtering and drying systems were added to the compressed air supply line to reduce contamination. Figure 18 shows the test specimen preparation using the portable grit blast system. After blasting, a jet of clean air was blown across the surface to remove loose grit particles. The chemicals listed in Table 1 were then applied generously using brush-on or spray applications such that any contaminating residues were rinsed from the surface. To determine the feasibility of a quicker surface roughening option, hand sanding was included in the test matrix. Zirconium oxide sanding paper was applied in two perpendicular directions to produce a

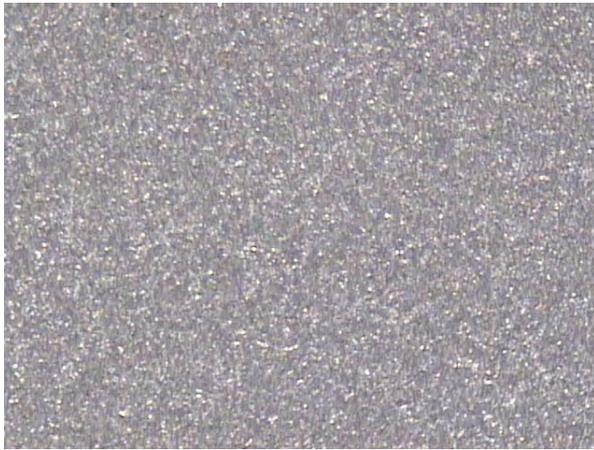
**Figure 19: 50X Microscopic View of Grit Blasted Surface at 60 PSI
(Surface Roughness = 52 μ inch RMS)**

scratched surface that was sufficiently roughened but much less uniform in appearance. Figures 19 and 20 compare two surfaces that were grit blasted and hand sanded.

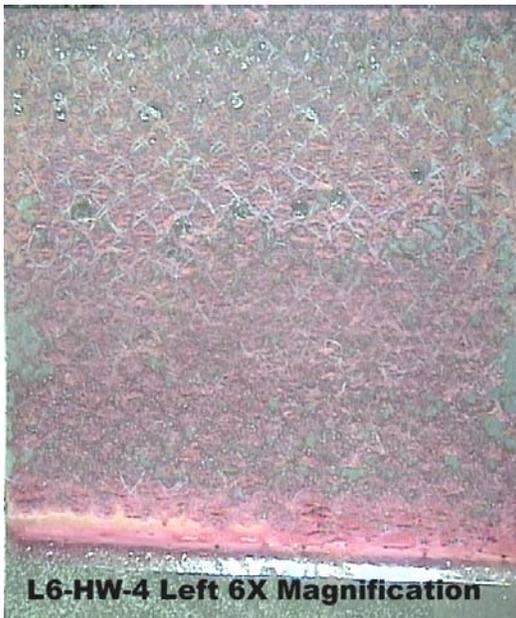
**Option 6
Primarily
Cohesive
Fracture**

**Option 4
Primarily
Adhesive (Disbond)
Failure**

A. Macroscopic View of Failure Surfaces

**Cohesive Fracture of Adhesive Film
(Option 6 silane treatment)**

**Adhesive Failure at Interface
(Option 4 no chemical treatment)**

B. Microscopic View of Failure Surfaces

Figure 38: Photo of Fracture Surface in Lap Shear Specimens

The strengths measured in the lap shear tests reflect the degree of cohesive and adhesive failure in the respective joints. For example, the low ultimate shear stress values produced by the Option 4 test specimens indicate that a large percentage of the failure surface will show adhesive failures. Conversely, when inspecting Option 6-8 post-failure surfaces, it was observed that the failures did not occur at the steel/silane interface or at the silane/adhesive interface, but rather at the boundary layer region that is strengthened by the presence of the silane coupling agent. The addition of the silane clearly improved the interfacial durability so that cohesive fracture of the adhesive could be reliably produced. By avoiding adhesive disbond failures, the full strength of the adhesive can be achieved. Figure 38 shows the adhesive regions from the failed specimens that used Option 4 (no chemical treatment) and Option 6 (silane treatment) processes. In the photo on the left, note the clear presence of the pink adhesive on both halves of the specimen indicating that the adhesive has fractured. In the photo on the right, note the large number of dark regions which are the exposed portions of the steel surface. These are disbond areas where the adhesive separated from the substrate steel material. The diagonal patterns present in both

photos are created by the scrim cloth that is used to carry the film adhesive. It is estimated that the better surface preparation techniques produced joints with less than 1% adhesive failure while the poor surface preparation techniques produced joints that exhibited 50% to 75% adhesive failure.

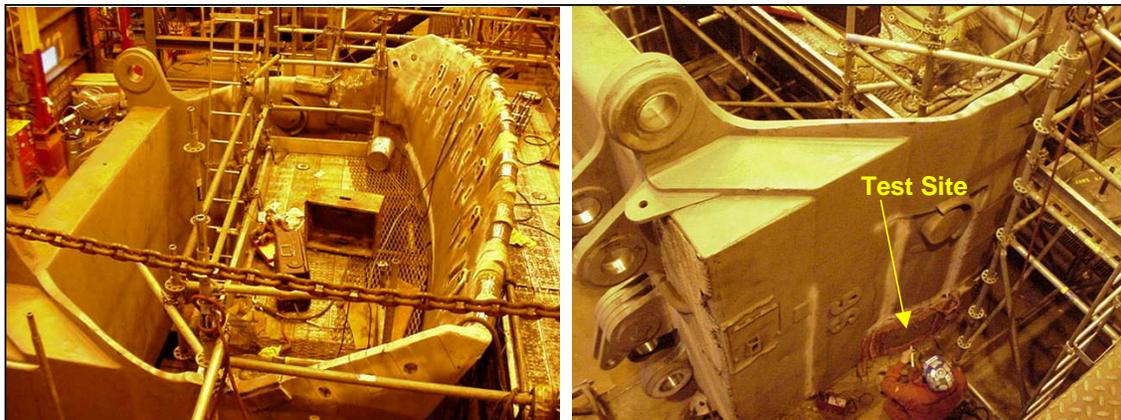
Figure 41: View of Shovel Bucket and Heat Source/Sink Test Location

With the list of potential repair applications in mind and some idea of the approximate size of the patches, the Syncrude-Sandia team conducted a heat source and heat sink test on a thick-walled Syncrude structure. Figure 41 shows the shovel bucket that was used for this test. The wall of the bucket was approximately 3" thick and the heat sinks included a thicker region immediately adjacent to the zone to be heated and a free edge exposed to open air. It was immediately apparent that the rubberized heat blankets that Sandia has used in its aircraft repairs could not provide the heat necessary to raise the temperature to cure temperatures of 225°F. Discussions with Cooper-MQS Canada indicated that the Cooperheat ceramic blankets and associated control system would have sufficient power and control to produce the desired temperature profile. Other advantages include: 1) these are the blankets used by Syncrude, 2) the additional control system is contained in a mobile trailer, and 3) Cooperheat is currently contracted to Syncrude and is familiar with heating these type of structures.

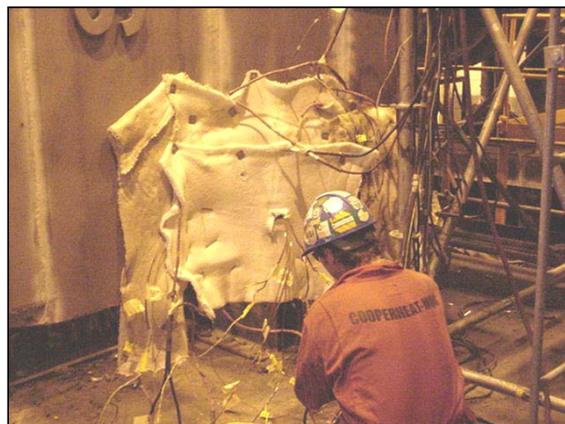
Figure 46: Final Assembly with Insulation Placed Over 7 Heater Pads

The approach was to mount the Cooperheat flexible ceramic pad heaters around the area to be "repaired" and to induce the temperature in this region using the projection heating method depicted in Figure 42. Numerous rings of heat blankets can be placed around the region to be repaired and placed over large flanges, etc. to counteract the heat sinks. Figure 43 shows several of the blankets and associated thermocouples being installed around the 18" X 18" repair region. Tack welds were used to secure the heaters and thermocouples. Figure 44 shows the final arrangement of ceramic heaters and thermocouples around the test site. The thermocouples around the exposed steel repair region and a close-up of the ceramic heat blankets are shown in Figure 45. Figure 46 is a photo of the complete assembly with insulation placed over the 7 heat blankets.

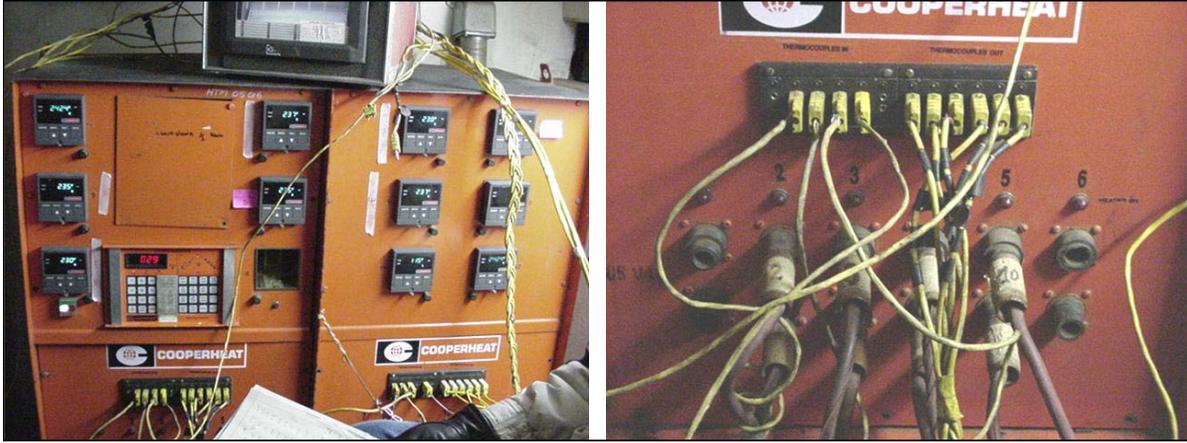
Figure 47: Cooperheat Controller Showing Input from Thermocouples, Output to Heater Pads, and Temperature Logging

The Cooperheat control system, shown in Figure 47, was programmed to produce a temperature ramp-up rate of 3°F/minute, a temperature hold at 225°F, and a temperature ramp-down of 5°F/minute. Figure 48 shows this target temperature profile along with the temperatures from all 15 thermocouples. Thermocouples 1-7 were located under heater pads 1-7, respectively, so they can be interpreted as the driving temperatures for the projection heating process. Note that they match the programmed profile quite well. The remaining thermocouples, #8-15, are inside the perimeter of the heater pads and represent the cure temperatures for a composite doubler. As expected, there is some lag in the temperature ramp-up but the slope gradually improves to the 3°F/minute target. As noted in Fig. 48, the set point was adjusted to 240°F to speed up the rise to 225°F. There was some concern that the thermal mass of the structure would cause us to overshoot the 225°F target, however, the temperature in the repair region remained very stable. Once the inner repair region reached the hold temperature (see t= 95 minutes), the temperatures in thermocouples 8-15 remained well within the $\pm 25^\circ\text{F}$ tolerance (min temp. = 222°F; max temp. = 234°F). After the hold temperature was maintained for 20 minutes, the Cooperheat system was shut down. The two data points taken after shut-down showed that the thermal mass does make it difficult to quickly cool the structure. Temperature logs from the strip chart recorder, left on overnight, showed that the structure cooled at about 0.5°F/minute. Although we would like to cool the doubler a little faster than this (cure profile calls for temperature ramp-down of 1-5°F/min), the temperature ramp-down parameter is the least critical aspect of the cure profile. Overall, this was an excellent demonstration of the heating process. While the Cooperheat system shown here may be supplemented by placing rubberized heat blankets over the composite patch itself, there are no other changes needed for this system to properly cure a composite doubler.

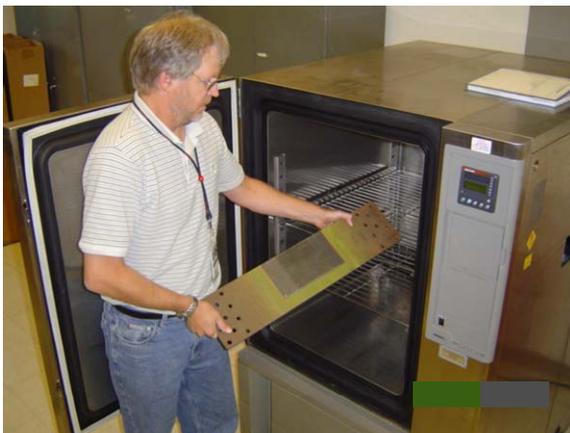
Figure 65: Tension Specimens Being Placed into Environmental Chamber and Freezer for Hot/Wet and Cold Conditioning

Temperature and Humidity Conditioning – Table 9 also indicates the specimens that were subjected to temperature and humidity conditioning. In order to simulate moisture absorption that may occur during field operations, the specimens were placed in an environmental conditioning chamber at $140^{\circ}\text{F} \pm 5^{\circ}\text{F}$ and $97\% \pm 3\%$ relative humidity. The specimens remained in the chamber for 30 days to provide a period of time sufficient to achieve saturation moisture content. Some of the test specimens were then subjected to temperatures of 0°F to simulate low temperature operating conditions for composite doublers containing a high moisture content. Any trapped moisture could freeze and fracture the composite fibers. Figure 65 shows a photo of the specimen being inserted into the environmental chamber for hot-wet conditioning and the

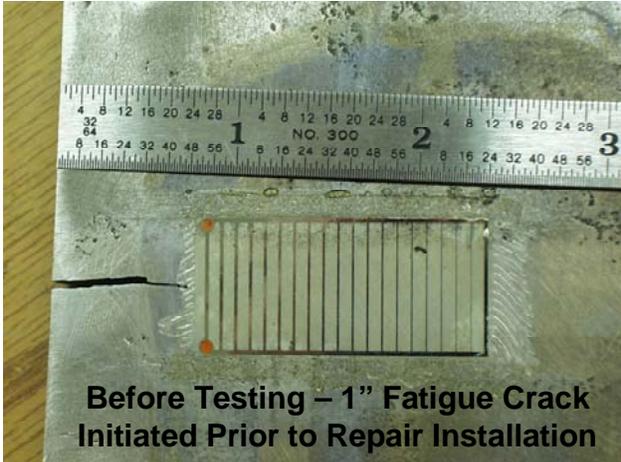
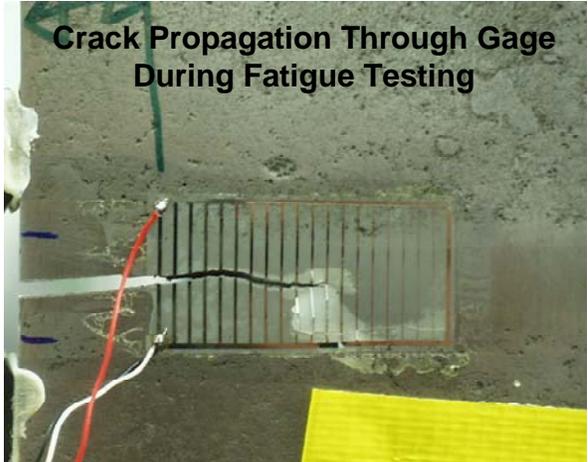
Before Testing – 1" Fatigue Crack Initiated Prior to Repair Installation

Crack Propagation Through Gage During Fatigue Testing

Figure 72: Crack Growth Gage on Back of Steel Coupon and Crack Status Before and After Fatigue Testing

Photographs of the damage tolerance test set-up and a close-up view of a composite doubler test coupon are shown in Figure 71. Figure 72 shows the seeded fatigue crack, generated before the composite repair was installed, and the crack propagating through the crack growth gage during testing. The results from all of the fatigue tests are summarized in Table 10 which is broken down into performance for low (24 ksi), medium (33 ksi), and high (41 ksi) stress spectrums. Results from the low stress spectrum tests, which are believed to be the stress levels that are the most representative of those incurred in the field, clearly show the ability of composite doublers to eliminate crack growth when bonded to thick steel structure. The 24 ksi fatigue spectrum specimens are plotted in Figure 73. No fatigue crack growth was observed after 251,000 to 331,000 cycles. Nondestructive inspections, conducted after the fatigue tests, also revealed that there was no flaw initiation or growth in the composite laminate or laminate-to-steel bondline (see Section 4.2). These results were achieved in all specimens, even those containing engineered flaws and subjected to hot-wet and cold conditioning. Note that these performance impediments are anticipated to be extreme worst-case scenarios in that the disbonds removed 20% of the critical load transfer region in the doubler and also eliminated local reinforcement directly over the crack.

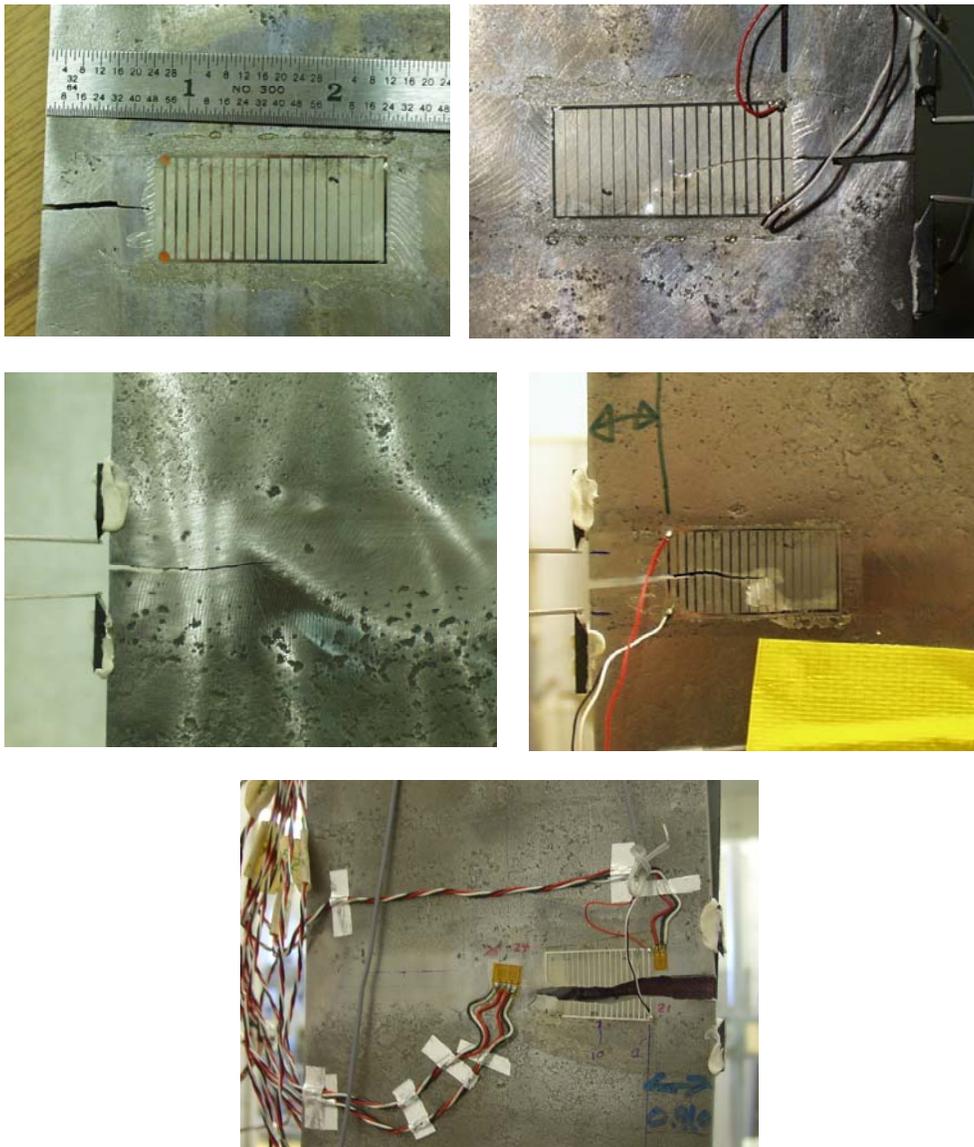
Views of fatigue cracks at different stages of propagation are shown in Figure 79. The upper left photo shows the starter notch and fatigue crack that was induced before the composite repair. This crack has not engaged the crack growth gage yet. The following three photos show the fatigue cracks generated during cyclic testing and the degree of opening associated with a free-edge crack. The lower photo shows that this crack opening gets extreme – approaching 0.5” – as the crack reaches several inches in length and the test loads are increased to ultimate failure levels. These photos highlight the local displacement in the steel around the crack. This local displacement produces one of the primary forms of degradation in the adhesive layer: cohesive fracture. As the crack opens and closes the adhesive will fracture in the area of the propagating crack. This is not a disbond (i.e. the full strength of the adhesive has been achieved) and the fracture zone is confined to the immediate region of the crack.

Figure 79: Photos of Various Stages of Crack Propagation Showing the Local Opening in the Steel Structure

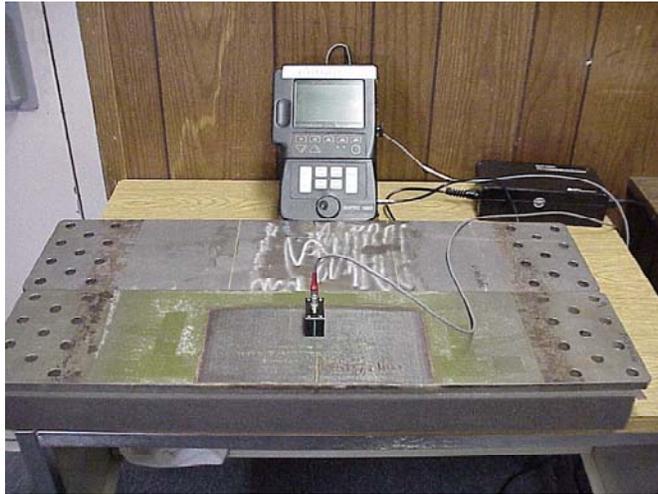
EC Spot Probe

Figure 122: Eddy Current Inspection Set-Up with Nortec 1000 Readout Device Connected to EC Spot probe or EC Sliding Probe

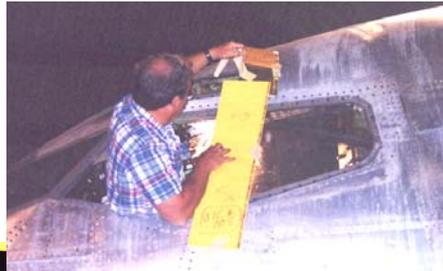
Positioning Film for Cockpit Window Post Inspection

Locating X-Ray Source for Door Frame Crack Inspection

Figure 131: Aircraft Fuselage Inspection for Cracks Using X-Ray

Radiographic inspection is a nondestructive method of inspecting materials for surface and subsurface discontinuities [26]. The method utilizes radiation in the form of either x-rays or gamma rays, which are electromagnetic waves of very short wavelength. The waves penetrate the material and are absorbed depending on the thickness or density of the material being examined. By recording the differences in absorption of the transmitted waves, variations in the material can be detected. Figure 131 shows an application of X-radiography in a field

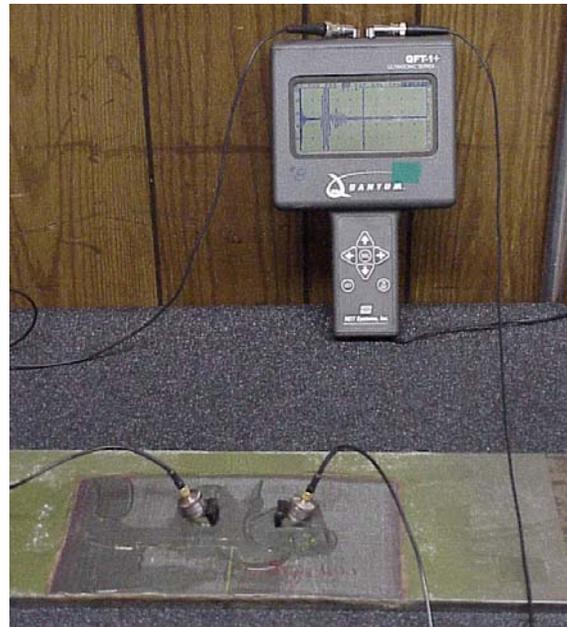
Figure 134: Pulse-Echo Ultrasonic Inspection of a Steel Structure with a Composite Doubler Installed

Figure 134 and 135 show a Quantum ultrasonic device being used to perform a pitch-catch UT inspection (pulse-echo mode) of a composite doubler bonded to a carbon steel structure. In most pulse-echo systems, a single transducer acts alternately as the sending and receiving transducer. In the pitch-catch inspection mode deployed for this inspection one transducer transmits the UT wave and a second, remotely positioned transducer receives the signal after it travels through the materials being inspected. Figure 136 contains a schematic showing the pitch-catch inspection method and the UT wave travel within the structure during this inspection. During testing, the transmitting transducer was placed on top of the composite doubler and the receiving transducer was placed on top of the parent steel material. If the adhesive bond between the two articles is intact, the ultrasonic signal will pass unobstructed to the receiving transducer.

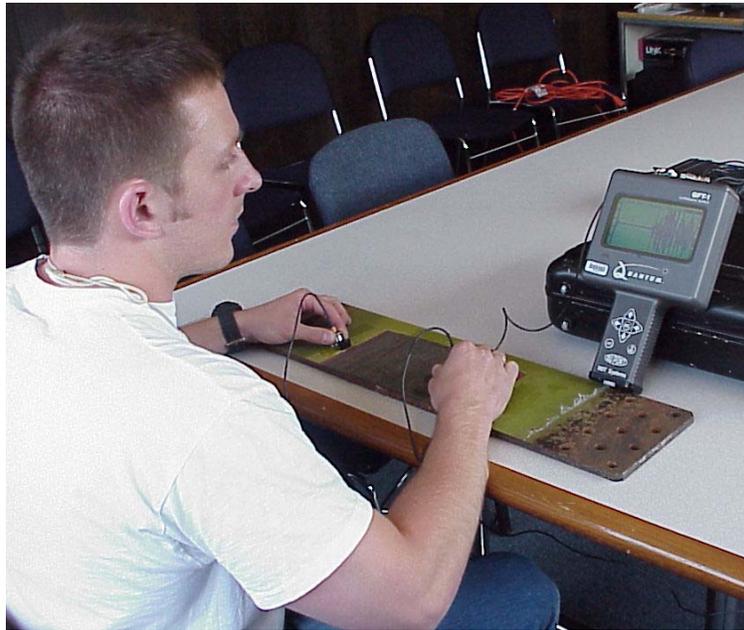
Figure 135: Inspector Deploying Pulse-Echo Inspection on Composite Doubler Repair

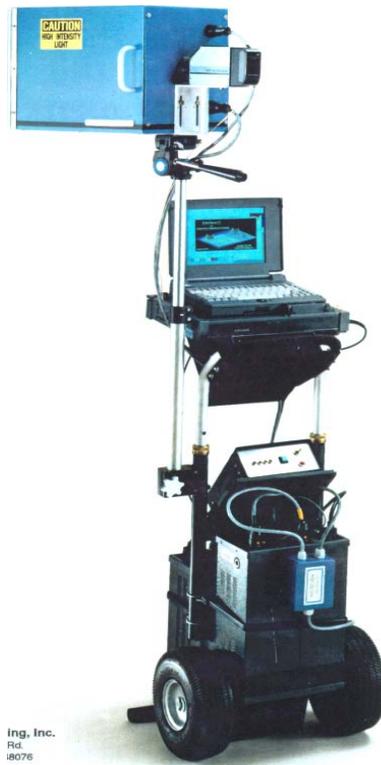
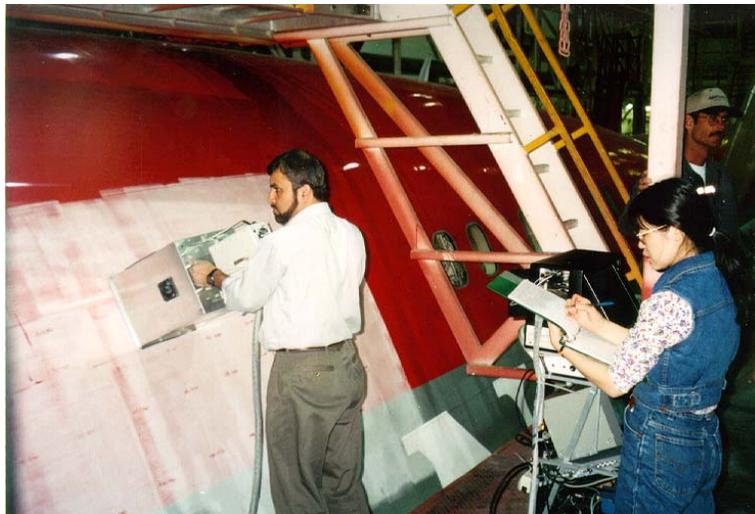
(a) Close-Up View of TWI Equipment

(b) Application of Thermography on 747 Aircraft

Figure 140: Thermal Wave Imaging System Inspecting an Aircraft

Thermal wave imaging is accomplished using high-power flash lamps, an infrared (IR) video camera, and image processing hardware and software, all of which are controlled by a personal computer. The flashlamps put out a short, high-power pulse of light, which raises the surface temperature of the structure approximately ten degrees when it is absorbed by the surface. This temperature pulse propagates into the material as a thermal wave and gets reflected by any defects which may be present in the material. The resulting temperature distribution is then recorded by the IR camera and displayed on the computer monitor. In practice, the computer actually obtains several images at progressively later times after each flash. This method is particularly useful for imaging and determining the depths of disbonds and delaminations in Boron-Epoxy repair doublers. A photograph of the Thermal Wave Imaging System being applied to an aircraft inspection is shown in Figure 140.

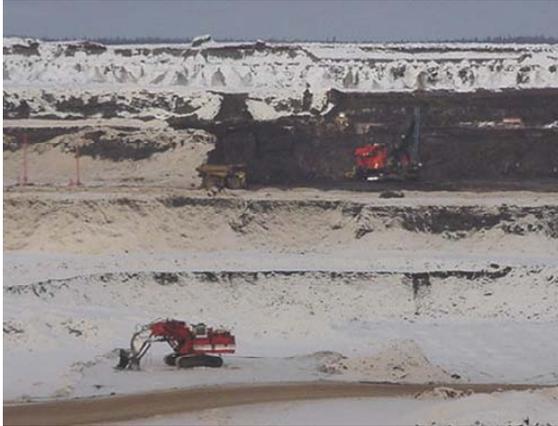
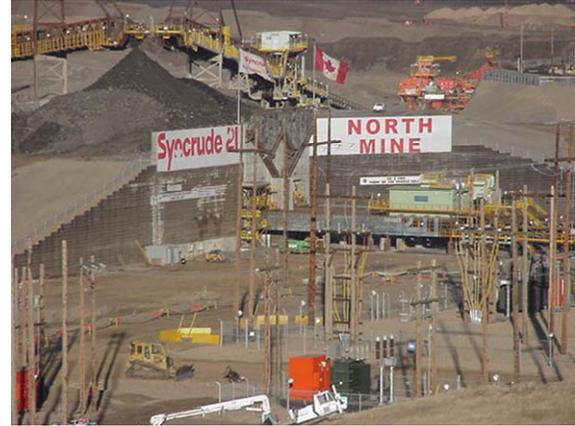
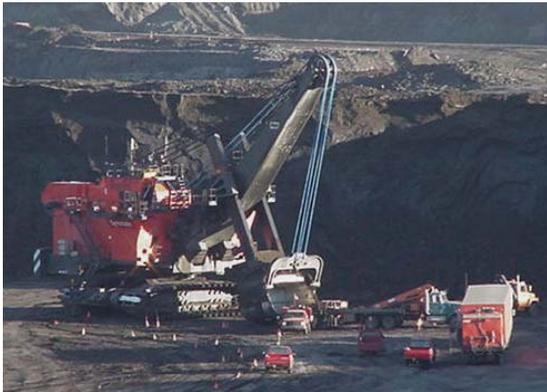
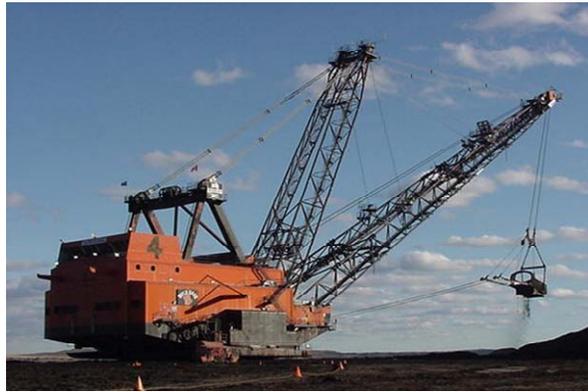
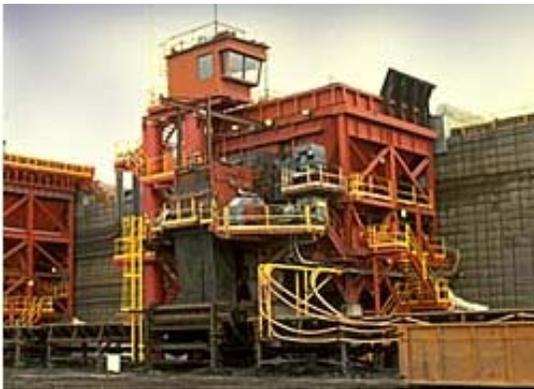
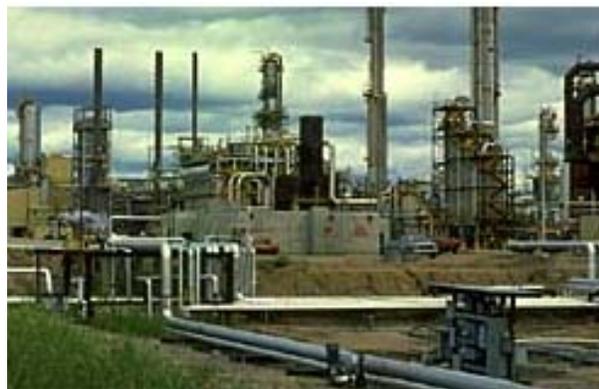
Rock Crusher

Upgrading Plant

Figure 145: Sample Syncrude Equipment that Could Utilize Composite Doublers Repair Technique

Following is a description of some issues that will be considered and some follow-on tasks that may be pursued to produce the ultimate goal of a composite repair installation on an operating Syncrude structure. Some additional candidate repair applications are shown in Figure 145.

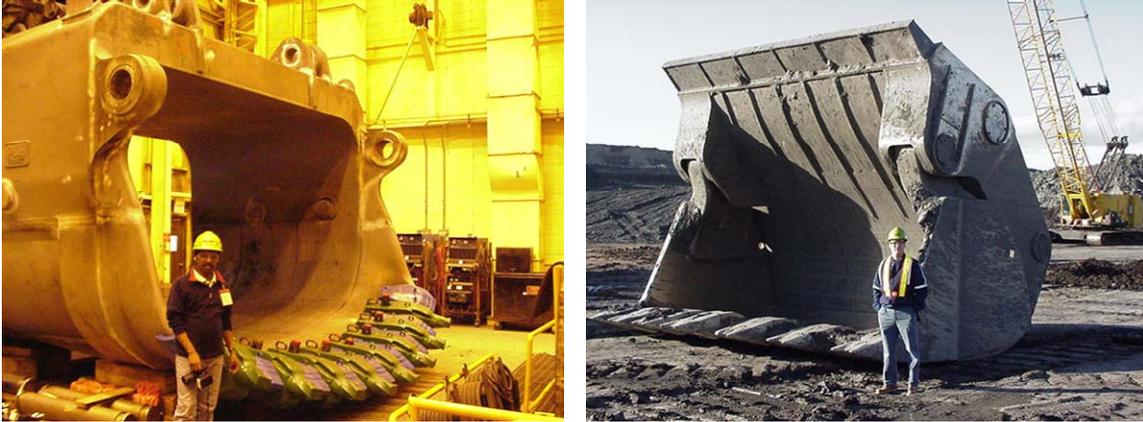
Figure 145 (continued): Sample Syncrude Equipment that Could Utilize Composite Doubler Repair Technique

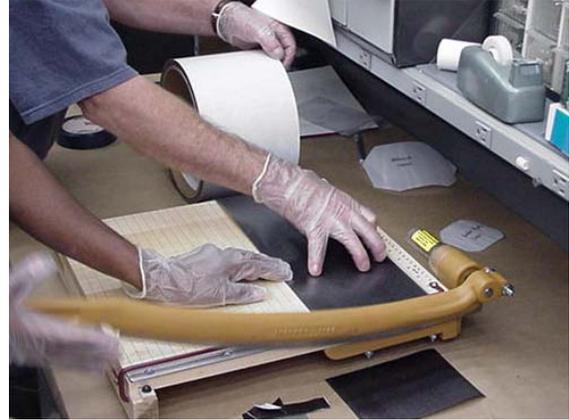
Figure A-2: Cut Roll of B-E Tape into Doubler Plies

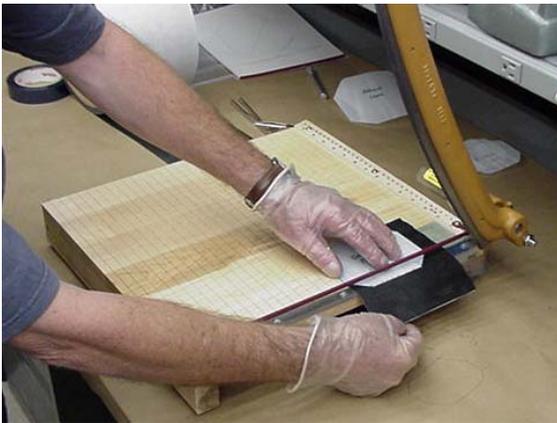
Figure A-3: Use Template for Proper Sizing and Ply Orientation

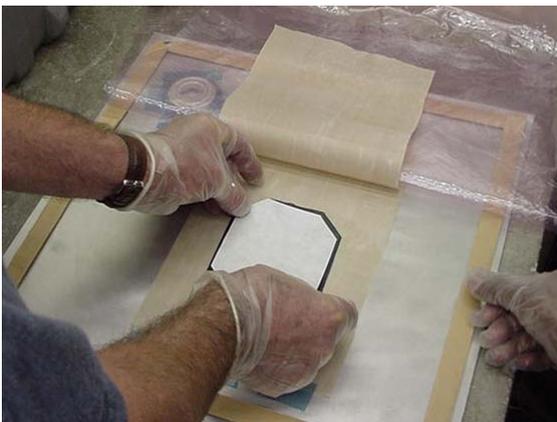
Figure A-5: Lay Up B-E plies in Proper Stack (1st ply goes face down)

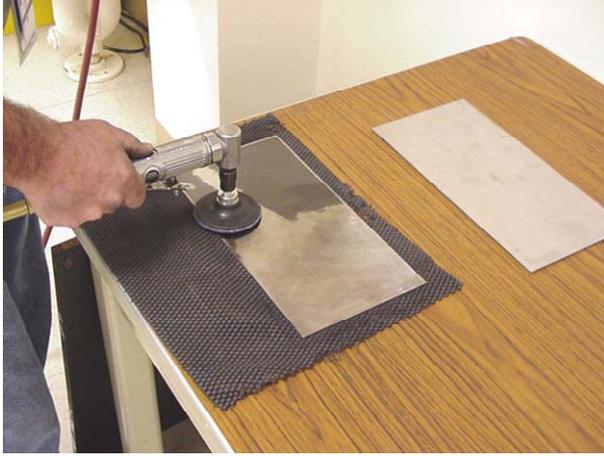
Figure A-7: Coarse Scotchbrite Grind to Remove Excess Scale/Oxide

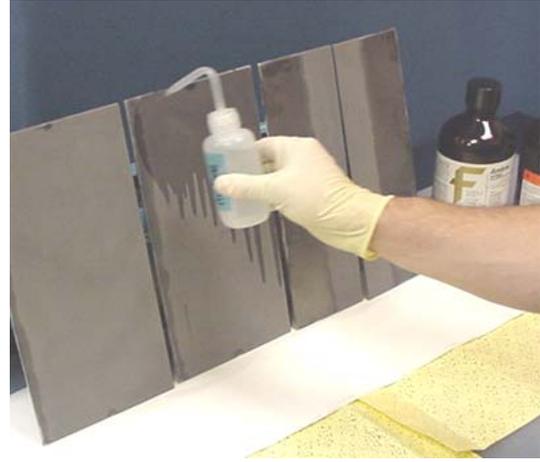
Figure A-8: Degrease with Acetone Followed by Methyl Alcohol

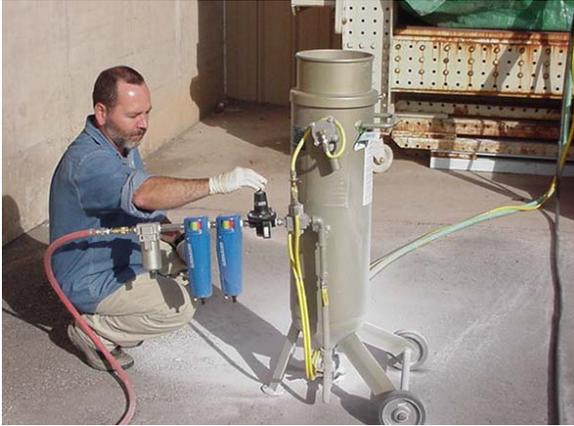
Figure A-9: Grit Blast Device Uses 50 μm Aluminum Oxide Grit

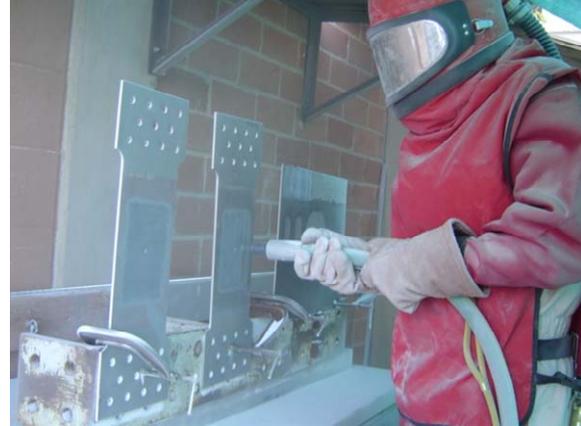
Figure A-10: Grit Blast Steel Surface

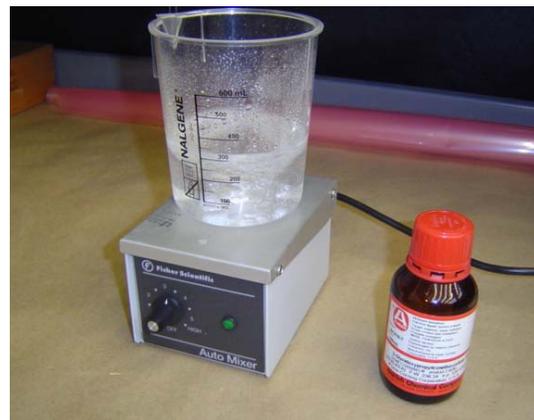
Figure A-12: Mix Silane Solution (99:1 ratio of distilled water to Silane)

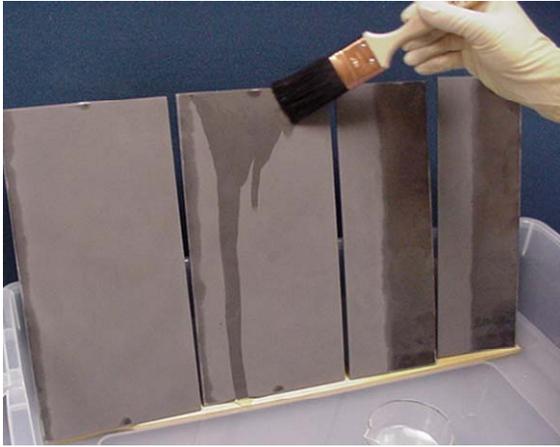
Figure A-13: Brush-On Application of Silane Mixture to Steel Surface

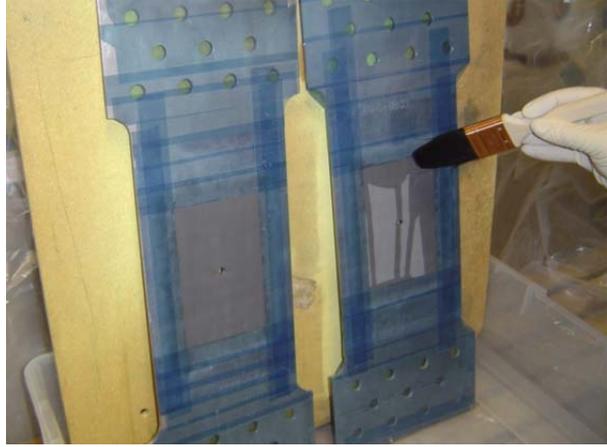
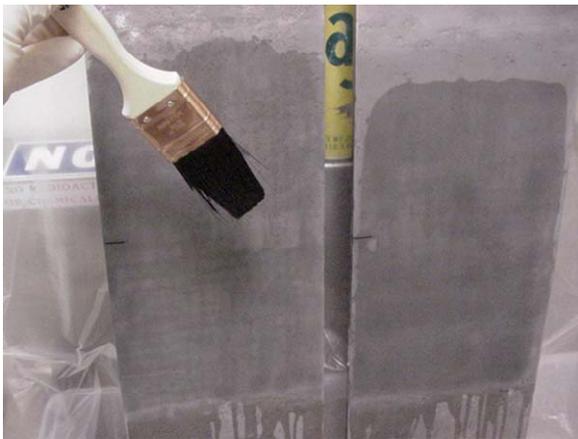
Figure A-14: Wet Surface with Silane Solution for Ten Minutes

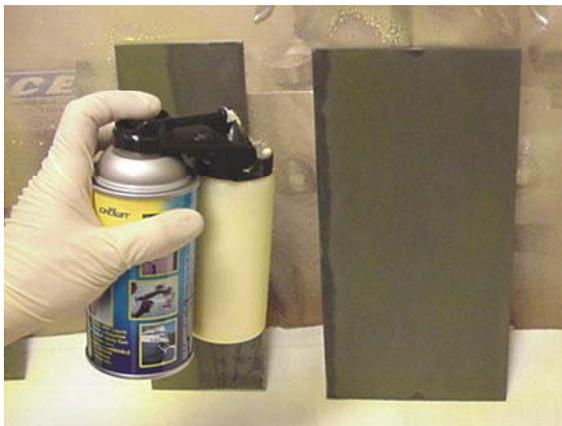
Figure A-16: Spray BR6747 Primer on Steel Surface

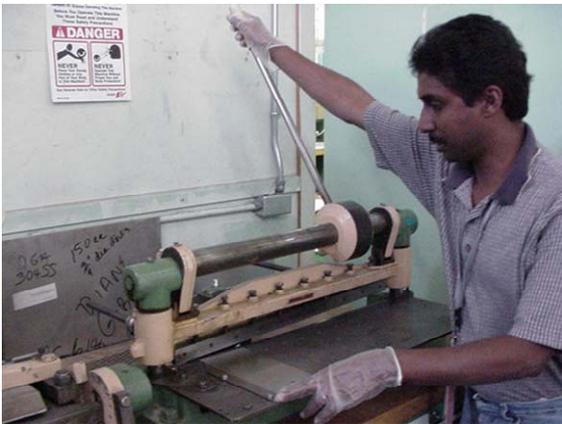
Figure A-19: Cut Two Witness Coupons from Steel Plate and Prepare Surface for Bonding Process

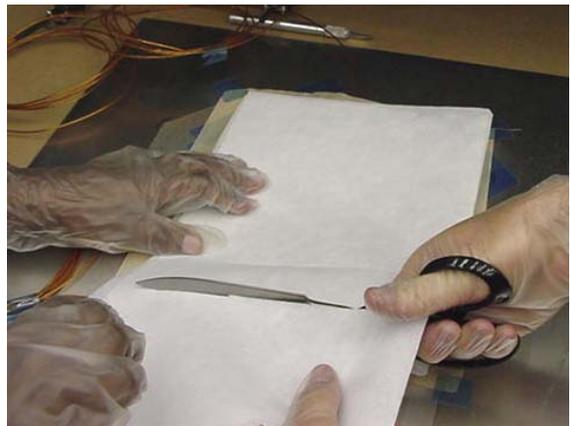
Figure A-24: Place Multiple Plies of Bleeder Cloth

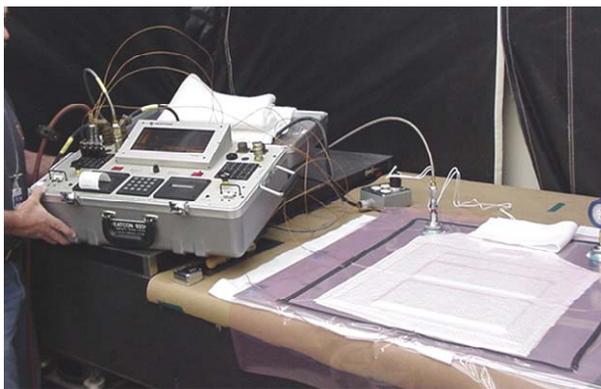
Figure A-30: Program the Heat Control System for Cure Cycle

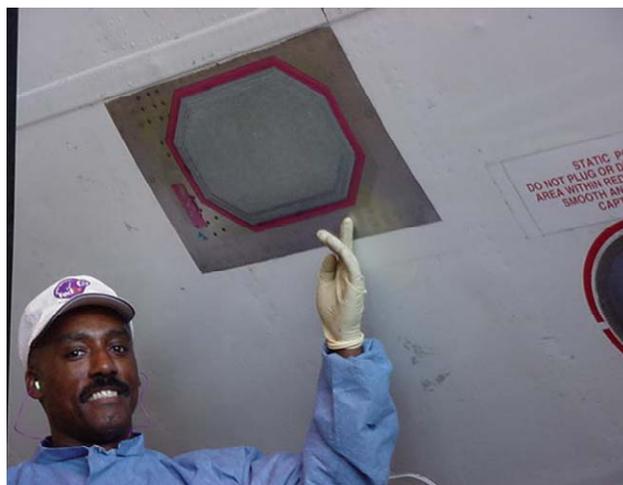
Figure B-14 Finished Product – Composite Doubler Repair Installed on Metal Aircraft Structure

D. Remove bagging material from doublers (see finished product shown in Figures B-13 & B-14).
