SANDIA REPORT

SAND2007-4088
Unlimited Release
Printed July 2007

Development and Validation of Bonded Composite Doubler Repairs for Commercial Aircraft

Dennis Roach and Kirk Rackow

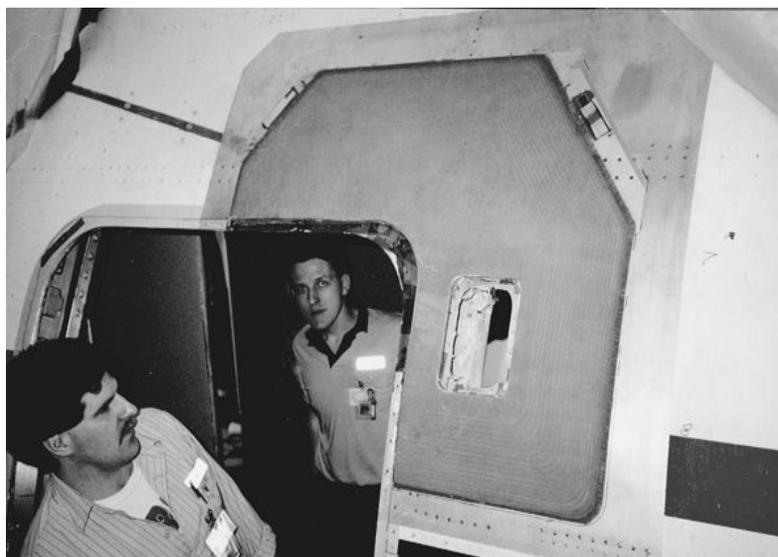
**(a) Sample Fuselage Skin Repair
(composite doubler approx. 12" X 10")**

**(b) Sample Door Corner Repair – First Composite Doubler Repair (L-1011 Aircraft)
(composite doubler approx. 5 ft.² footprint)**

**Figure 2: Sample Bonded Composite Doubler Installations Showing Two Families of
Potential Repair Applications**

Typical Composite Doubler Installation - Figure 1 shows a typical bonded composite doubler repair over a cracked parent aluminum structure. Sample composite doubler installations, showing two families of potential aircraft repair applications, are shown in Figure 2. The number of plies and fiber orientation are determined by the nature of the reinforcement required (i.e. stress field and configuration of original structure). Surface preparation is the most critical aspect of the doubler installation. This consists of paint removal, solvent clean, scotch-brite abrasion and chemical treatment to assure proper adhesion. Since the doubler must be installed in the field, vacuum bag pressure and thermal heat blankets, commonly used on in-situ honeycomb repairs, are used to cure the composite laminate and adhesive layer.

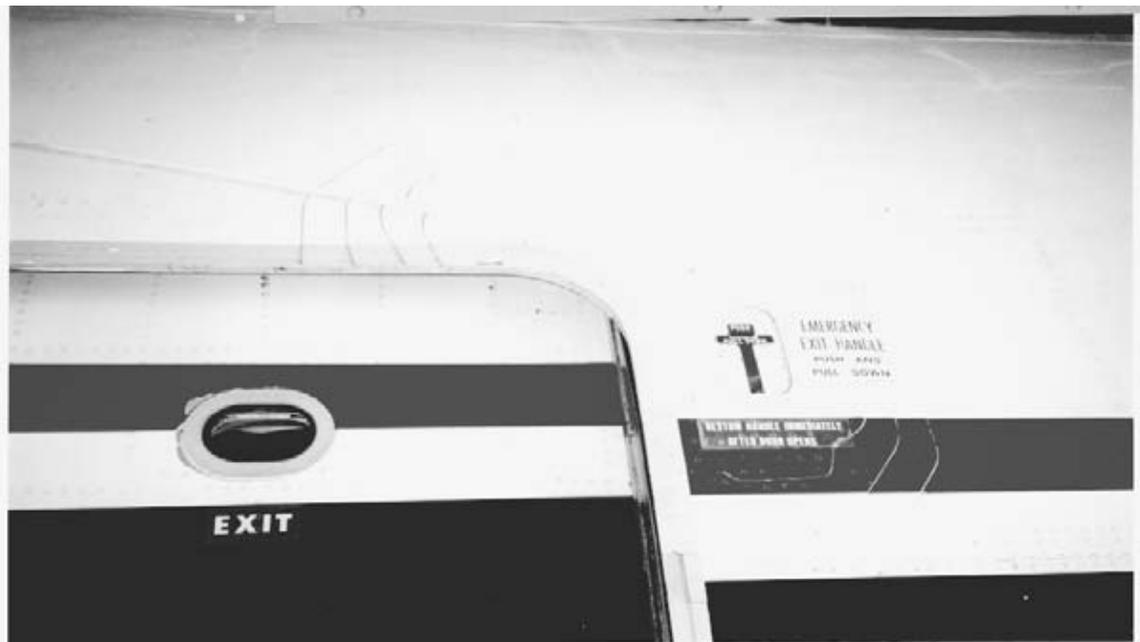
Figure 3: Conventional Door Corner Repair with Four Riveted Metal Plates; Close-Up View Shows Intricate Rivet Pattern and Complex Shape of Quadrupler Plates

The taper at the edge of the doubler is used to produce a gradually increasing stress gradient in the area of primary load transfer. In some applications, such as the L-1011 door corner doubler design, lightning protection is provided by a copper wire mesh which is imbedded in an adhesive film and applied as a top ply over the doubler. The lightning protection ply has a larger footprint than the composite laminate in order to provide a conductive link between the copper mesh and the surrounding aluminum skin. Finally, a top ply of fiberglass is installed to supply mechanical and environmental protection for the installation. Figure 3 shows a riveted, metal repair for the door corner application shown in Fig. 2. The fastened repair consists of two layers of aluminum skin and two layers of titanium skin. In addition, each plate has a unique and complex shape and must be formed to match the fuselage contour. Finally, the plates are mounted to the aircraft using an intricate rivet pattern. The composite doubler repair on the Delta Airlines door corner produced a 50% reduction in installation man-hours versus the riveted repair shown in Fig. 3

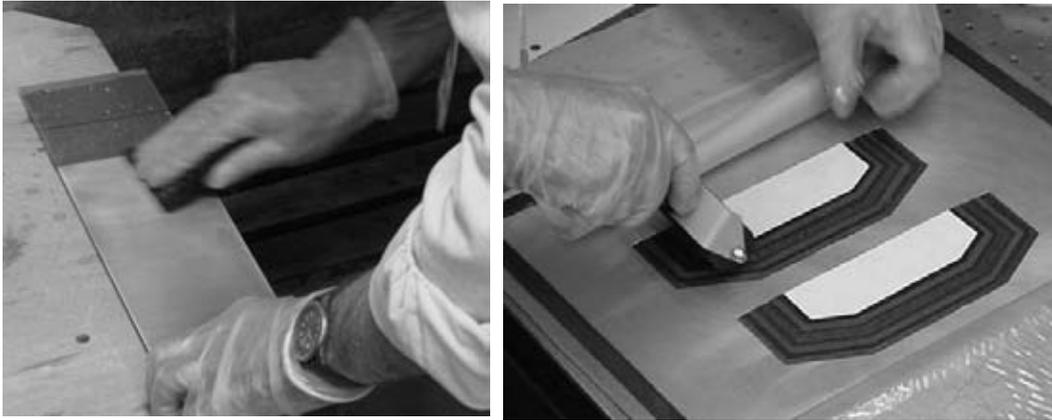
Figure 79: Scotchbrite Abrade to Water Break-Free Surface (left); Laying Up Doubler with Individual Boron-Epoxy Plies (right)

1. Aluminum Surface Preparation - Solvent clean per BAC 5750. Remove the oxide on the aluminum prior to Sol-Gel application using Scotch Brite pads and machine sanding to achieve a 30 second water-break free condition. Apply freshly-mixed Sol-Gel solution to the aluminum surface using brush-on or spray-on application processes.

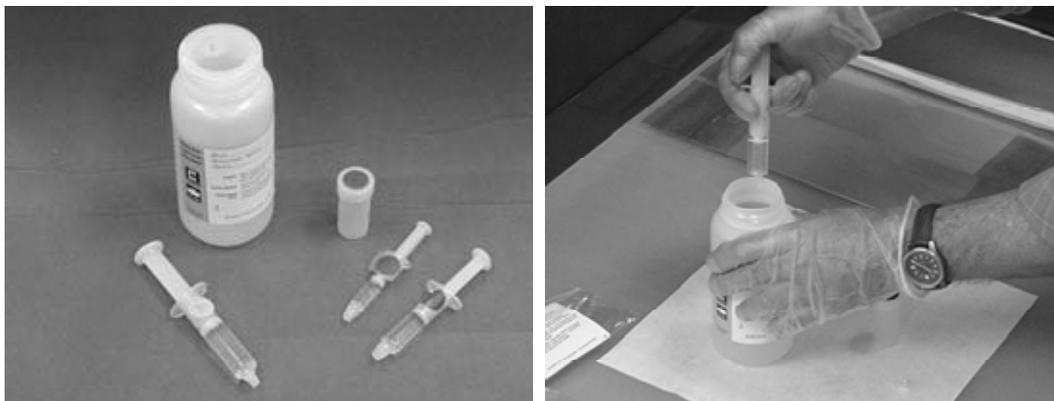
Figure 81: Sol-Gel Kit and Mixing Sol-Gel Chemicals

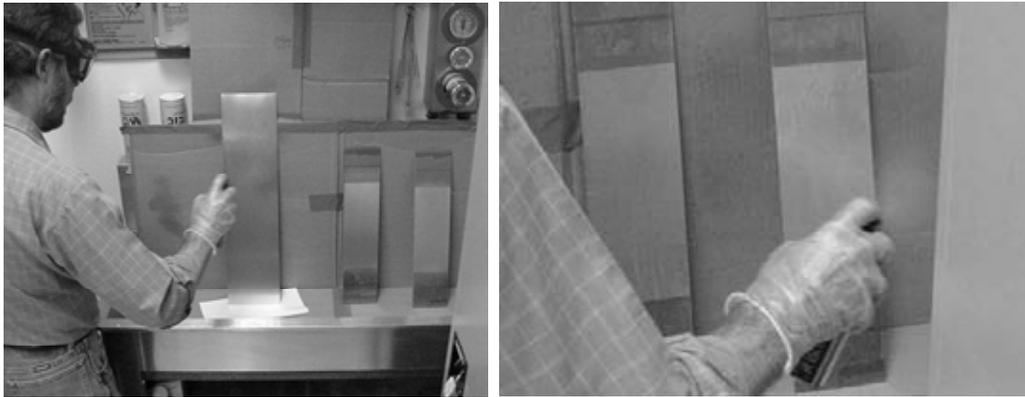
Figure 82: Spray-On Application of Sol-Gel Surface Prep Chemicals - 5 applications in 3-4 minutes

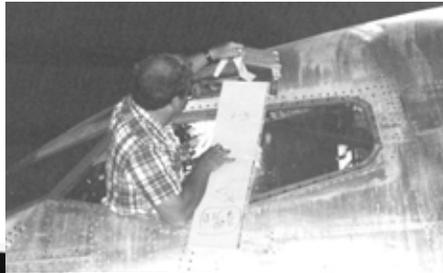
Positioning Film for Cockpit Window Post Inspection

Locating X-Ray Source for Door Frame Crack Inspection

Figure 105: Aircraft Fuselage Inspection for Cracks Using X-Ray

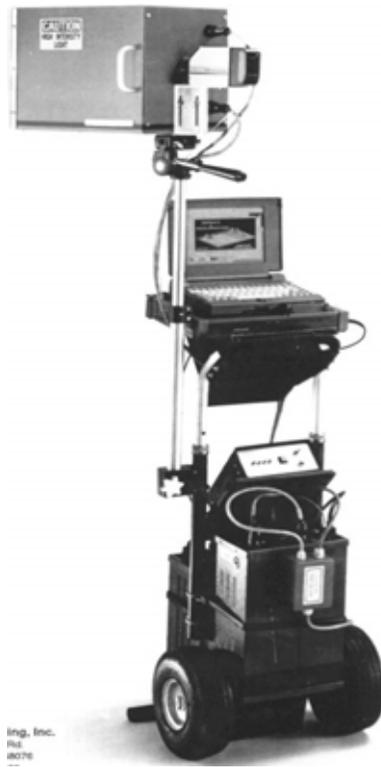
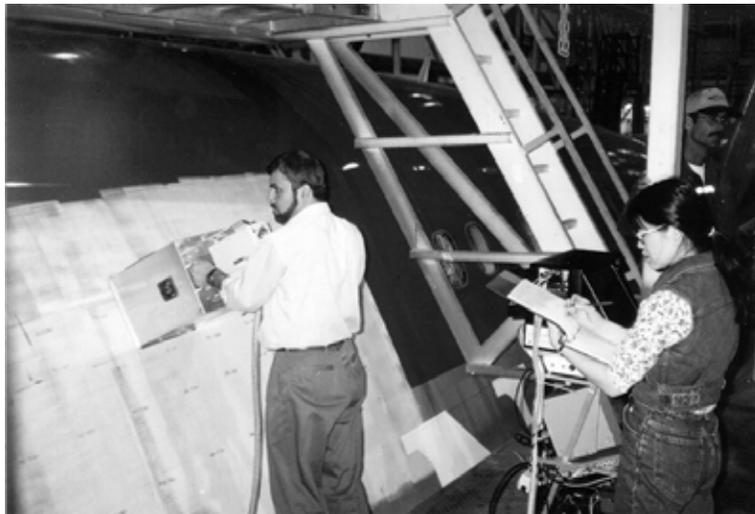
(a) Close-Up View of TWI Equipment

(b) Application of Thermography on 747 Aircraft

Figure 115: Thermal Wave Imaging System Inspecting an Aircraft

Thermal wave imaging is accomplished using high-power flash lamps, an infrared (IR) video camera, and image processing hardware and software, all of which are controlled by a personal computer. The flashlamps put out a short, high-power pulse of light, which raises the surface temperature of the structure approximately ten degrees when it is absorbed by the surface. This temperature pulse propagates into the material as a thermal wave and gets reflected by any defects which may be present in the material. The resulting temperature distribution is then recorded by the IR camera and displayed on the computer monitor. In practice, the computer actually obtains several images at progressively later times after each flash. This method is particularly useful for imaging and determining the depths of disbonds and delaminations in Boron-Epoxy repair doublers. A photograph of the Thermal Wave Imaging System being applied to an aircraft inspection is shown in Figure 115.

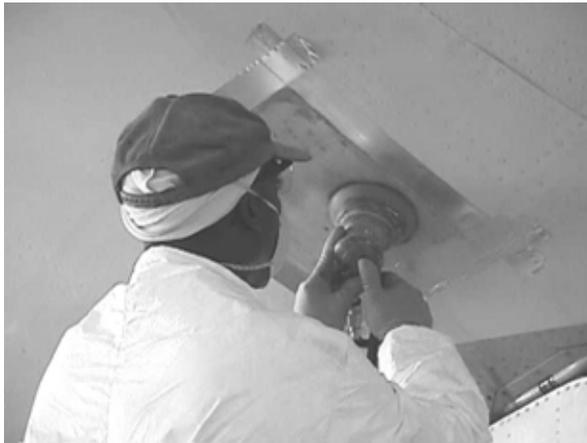
Figure 138: Scotch Brite Abrasion for Water - Break Free Surface

actually crossed a number of substructure elements such as stringers and frames. Figures 136-141 show the damage locations, several of the installation steps and a completed fuselage repair. At the top of the photo in Fig. 141 is a witness coupon that is part of the quality assurance check for every doubler installation. The witness coupon is an aluminum strip that is bonded to the prepared surface alongside the composite doubler. After curing, the witness strip is pried off with a wedge. If the adhesive is found on both the coupon and the fuselage skin, then the surface preparation is good. The full strength of the adhesive is assured since the failure mode was cohesive failure (fracture) rather than adhesive failure (disbond). The pitch-catch ultrasonic inspection of the composite doubler on the aircraft is shown in Figure 142.

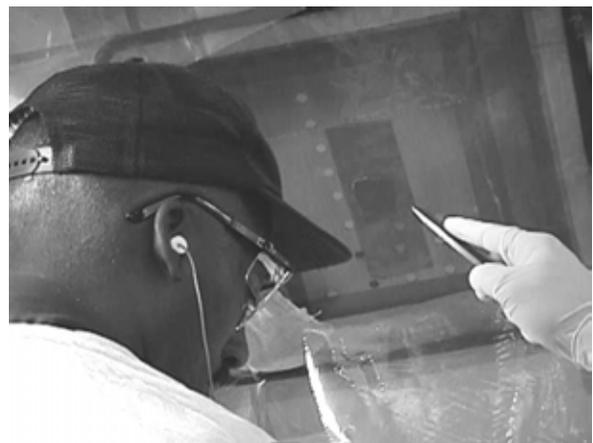
Figure 139: Application of Epoxy Adhesive Filler to Impact Damage

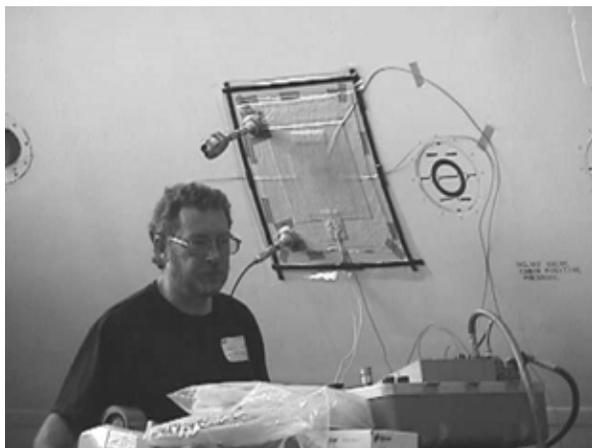
Figure 140: Monitoring Temperature and Vacuum During Cure Cycle

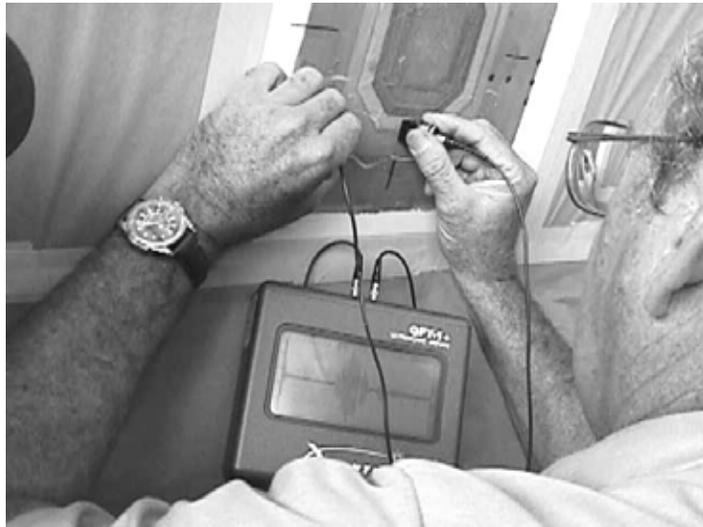
Figure 142: Pitch-Catch Ultrasonic Inspection of Aircraft 058 Composite Doubler

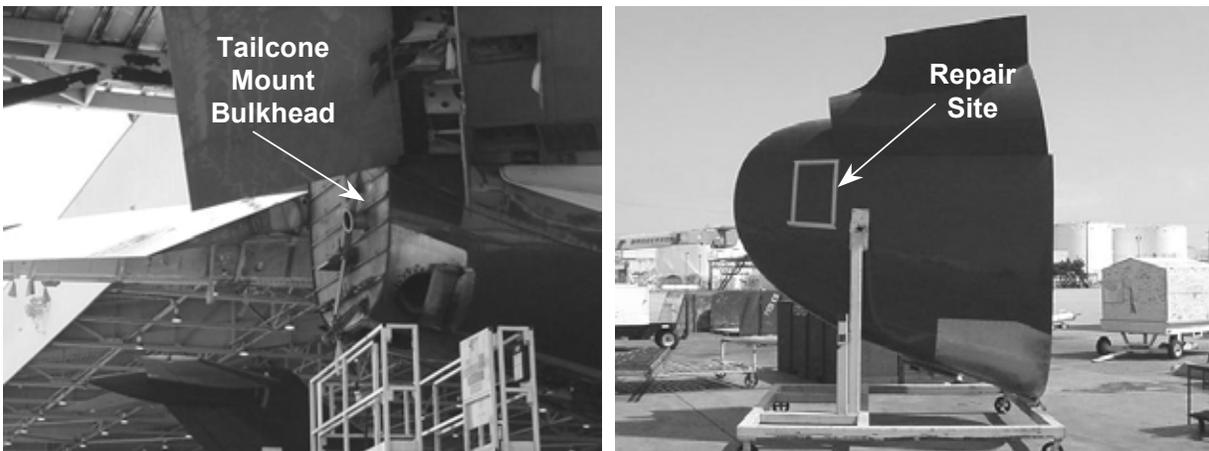
Figure 143: Composite Doubler Repair Location on Aircraft 384 Tailcone

Aircraft 384 - Figure 143 shows the repair region on the right hand side of the tailcone between station 2234 and 2239 at Z=39. The tailcone repair is of particular interest because it produced performance history for a composite doubler located in a sonic fatigue area near the aft engine. Figures 144-146 show the installation process, the completed fuselage repair, and the inspection process, respectively.

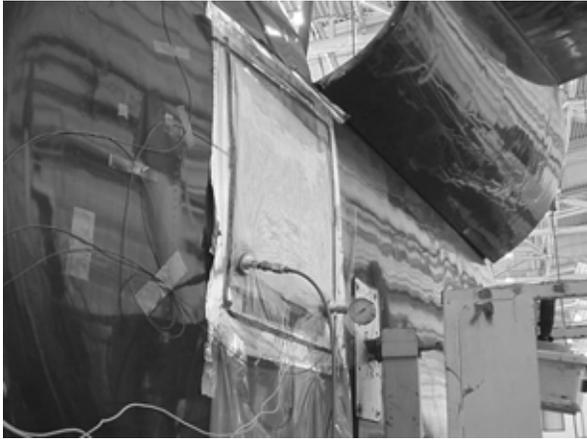
Figure 144: Doubler Cure Cycle on Tailcone

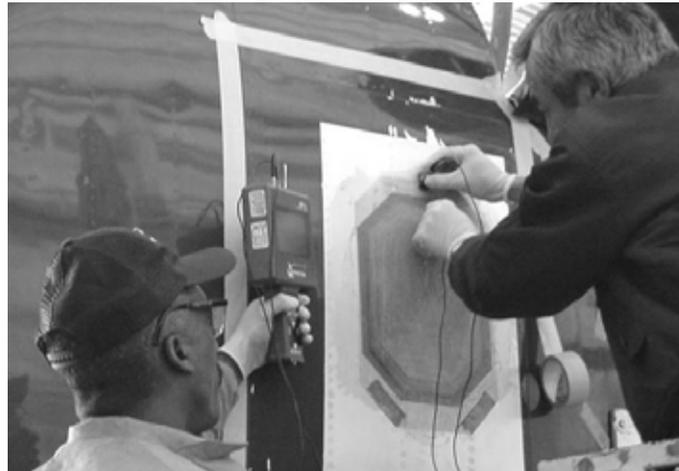
Figure 146: Pitch-Catch Ultrasonic Inspection of Aircraft 384 Composite Doubler

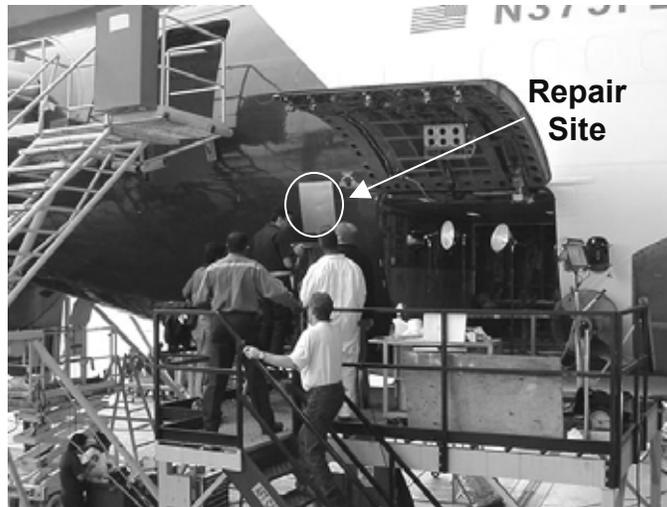
Figure 147: Composite Doubler Fuselage Repair Location on Aircraft 375

Aircraft 375 - Fuselage damage was repaired on aircraft 375 in the area shown in Figure 147. The doubler crossed two stringers and the first frame aft of the cargo door. A description of the damaged area location is as follows: R/H side of fuselage between station 1902 and 1921; between LG 17R and 18R; approximately 26" aft of center cargo door.

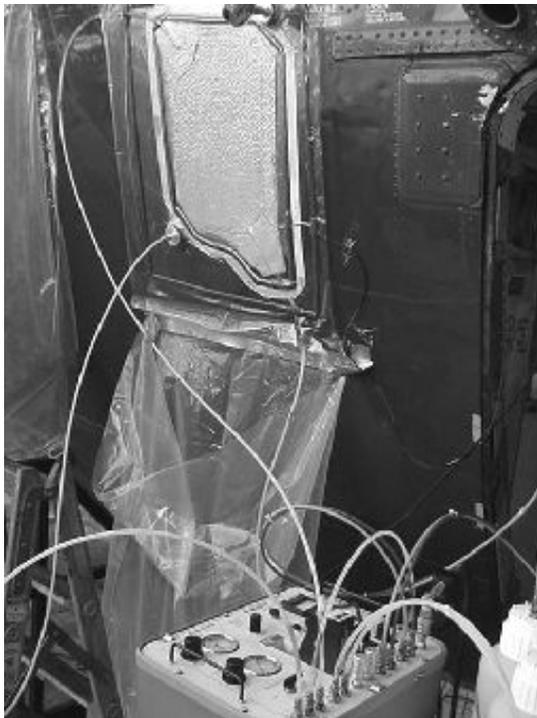
Figure 148: Surface Prep - Phosphoric Acid Anodize on Aircraft 375 Adjacent to Cargo Door

Several of the installation steps are shown in Figures 148 and 149. No access to the inside structure was required for this repair. Figures 150 and 151 show the completed fuselage repair and a close-up of the pitch-catch ultrasonic inspection, respectively.

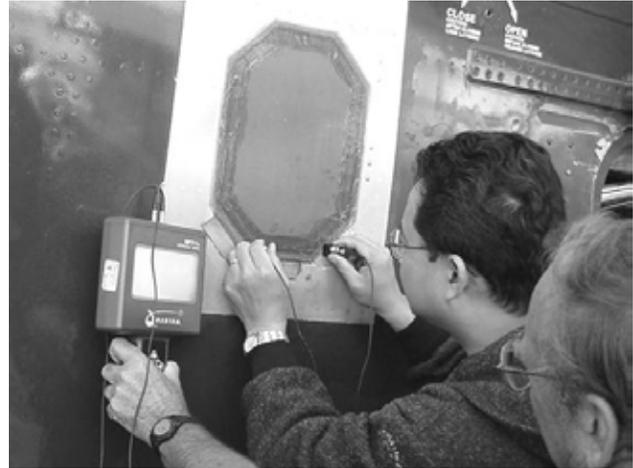
Figure 151: Pitch-Catch Ultrasonic Inspection of Aircraft 375 Repair

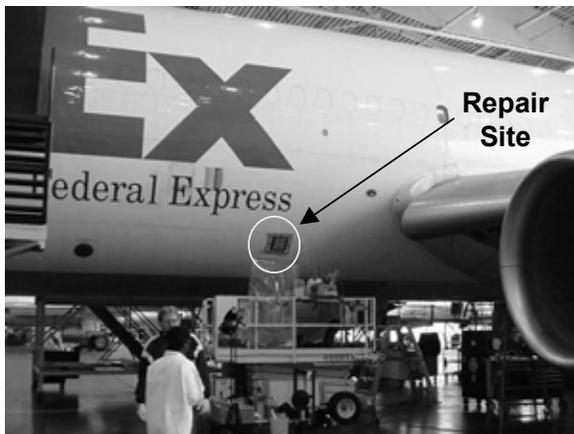
Figure 152: Composite Doubler Fuselage Repair Locations on Aircraft 060 – Fuselage R/H Side and Tailcone

Aircraft 060 - Fuselage impact damage was repaired on aircraft 060 in the two areas shown in Figure 152. Descriptions of the two damaged area locations are as follows:

1. L/H side of fuselage between station 1000 and 1020; between LG 35 and 36; aft of primary static ports.
2. R/H side of tailcone between station 2186 and 2191 at Z=39.

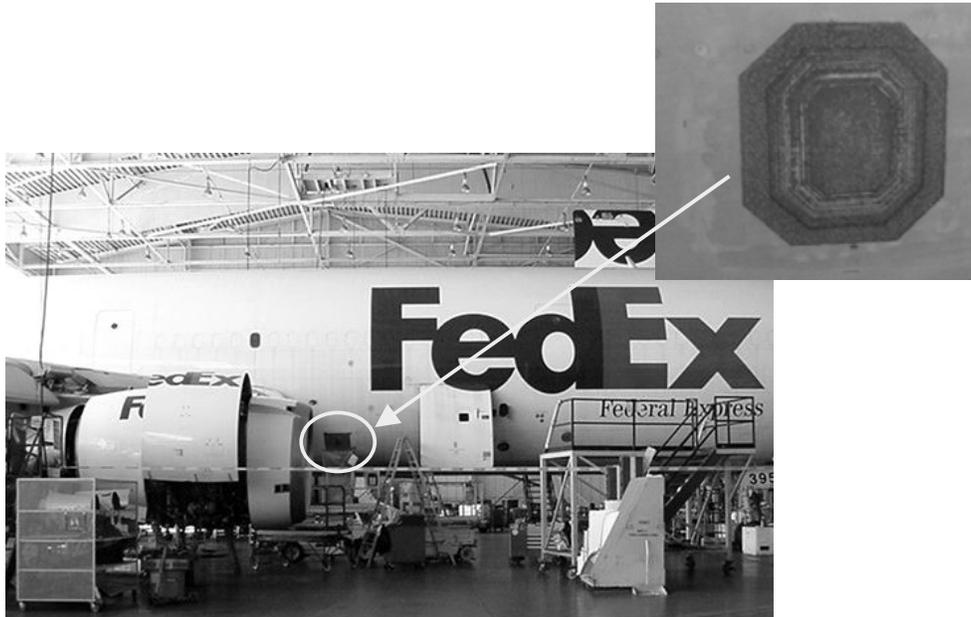
Figure 154: Composite Doubler Fuselage Repair Location on Aircraft 395 and Completed Fuselage Skin Repair

Aircraft 395 - A composite doubler was used to repair fuselage skin damage on the R/H side of aircraft 395 between stations 1019 and 1039 and between stringers 36 and 37. This was the first composite repair on a commercial aircraft to use the new Sol-Gel surface preparation process. Through our Pilot Program partner Federal Express, a Telex was submitted to Boeing and the FAA ACO requesting the substitution of the Sol-Gel aluminum surface preparation process for the currently-used Phosphoric Acid Anodize (PANTA) process. The Sol-Gel process has less room for human error, is more environmentally friendly, and results in a significant time savings during installation. This repair was completed in one day versus the two day approach that had been used on all of the previous PANTA-based repairs. Figure 154 shows the repair location on aircraft 395 along with the finished composite doubler repair. Use of the Sol-Gel process allowed the repair installation to be completed in a single shift. This process will permit overnight repairs such that aircraft can be available for their first flight the next day.

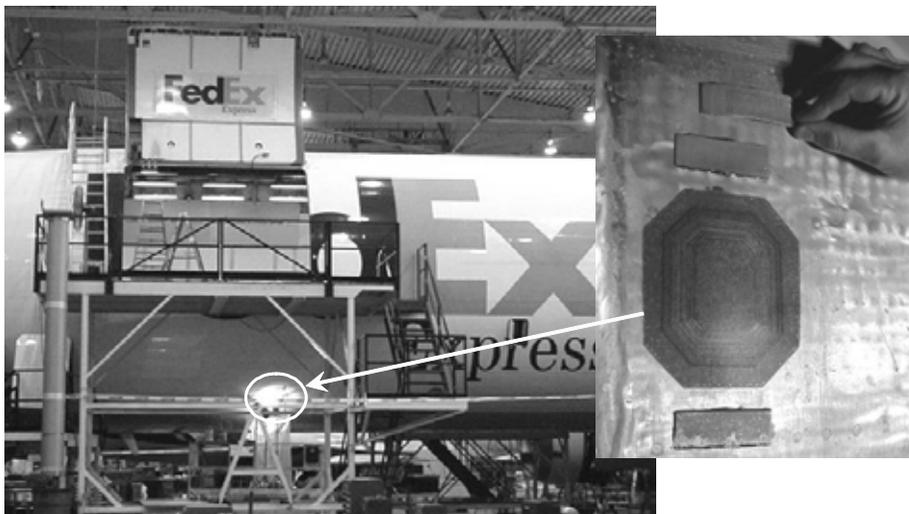
Figure 155: Composite Doubler Fuselage Repair Location on Aircraft 566 and Completed Fuselage Skin Repair

Aircraft 566 - A composite doubler was used to repair skin impact damage on the R/H side of aircraft 566 at fuselage station 540 between stringers 41 and 42. This was the second composite repair on a commercial aircraft to use the new Sol-Gel surface preparation process. Figure 155 shows the repair location on aircraft 566 along with the finished composite doubler repair. No access to the inside structure was required for this repair. The witness coupons, showing a successful QA check on the surface preparation process, are also shown in Fig. 155.
