SAND76-8206

# Hydrogen Compatibility of Structural Materials for Energy Storage and Transmission Applications

(Semiannual Report for Period Through January 15, 1976)

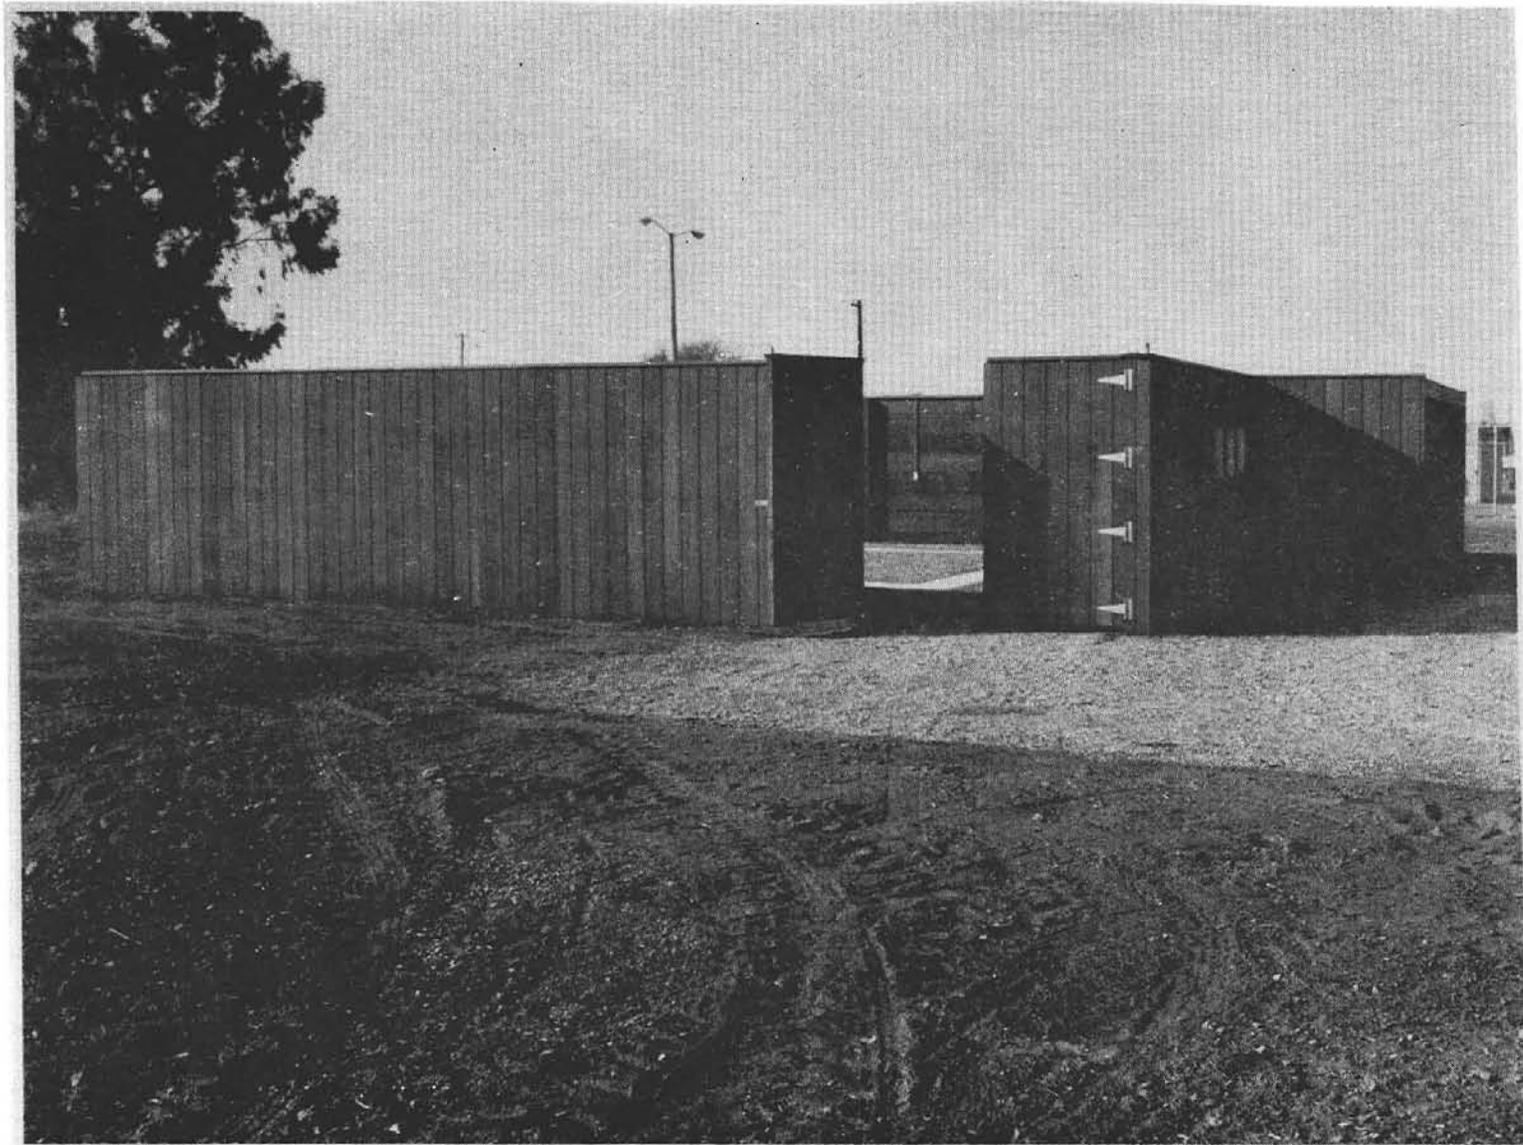
Figure 2A. Exterior of Site Showing Redwood Fencing.

Photographs of the completed site including the instrumentation trailer are shown in Figure 2. Major pipeline components, including pipeline segments and the circulating pump housing are now being fabricated by outside contractors. To help insure safety of our experimental operations, the chemistries of all structural materials used in the pipeline loop are being certified back to their melted ingots and a detailed welding and nondestructive test specification has been developed at Sandia for this application.

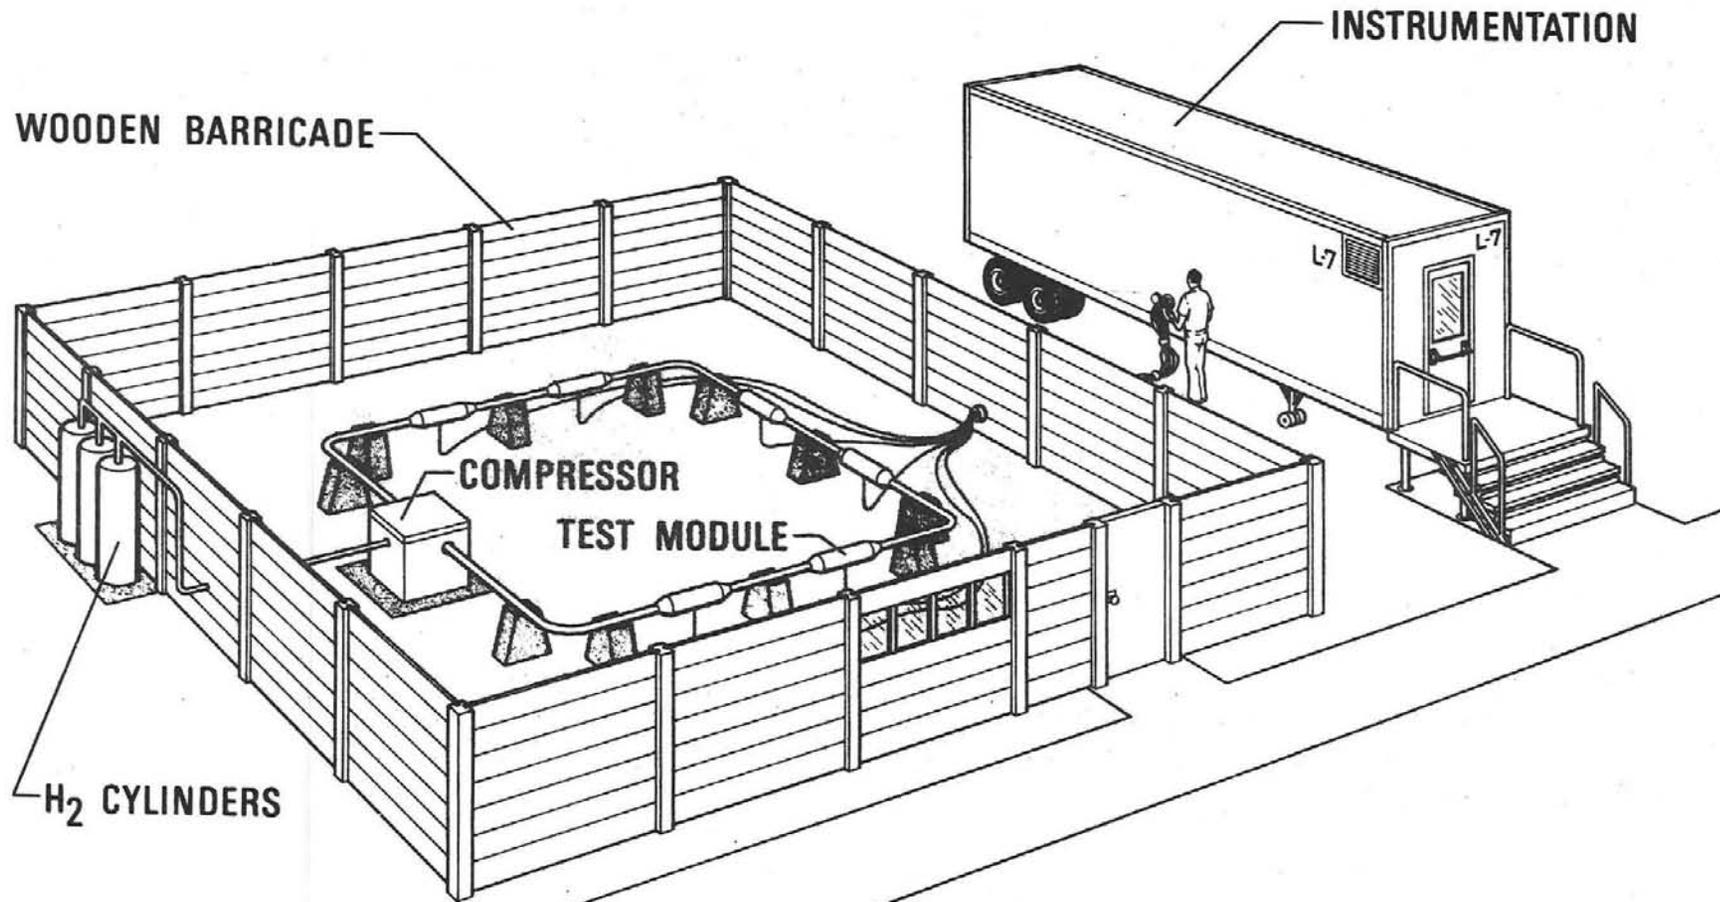
Figure 3. Experimental Hydrogen Pipeline Facility

A schematic layout of the site is shown in Figure 3, and the test module to be used in the pipeline is shown in Figure 4. The annular space in the test modules will be backfilled with inert gas so that any ruptures occurring in the thin test sections will not compromise other tests in progress in the pipeline. The modules are fitted with an instrumentation port to allow us to monitor slow leaks, potential ruptures, and permeation as needed. Multi-channel data acquisition units, with alarms in the event of an inner liner rupture, and recording devices to monitor pressure in the annulus will be operated. An oxygen detector will be operated continuously inside the pump chamber (for safety considerations).

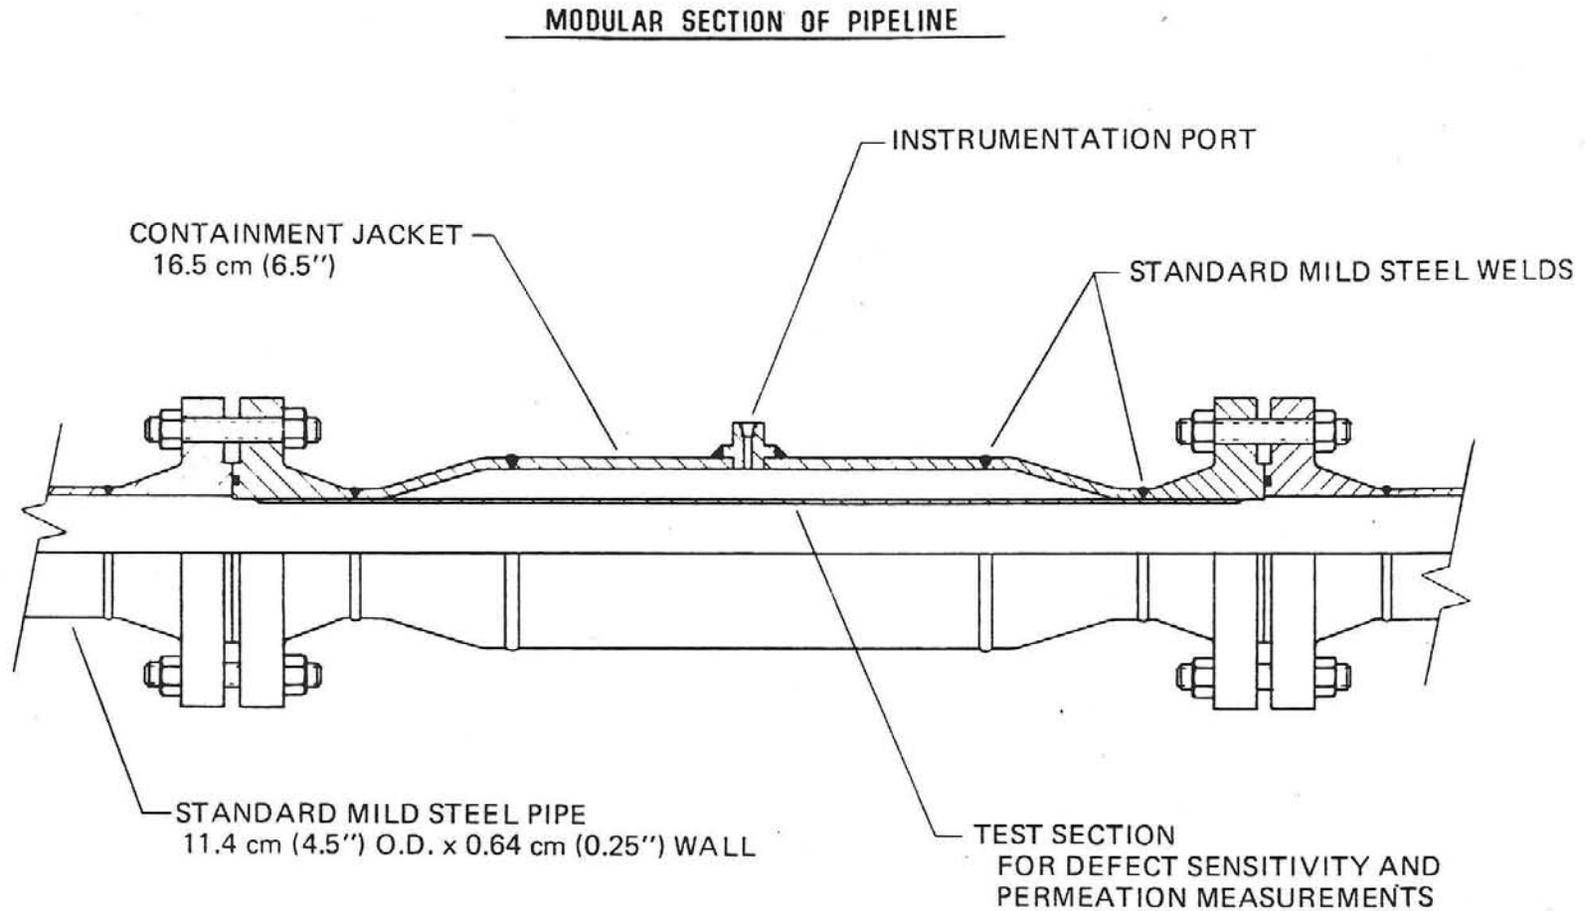
Figure 4. Modular Section of Pipeline

- \*HYDROGEN GAS PRESSURE = 6.9 MPa (1000 psi)
- \*ALL MILD STEEL CONSTRUCTION
- \*MATERIAL STRESS LEVELS  $\approx$  25% of YIELD STRENGTH  
(EXCEPT TEST SECTION  $\approx$  75%)

Prior to actual assembly of the pipeline, a set of safety-oriented tests are planned. Three sections of flawed pipe will be hydrogen charged to simulate service conditions, and then burst with nitrogen gas. The purpose of this test series is to discover and protect against unsafe design features. Initially two modules of the design shown in Figure 4 will be constructed and installed in the line.

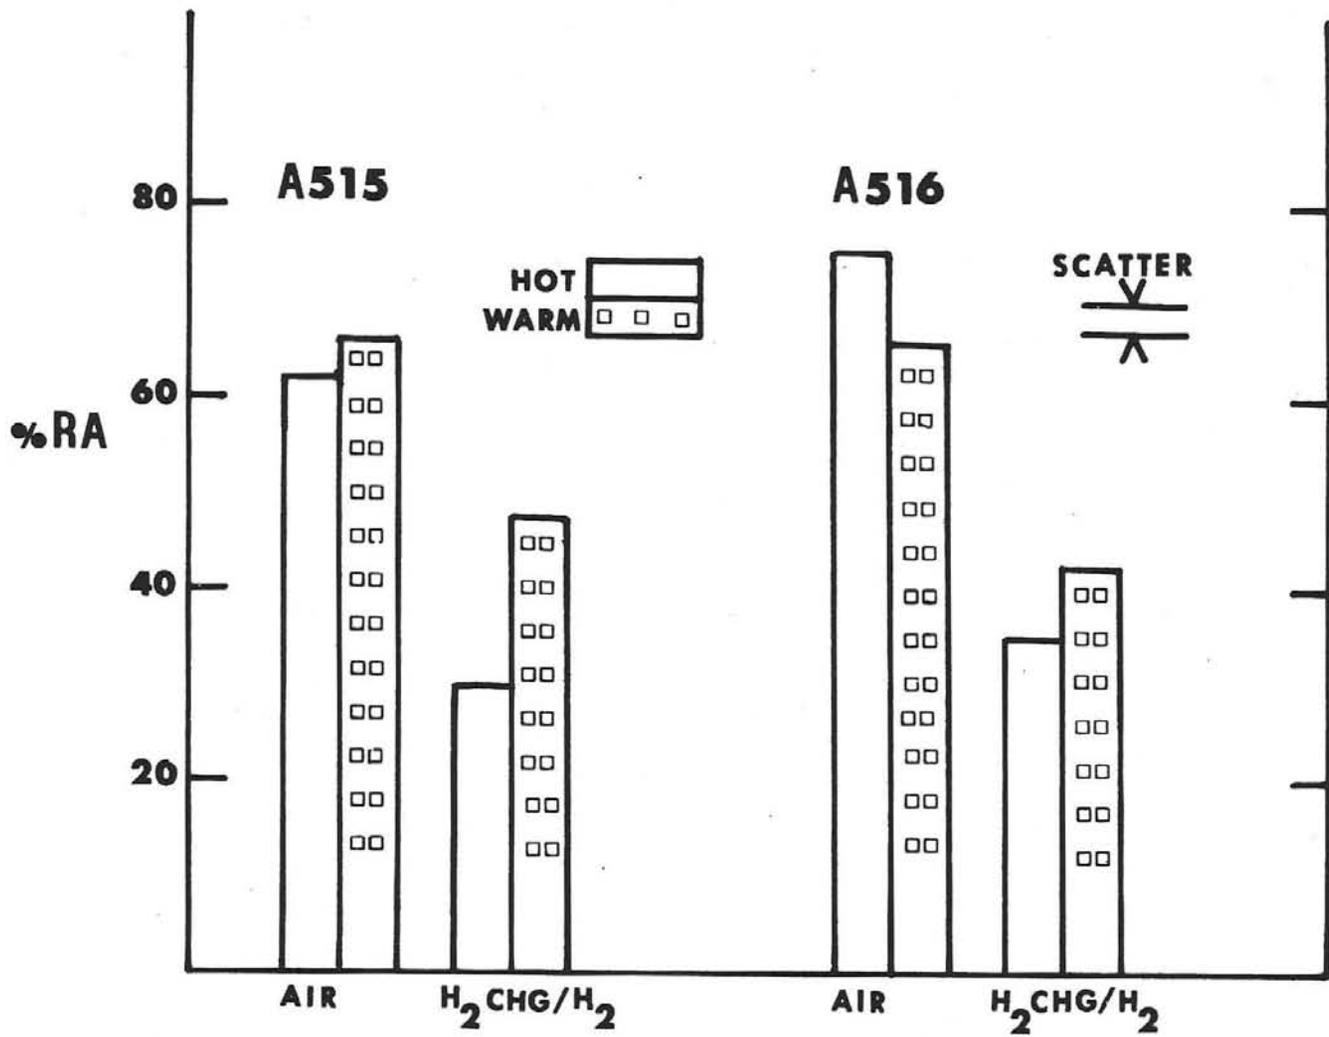
Figure 5. Influence of Warm Rolling on Hydrogen Compatibility of Pressure Vessel Steels

Comparisons have been made between the mechanical behavior of warm worked and mill finished mild steels. This comparison is summarized in Figure 5, showing that a significant ductility improvement (%RA) may be obtained in the manganese-carbon pressure vessel steels A515 and A516. The sources of that ductility improvement may be seen to derive primarily from microstructural changes due to the warm working. Microstructures obtained prior to and after warm working are shown in Figure 6. Grain refinement, texture formation, partial spheroidization of cementite and probably some subgrain formation result from the warm working process. There are positive suggestions in the literature that low angle boundaries, fine grain size, and dislocation networks all contribute to improved hydrogen resistance (References #1, 2, and 3). Spheroidization has not yet been shown to be unequivocally beneficial, and the reduced scale of the carbides may play a more significant role in the net response to hydrogen.

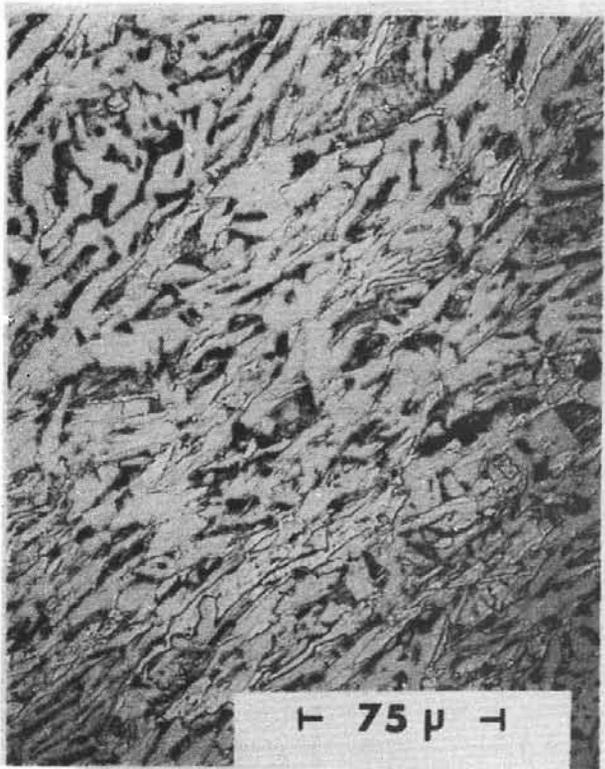
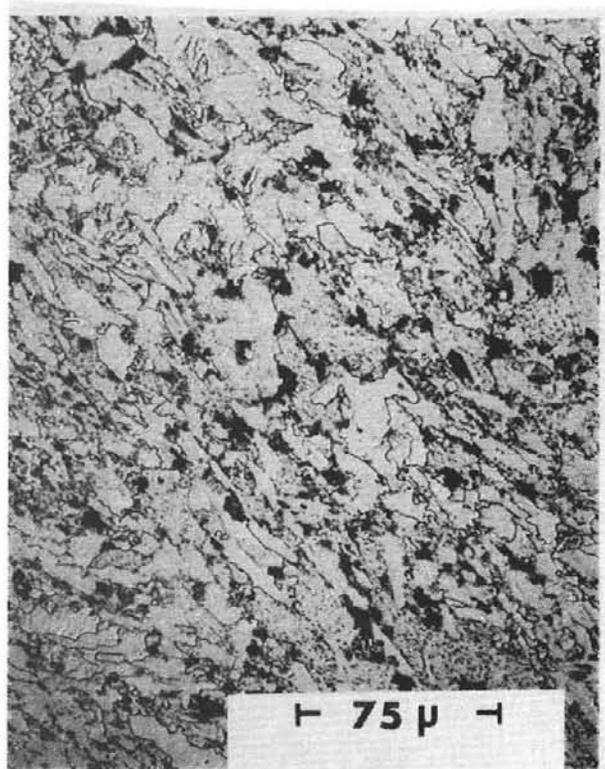
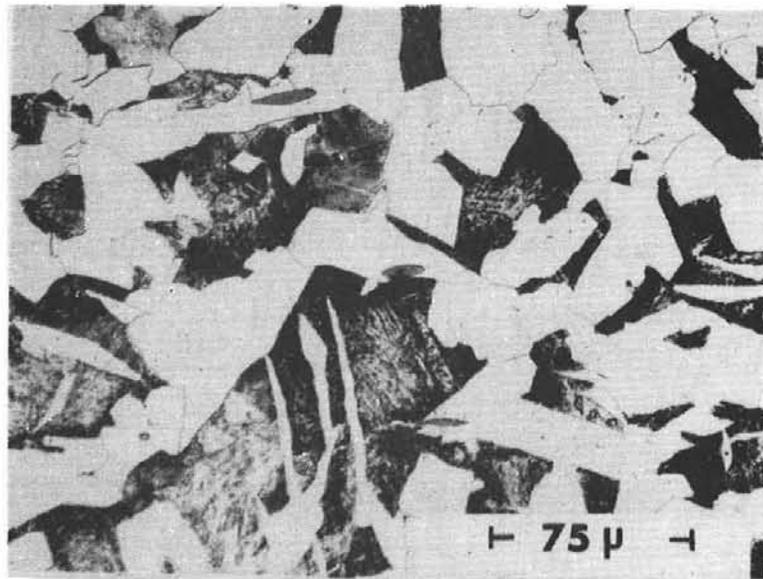
Figure 6. Microstructure Modification of A515 and A516 Steels by Warm Rolling

A516 After warm working 400X

A515 After warm working 400X

A515 Before warm working 400X

Preliminary studies using the X-ray dispersive analyzer on the scanning electron microscope suggest that chemical segregation of alloying elements may also play a contributory role in hydrogen susceptibility. Banded structures such as the A516 in the as-received condition showed manganese enrichment in the pearlite colonies, and manganese gradients away from the pearlite into the bulk ferrite. Ferrite lamellae in pearlite were found to

be similarly enriched. As received, the more equiaxed A515 showed significantly less segregation. Warm working of these alloys was found by dispersive analysis to have reduced the indicated segregation to very low values.

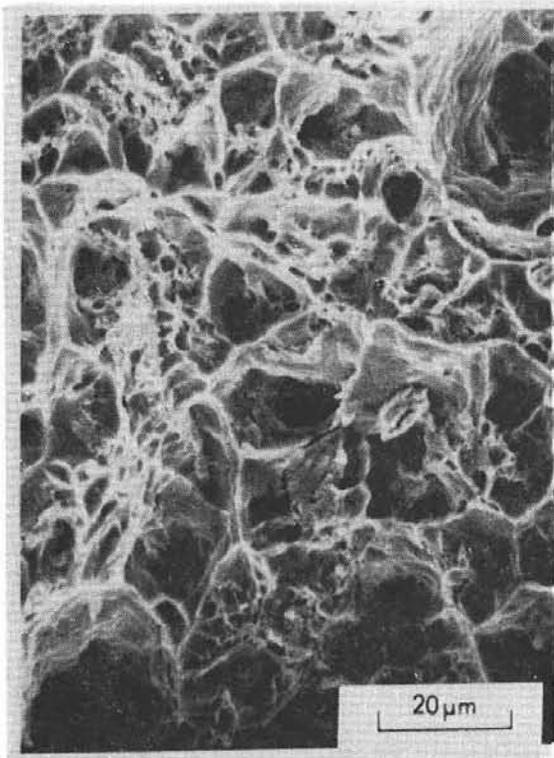
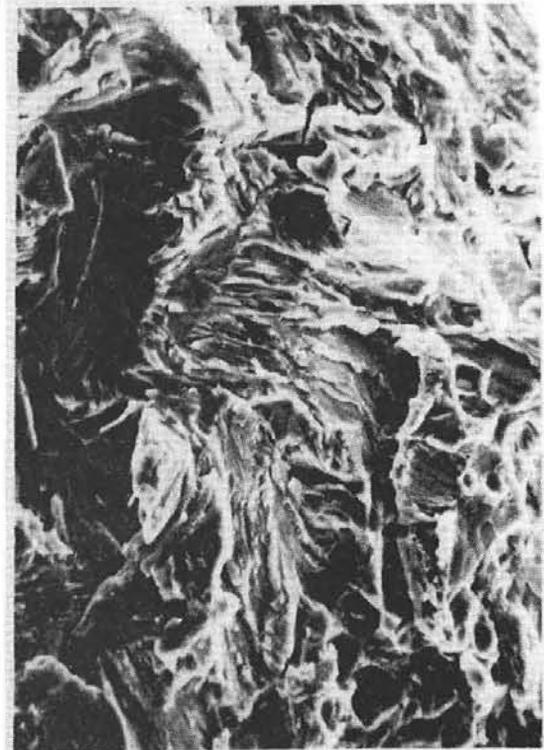
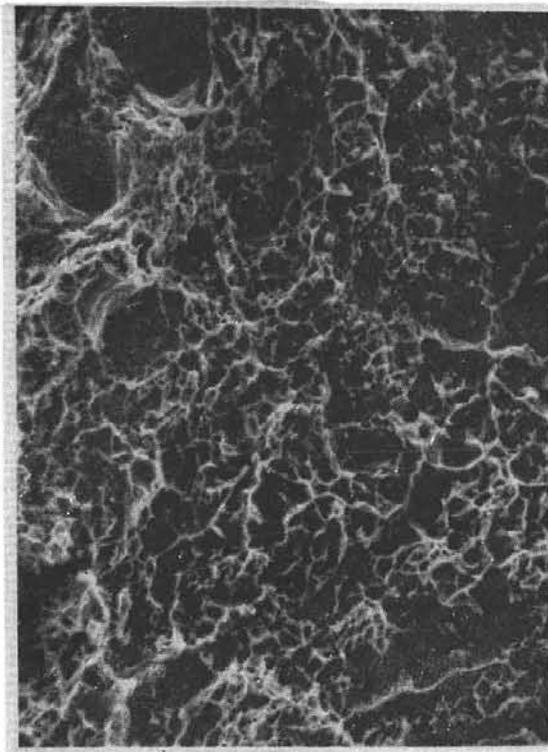
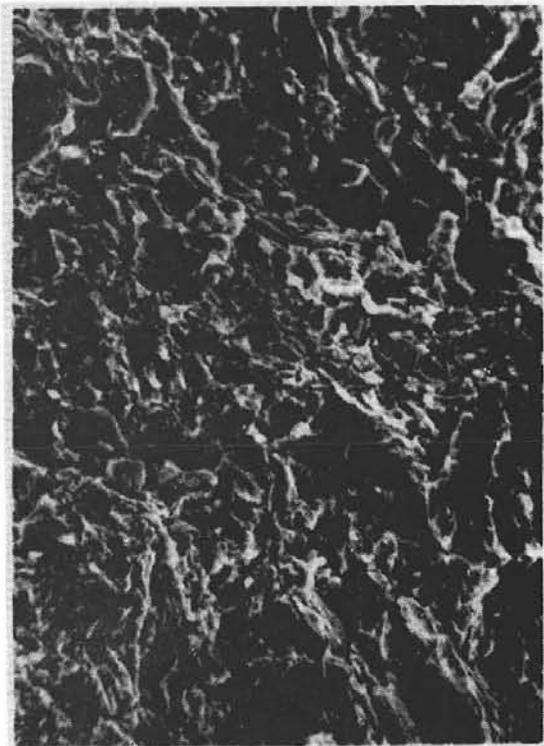
Figure 7A. Fracture Surfaces of Mill Finished and Warm Rolled A515 Steels.

Fracture surfaces of the A515 and A516 have been compared in warm worked and mill finished conditions (See Figures 7A and 7B). Warm working reduces the dimple size of both A515 and A516 when tensile tested in air. In addition, fracture surfaces of the warm worked materials tested in hydrogen exhibit more ductility than their mill finished counterparts.

HOT ROLLED  
UNEXPOSED TO H<sub>2</sub>

HOT ROLLED - THERMAL CHARGE  
4.14 MPa H<sub>2</sub> TEST

WARM ROLLED  
UNEXPOSED TO H<sub>2</sub>

WARM ROLLED - THERMAL CHARGE  
4.14 MPa H<sub>2</sub> TEST

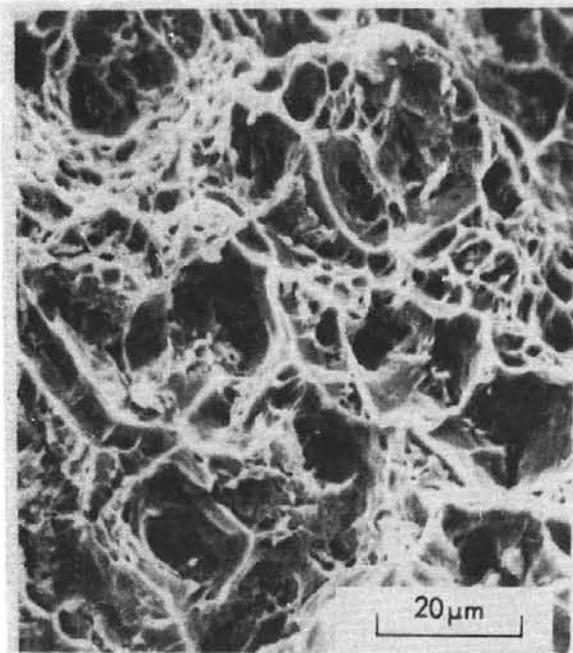
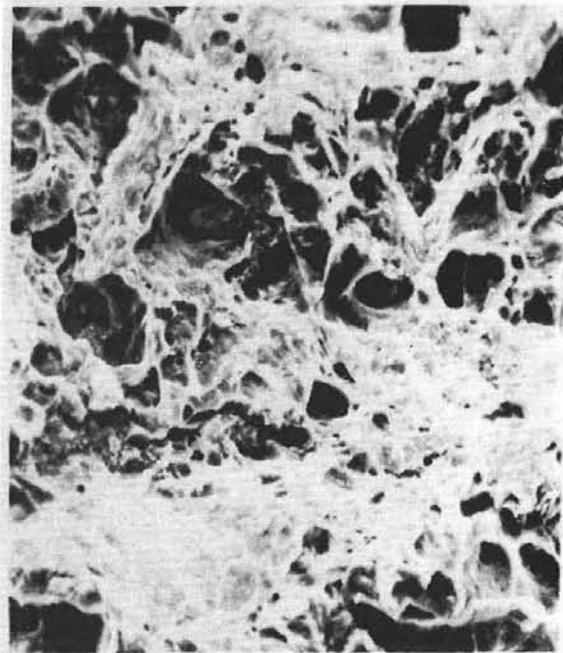
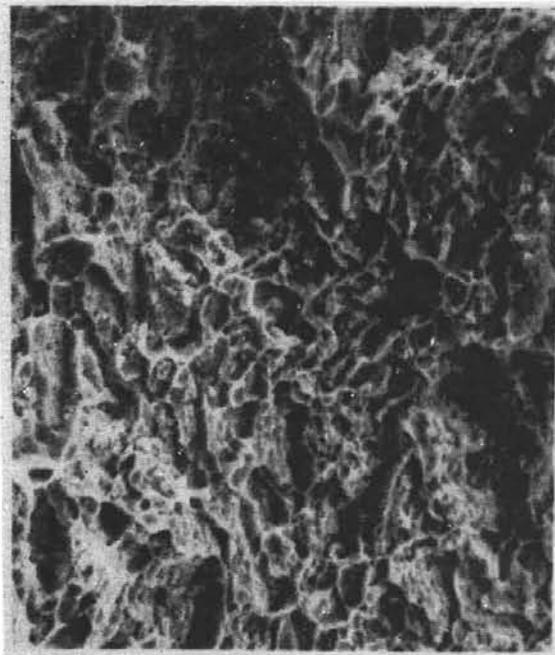
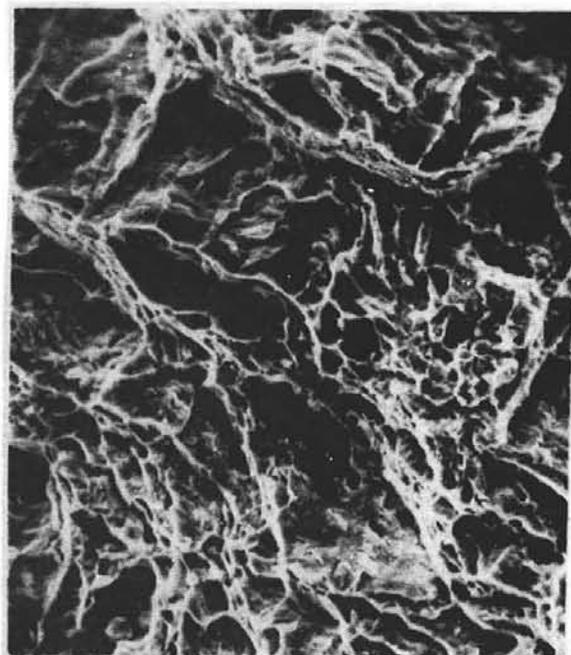
Figure 7B. Fracture Surfaces of Mill Finished and Warm Rolled A516 Steels.

HOT ROLLED  
UNEXPOSED TO H<sub>2</sub>

HOT ROLLED - THERMAL CHARGE  
4.14 MPa H<sub>2</sub> TEST

WARM ROLLED  
UNEXPOSED TO H<sub>2</sub>

WARM ROLLED - THERMAL CHARGE  
4.14 MPa H<sub>2</sub> TEST

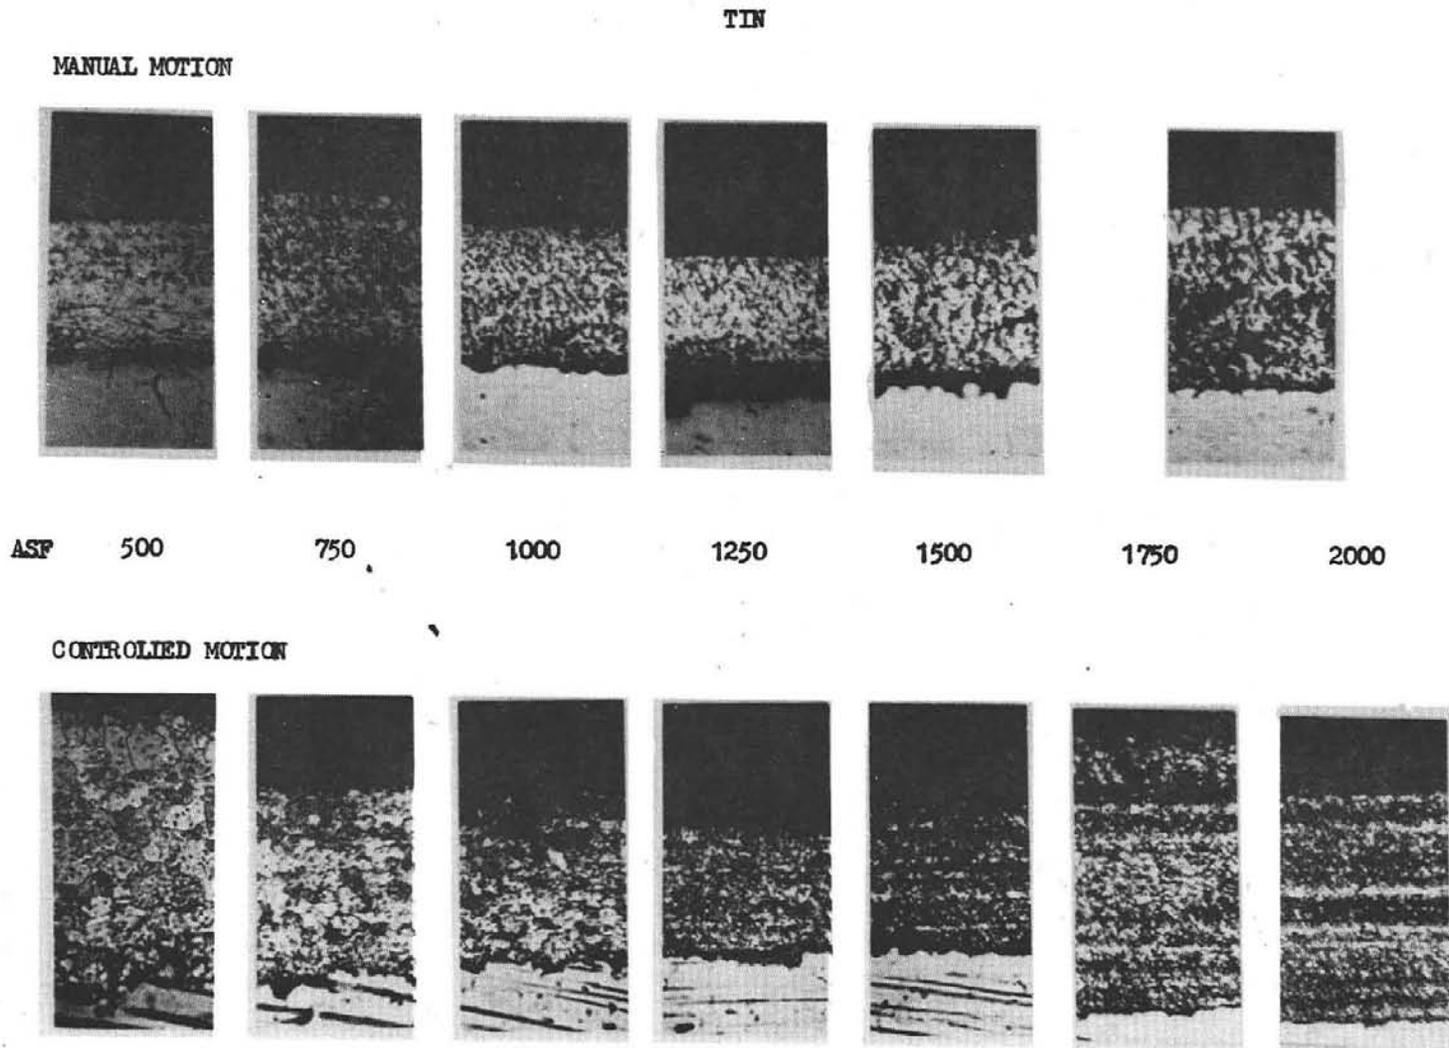
Figure 8. Controlled Motion vs Manual Motion Tin Plating Studies.

We have examined the quality of controlled motion vs. manually applied brush electroplated coatings at various current densities. Optimum coatings were obtained at low densities (500 amps/ft<sup>2</sup>) with mechanically controlled motion. A typical series of microstructures produced by both methods is shown in Figure 8 for a tin coating. Permeation measurements were performed only on the optimum coatings.

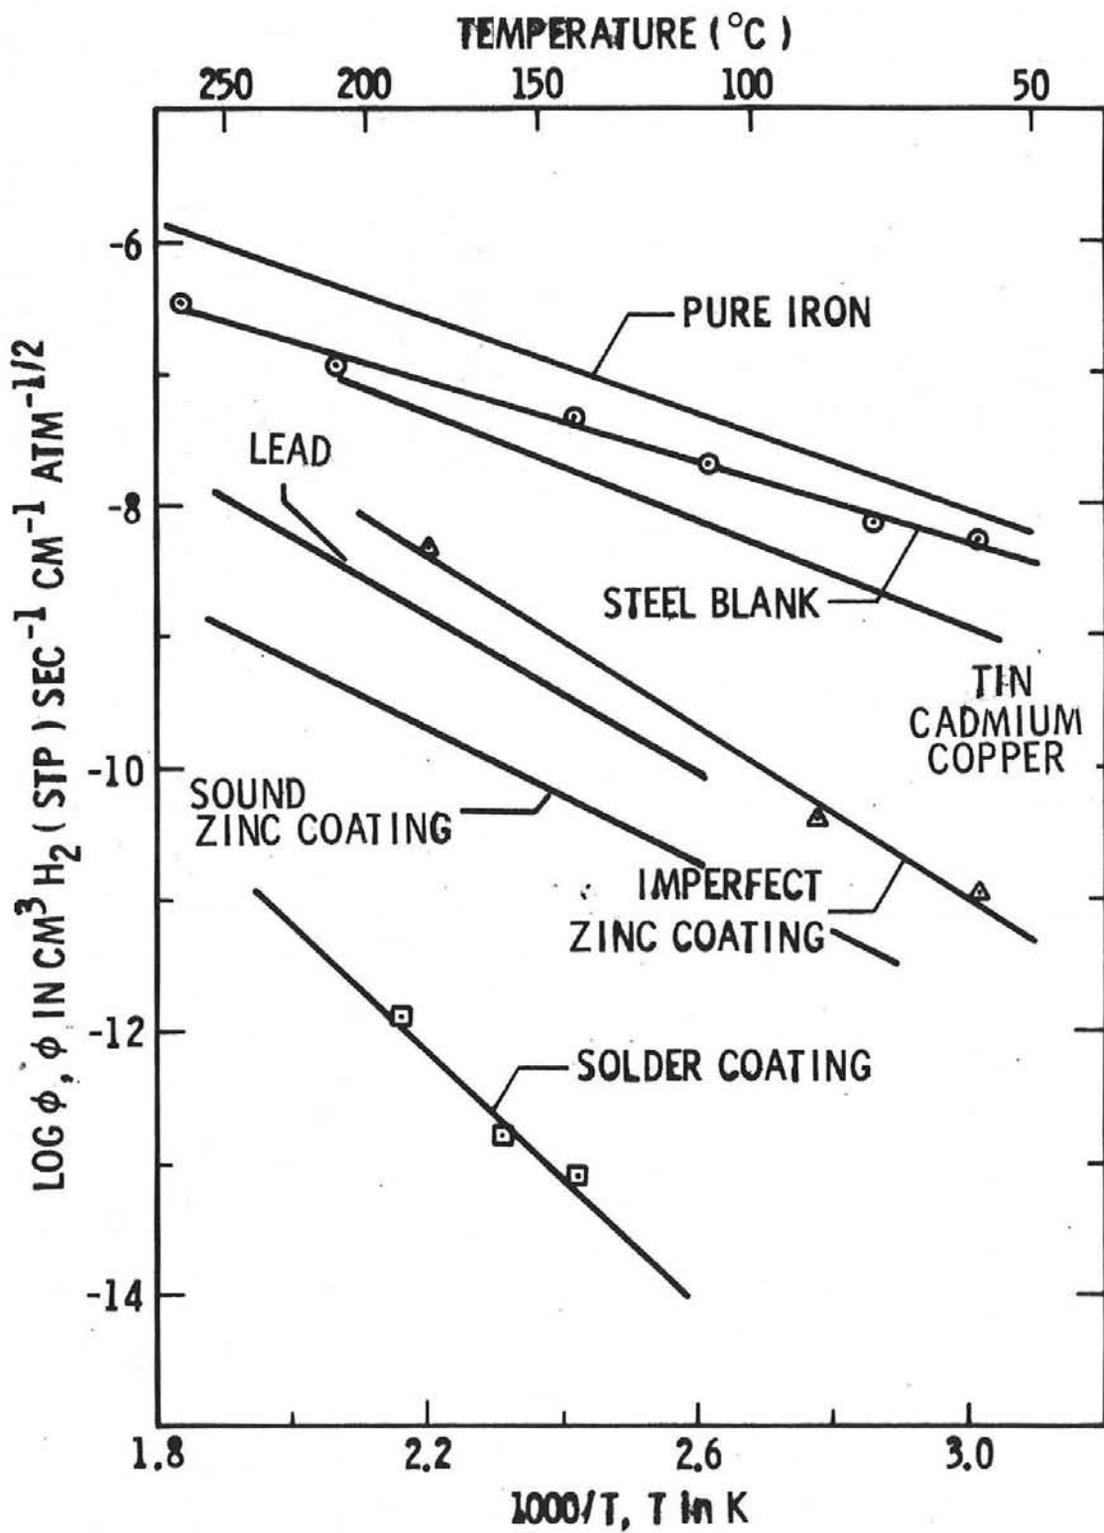
FIGURE 9. BRUSH PLATING AS A MEANS OF REDUCING HYDROGEN UPTAKE AND PERMEATION IN STEELS

Lead was thought to be a desirable material to test since (1) the 70% Sn - 30% Pb coating was highly successful, and (2) tin itself was not found to produce low permeabilities. It was, therefore, suggested that lead might in fact be responsible for the performance of the alloy. As may be seen in the permeability plot of Figure 9, the explanation is more complex, since the permeability of lead is high. The reasons for the effectiveness of the 70% Sn - 30% Pb coating must lie in metallurgical structure and electroplating characteristics of the alloy itself.
