SAND REPORT

SAND2002-4135

FY02 Field Evaluations of an In-Situ Chemiresistor Sensor at Edwards Air Force Base, CA

Clifford K. Ho, Lucas K. McGrath, and James May

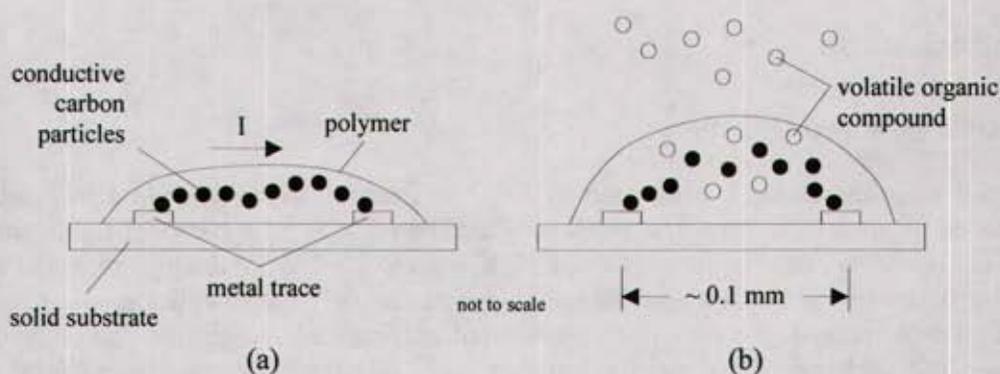
Figure 1. VOC detection by a thin-film chemiresistor: (a) Electrical current (I) flows across a conductive thin-film carbon-loaded polymer deposited on a micro-fabricated electrode; (b) VOCs absorb into the polymer, causing it to swell (reversibly) and break some of the conductive pathways, which increases the electrical resistance.

The chemiresistor sensor used in the tests at Edwards Air Force Base is essentially a chemically sensitive resistor comprised of a conductive polymer film on a micro-fabricated circuit. The chemically-sensitive polymer is dissolved in a solvent and mixed with conductive carbon particles. The resulting ink is then deposited and dried onto thin-film platinum traces on a solid substrate (chip). When chemical vapors come into contact with the polymers, the chemicals absorb into the polymers, causing them to swell. The swelling changes the resistance of the electrode, which can be measured and recorded using a data logger or an ohmmeter (see Figure 1). The swelling is reversible if the chemical vapors are removed, but some hysteresis can occur at high concentration exposures. The amount of swelling corresponds to the concentration of the chemical vapor in contact with the chemiresistor, so these devices can be calibrated by exposing the chemiresistors to known concentrations of target analytes.

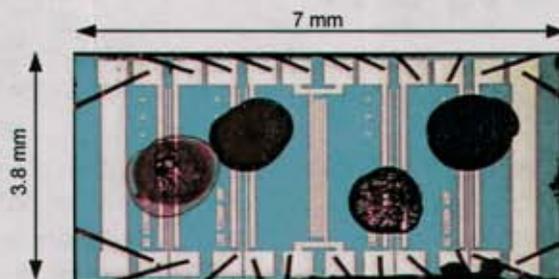
Figure 2. Chemiresistor array (chip C12) developed at Sandia National Laboratories with four conductive polymer films deposited onto a microfabricated circuit. A temperature sensor (middle) and heating elements (ends) are also integrated.

Two unique features exist regarding the chemiresistor sensor package used in these tests. First, the architecture of the microsensor (Hughes et al., 2000) integrates an array of chemiresistors with a temperature sensor and heating elements (Figure 2). The chemiresistor array has been shown to detect a variety of VOCs including aromatic hydrocarbons (e.g., benzene), chlorinated solvents (e.g., trichloroethylene (TCE), carbon tetrachloride), aliphatic hydrocarbons (e.g., hexane, iso-octane), alcohols, and ketones (e.g., acetone). The on-board temperature sensor comprised of a thin-film platinum trace can be used to not only monitor the in-situ temperature, but it can also provide a means for temperature control. A feedback control system between the temperature sensor and on-board heating elements can allow the chemiresistors to be maintained at a fairly constant temperature, which can aid in the processing of data when comparing the responses to calibrated training sets. In addition, the chemiresistors can be maintained at a temperature above the ambient to prevent condensation of water, which may be detrimental to the wires and surfaces of the chemiresistor. However, a fieldable version of the automated temperature control has just recently been tested in the laboratory, and it was not implemented in the field tests at Edwards Air Force Base.

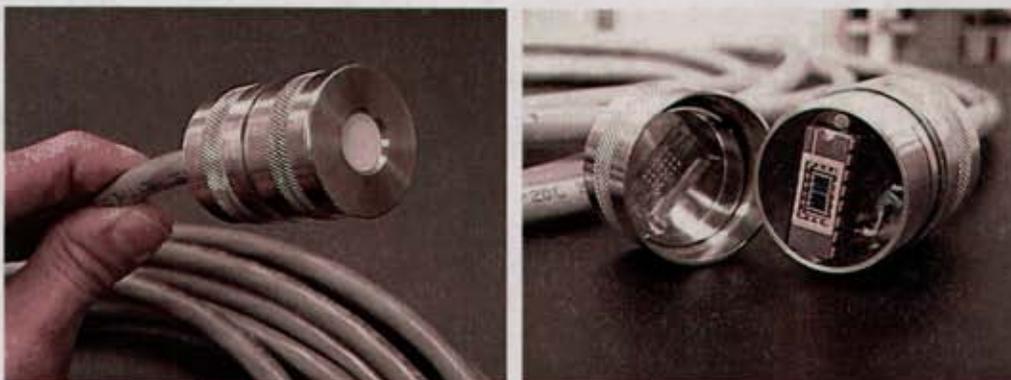
Figure 3. Stainless-steel waterproof package that houses the chemiresistor array. Left: GORE-TEX[®] membrane covers a small window over the chemiresistors. Right: Disassembled package exposing the 16-pin dual-in-line package and chemiresistor chip.

A second unique feature is that a robust package has been designed and fabricated to house the chemiresistor array (Ho and Hughes, 2002). This cylindrical package is small (~ 3 cm diameter) and is constructed of rugged, chemically-resistant material. Early designs have used PEEK (PolyEtherEtherKetone), a semi-crystalline, thermoplastic with excellent resistance to chemicals and fatigue. Newer package designs have been fabricated from stainless steel (Figure 3). The package design is modular and can be easily taken apart (unscrewed like a flashlight) to replace the chemiresistor sensor if desired. Fitted with Viton O-rings, the package is completely waterproof, but gas is allowed to diffuse through a GORE-TEX[®] membrane that covers a small window to the sensor. Like clothing made of GORE-TEX[®], the membrane prevents liquid water from passing through it, but the membrane “breathes,” allowing vapors to diffuse through. Even in water, dissolved VOCs can partition across the membrane into the gas-phase headspace next to the chemiresistors to allow detection of aqueous-phase contaminants. The aqueous concentrations can be determined from the measured gas-phase concentrations using Henry’s Law. Mechanical protection is also provided via a perforated metal plate that covers the chemiresistors. The chemiresistors are situated on a 16-pin dual-in-line package that is connected to a weatherproof cable, which can be of any length because of the DC-resistance measurement. The cable can be connected to a hand-held multimeter for manual single-channel readings, or it can be connected to a multi-channel data logger for long-term, remote operation.

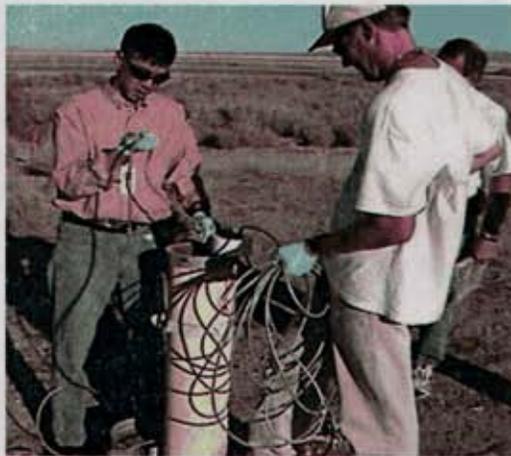
Figure 5. Lowering the chemiresistor sensor housing down well 18-MW37 for the Phase I test (11/14/2001).

The purpose of this test was to determine the long-term water-entry-pressure threshold by lowering the housing to greater and greater depths beneath the water table at well 18-MW37 (Figure 5). A small piece of tissue was placed where the chemiresistor sensors would normally reside in the housing, and a small red "X" was marked on the tissue, which would smear if water leaked into the housing (see Figure 6). On November 14, 2001, the housing was placed two feet below the water table in well 18-MW37. A week later, the sensor package was pulled up, inspected, and then lowered an additional five feet below the water table. This process continued on a weekly basis until leakage occurred.

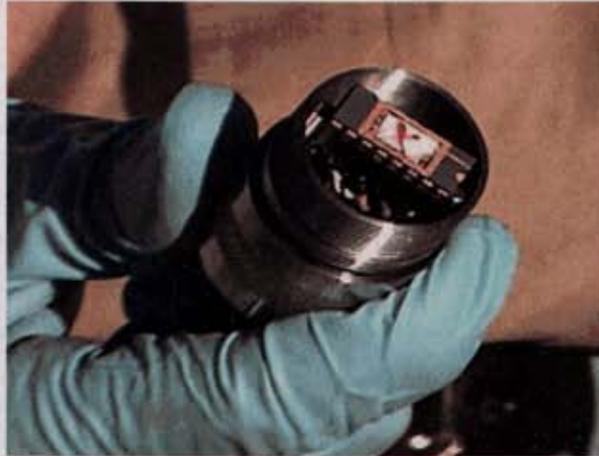
Figure 6. Chemiresistor sensor package with the cap removed, exposing the 16-pin sensor package. A red "X" was drawn on a tissue to indicate if water was leaking into the housing.

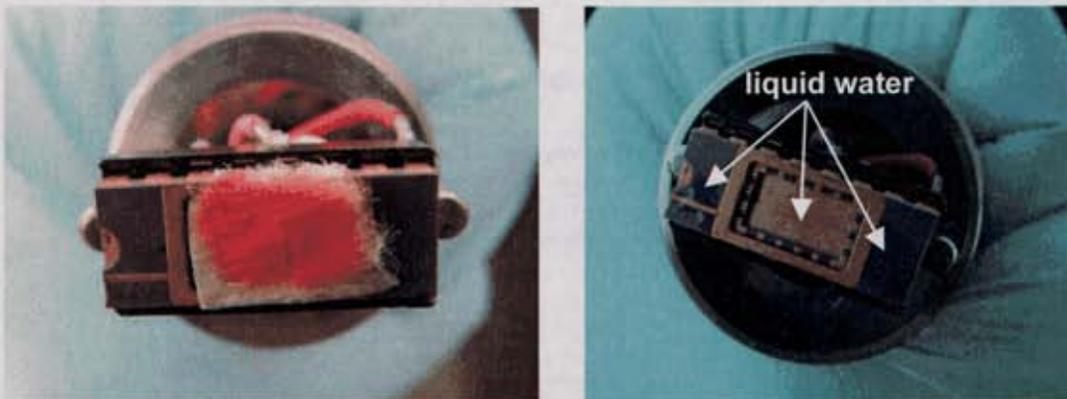
Figure 7. Weekly visual inspection of the housing interior (no chemiresistor chip). Left: Smeared red "X" after the housing had been submerged for 6 weeks (depth below water table was increased to 32 feet). Right: Liquid water observed in the housing after 9 weeks.

Results of the test (see Table 1) showed that the Gore-Tex[®] membrane withstood depths of up to ~30 feet below the water table (~13 psi) before allowing water to seep into the housing. After six weeks of continual immersion at increasing depths, we finally observed signs of moisture within the housing as evidenced by the smeared red "X" (see Figure 7). The sensor was placed at reduced depths beneath the water table (higher elevations) during subsequent weeks. The sensor was eventually raised to just five feet below the water table, but the housing continued to show signs of leakage (Figure 7). We suspect that the performance of the membrane may have been compromised once it was initially breached. However, later tests in Phase III showed that the membrane, which had been replaced, and housing were able to prevent water leakage for at least four months when the immersion depths were maintained at less than 5 feet beneath the water table.

It should be noted that the observed water-entry-pressure threshold of ~30 feet (~13 psi) is about 65% of the manufacturer-specified value of 20 psi. The difference is attributed to the continuous long-term immersion of the membrane in the current test, which contrasts the short-term tests conducted by the manufacturer. Alternative polymer laminates are available from W.L. Gore & Associates that have larger water-entry pressure ratings. Custom membranes are available that are rated at 250 psi, but assuming that that long-term continuous immersion will decrease this threshold by the same percentage as observed in the current test, the water-entry-pressure threshold of these new samples would be approximately 163 psi, or approximately 114 feet of water head. These samples have not yet been tested.

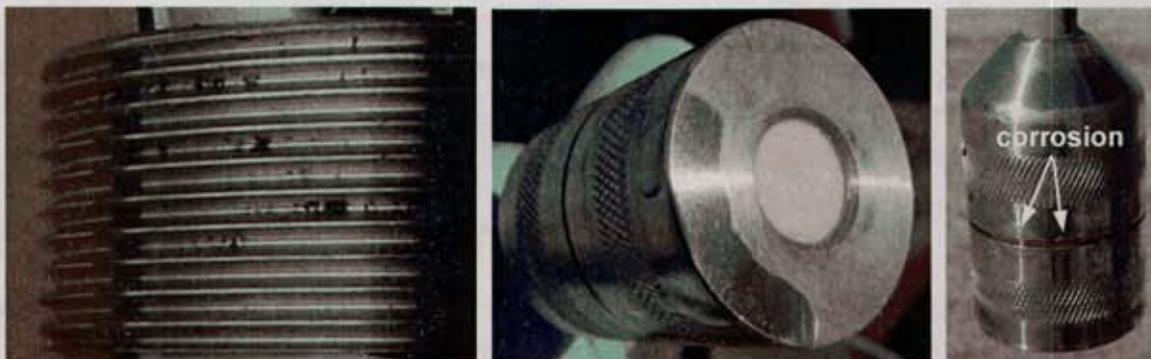
Figure 8. Evidence of corrosion and microbial activity. Left: Black spots were observed on the threads of the housing after 2 weeks of immersion. Middle: "Slime" observed at 9 weeks (began at 2 weeks). Right: Corrosion was observed near the seam and O-ring of the housing at 10 weeks (began at 5 weeks).

Visual observations of the 304 stainless-steel housing during the test revealed that there were signs of possible corrosion and microbial degradation (see Table 1). Small black spots were observed on the inside threads of the housing after the 3rd week, and these continued to accumulate throughout the test. Crevice corrosion of the stainless-steel may have occurred on the threads, and the black spots were suspected to be magnetite (iron oxide), a product of oxidation. Observation under a magnifying glass showed that samples of the black material were planar, and the samples were attracted to a magnet when the samples were suspended in water. These observations support the speculation that the black spots were magnetite (a likely product of crevice corrosion).

A thin film of slime was also noted on the exterior of the housing by the 2nd week, and it continued to accumulate in subsequent weeks. The slime was likely an indication of microbial activity, but no further tests were performed to identify the cause of the slime. By the 5th week, slight corrosion of the steel near the O-ring was observed, and by the 9th week, a discoloration of the membrane was observed. Figure 8 shows images of the housing that provide evidence of corrosion and microbial activity during this test. It should be noted, however, that aside from the deliberate breach of the membrane, the overall integrity of the housing was maintained during the duration of this test. This was verified during tests in Phase III in which the chemiresistor sensor operated continuously underwater without fail at well 18-MW37 for a period of four months. The primary difference was that the sensor was maintained at a depth within five feet of the water table during the entire duration of Phase III (the water-entry pressure of the membrane was not exceeded).

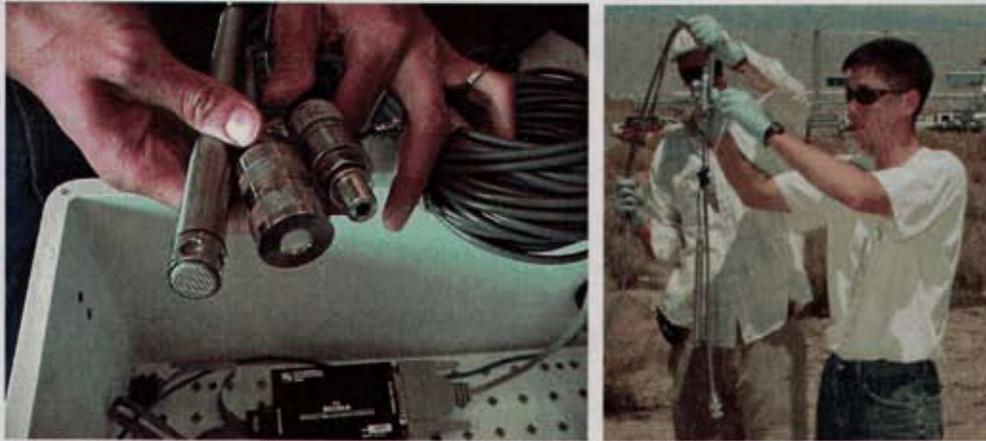
Figure 9. Left: Three sensors were deployed in Phases II and III (temperature/humidity probe, chemiresistor probe, and pressure transducer). Right: Tethering the sensors together before lowering them down well 18-MW37.

The chemiresistor probe was connected to a Campbell Scientific CR10X data logger via 65-ft long cable (Alpha 1299/20C 22 AWG). In addition, an Omega HX94C temperature/humidity probe and an Omega PX215 pressure transducer were connected via 100-ft cables to the data logger to record the temperature, relative humidity, and barometric pressure in the vicinity of the sensor (see Figure 9). A resistance temperature detector (RTD) on-board the chemiresistor chip was also used to record the local temperature of the chemiresistor sensor. The data logger was placed in a weatherproof enclosure that was mounted onto a steel tripod, which was anchored to

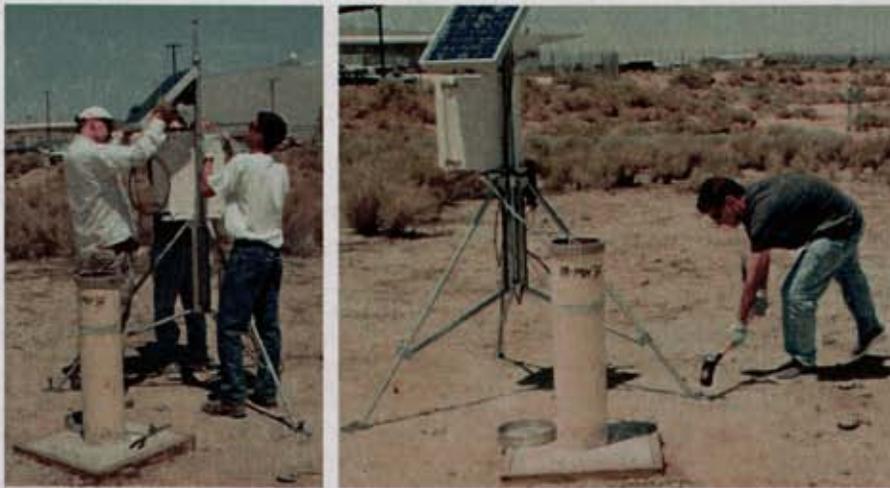
Figure 10. Left: Assembling the data-logging station at well 18-MW37. Right: Anchoring the tripod to the ground.

the ground (Figure 10). A 5-ft grounding rod was hammered into the ground and connected to a lightning rod mounted on top of the tripod. A 20-Watt solar panel mounted to the tripod was used to charge a 12 amp-hour battery connected to the data logger in the enclosure.

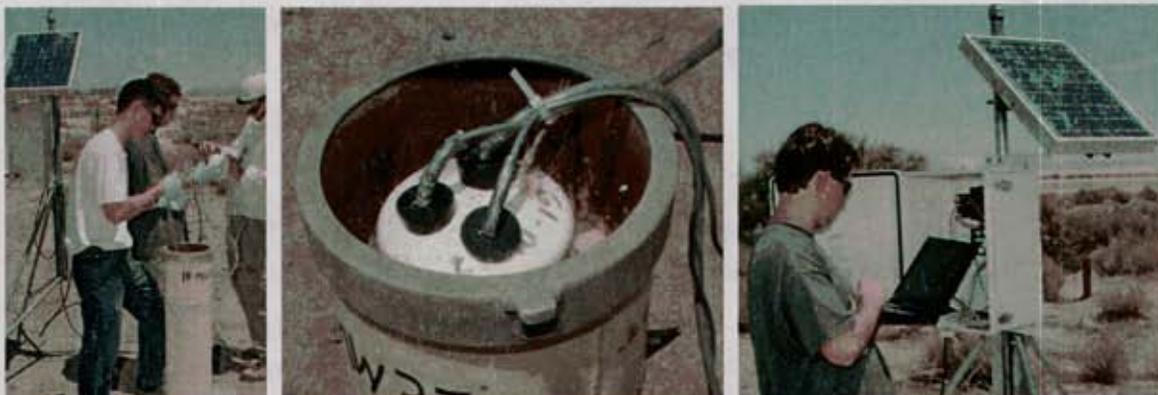
Figure 11. Left: Lowering sensors down well 18-MW37. Middle: View of cables from top of well casing. Right: Downloading data from the data logger.

inadvertently submerged after a few days of the Phase I test. Figure 11 shows photos of the sensors being lowered down the well and the subsequent downloading of data. The data logger was programmed to collect and store data once every hour during the Phase II and Phase III tests (see Appendix for program). Although we manually downloaded the data using a laptop in these tests, wireless communication devices (e.g., a cell phone) can be easily integrated with the data logger so that data collection can be performed remotely and automatically.

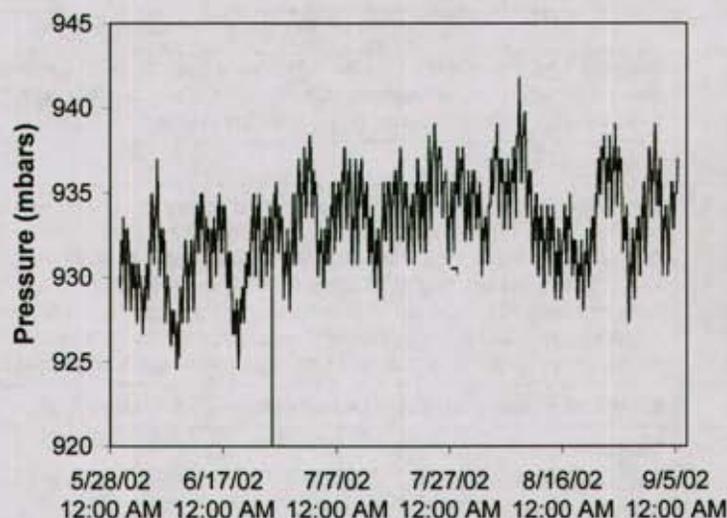
Figure 12. Barometric pressure in well 18-MW37.

The Omega PX215 pressure transducer recorded the barometric pressure in the well during the tests. Aside from an anomalously low reading at 3:00 PM, June 25, 2002, the pressure fluctuated between 925 and 940 mbars (converted from psia). Regressions between the pressure and the chemiresistor responses showed that these minor fluctuations in pressure did not impact the chemiresistor responses.

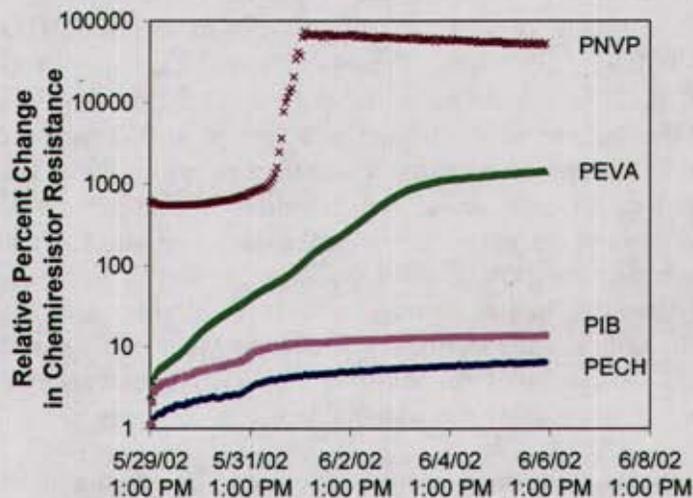
Figure 13. Response of the chemiresistor sensors during the first week. The chemiresistor probe was immersed by the rising water table. Baseline resistance was taken from dry conditions in the Earth Tech trailer (23°C, ~24% RH).

However, as shown in Figure 13, some problems were evident. First, the chemiresistors showed a large response when placed in the well relative to the baseline resistance measured in the relatively dry environment in the trailer. While we expected a response to the 100% relative-humidity environment, the relative change was far greater than anything we observed in the lab. In addition, the resistances continued to increase during the week, with a noticeable jump between May 31 and June 1. This may have been an indication as to when the chemiresistor was immersed by the rising water table. We suspect that the large water-vapor concentration (and perhaps some film condensation) was causing water to continually absorb into the polymers, creating a "creeping" effect. Most of the polymers, however, did stabilize towards the end of the first week.

Towards the end of the first week of testing, most of the chemiresistors showed signs of stabilization (see Figure 13). On June 6, the chemiresistor was pulled above the water table and suspended about a foot above the water table. The water table appeared to remain below the chemiresistor for the next several weeks, so the period between June 6 and June 25 was used for the Phase I (unsaturated-zone) test.

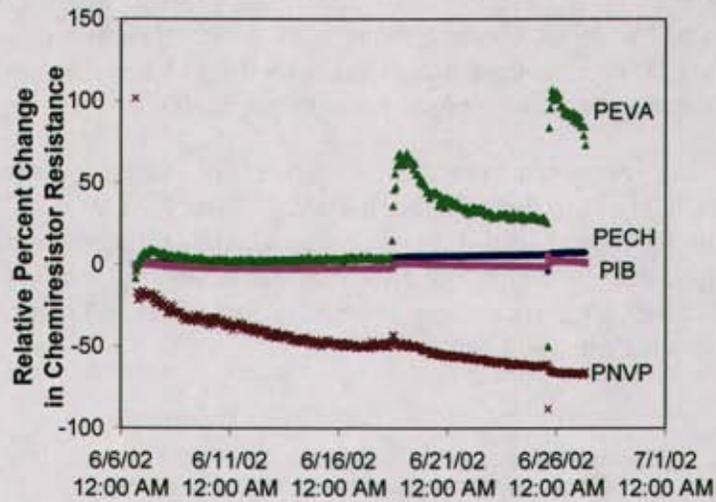
Figure 14. Relative percent change of the chemiresistor resistances during the Phase II unsaturated-zone test (June 6 – June 25, 2002). The baseline resistances were taken at the beginning of the test on June 6, 2002.

Figure 14 shows the relative change of the chemiresistor resistances during Phase II using resistances measured on June 6 as the baseline. These relative changes were used with the calibration curves to estimate the vapor concentration of TCE (Figure 15). Recall that the laboratory analyses indicated that the measured vapor concentrations were less than the detection limits of the chemiresistor. Therefore, we expect to see little, if any, estimated concentrations from the chemiresistor in the vapor phase. Deviations and drift from a zero value shown in Figure 15 are probably anomalous, caused by the large water-vapor concentrations present near the sensor. We suspect that creep caused by continual absorption of the water vapor on the polymer films caused the deviations.

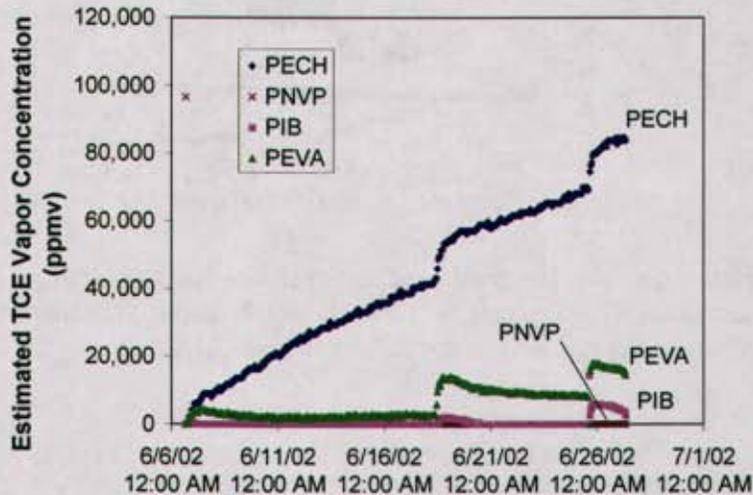
Figure 15. Estimated TCE vapor concentrations during the Phase II unsaturated-zone test.

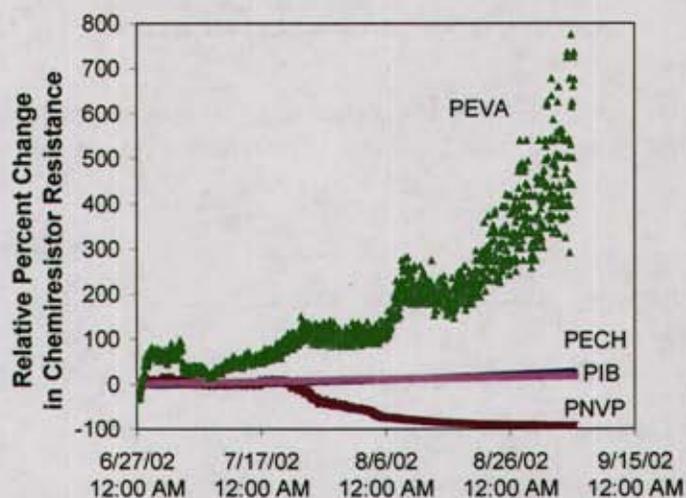
Figure 16. Relative percent change of the chemiresistor resistances during the Phase III unsaturated-zone test (June 27 – September 5, 2002). The baseline resistances were taken at the beginning of the test on June 27, 2002.

chemiresistor resistances during the Phase III test. Again, recall that the laboratory analyses revealed that measured aqueous concentrations were lower than the detection limits of the chemiresistor sensor. Deviations from a zero value are likely caused by interferences from the large water vapor concentrations (as opposed to responses to VOCs).

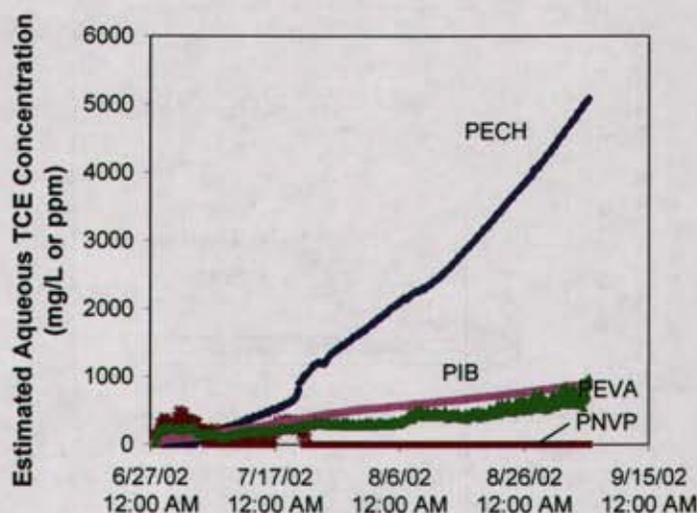
Figure 17. Estimated aqueous TCE concentrations during the Phase III saturated-zone test.

Figure 17 shows the estimated aqueous concentrations using the responses from the chemiresistor sensor along with the calibration curves. Henry's Law was used to convert the vapor concentrations (estimated from the calibration curves) to aqueous concentrations. The large fluctuations appear to be anomalous based on the laboratory analysis. Sections 4 and 5 provide recommendations to correct these anomalies and provide improved stability for the chemiresistor sensor in high-humidity environments.

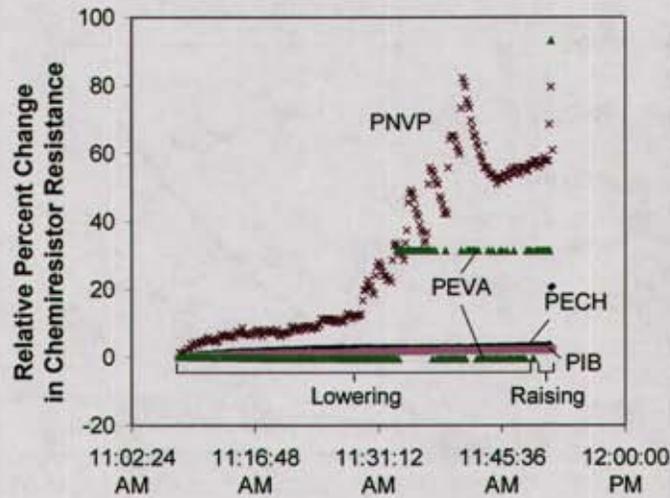
Figure 18. Relative percent change of the chemiresistor resistances during the transient test on September 5, 2002. The baseline resistances were taken while the chemiresistor was suspended 37 ft below TOC.

Figure 18 shows the relative percent change in chemiresistor resistances resulting from this transient test. Unfortunately, no systematic trends in readings were observed. The resistance did increase, but the trend seemed to be due to the re-exposure of the chemiresistor to the 100% relative-humidity environment after it had been pulled from the well. We suspect that the sensor did not have enough time to equilibrate with the water before the test began (the chemiresistor was pulled from the well before the test to be cleaned and re-baselined). In addition, because of time constraints, the sensor was raised from the well too rapidly to determine if a systematic decrease in chemiresistor resistances could be observed.

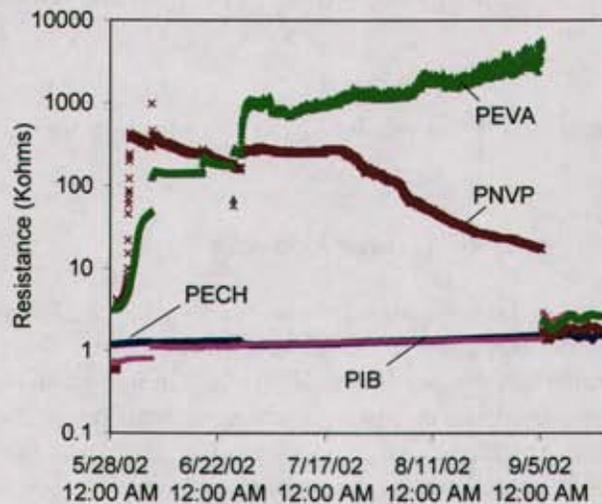
Figure 19. Measured chemiresistor resistances during all field tests (May – September 2002).

One of the general objectives of the field tests was to determine the long-term operation capabilities of the chemiresistor sensor. Figure 19 shows the measured resistances from the four polymers used in the chemiresistor sensor during the entire time it was placed in well 18-MW37. Although the results were often spurious, one positive observation was that the chemiresistor sensor provided continuous output during its operation over a four-month period in corrosive aqueous environments. The sharp changes in resistances that were recorded in Figure 19 are often correlated to events where the sensor was taken out of the well, handled, and placed back in the well for the start of a new phase or test.

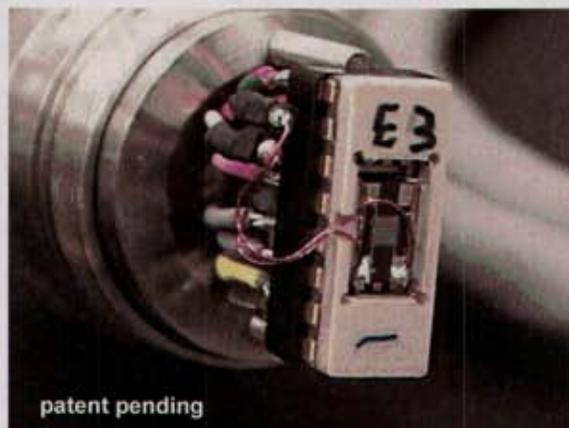
Figure 20. Integrated preconcentrator/chemiresistor assembly in the waterproof package.

A preconcentrator assembly has recently been developed at Sandia National Laboratories to increase the sensitivity of the chemiresistor by potentially several orders of magnitude. The preconcentrator consists of a "micro-hotplate" that is coated with a sorbent to collect VOCs.

After a period of time during which the preconcentrator is loaded with VOCs, a voltage is applied across the micro-hotplate to heat the sorbent rapidly to high temperatures and desorb the VOCs. The high-concentration plume of VOCs is then sensed by the nearby chemiresistor. The preconcentrator assembly has been recently integrated with the chemiresistor package (Figure 20). Preliminary laboratory tests show that the integrated preconcentrator is functioning well and can increase the detection limit for TCE by up to two orders of magnitude.

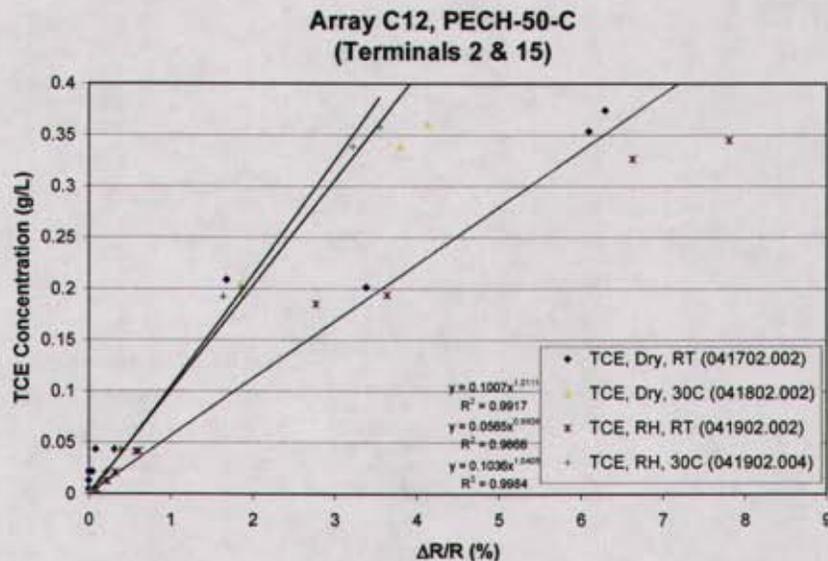
Figure 21. Calibration curves for PECH polymer on chip C12.

The calibration of the chemiresistor array was performed by introducing known concentrations of TCE and water vapor to each of the four polymers on chip C12 (from left to right in Figure 2): polyepichlorohydrin (PECH), poly(N-vinyl pyrrolidone (PNVP), polyisobutylene (PIB), and poly(ethylene-vinyl acetate) copolymer (PEVA). Digitally controlled mass-flow controllers were used to maintain precise flow rates of pure nitrogen through bubblers containing liquid TCE and water to the chemiresistor polymers. The tests were conducted at two different chemiresistor temperatures: 22 °C (room temperature (RT)) and 30 °C (in a controlled oven). In addition, the TCE exposures were conducted at two different relative humidities: 0% (pure TCE in nitrogen) and 100% relative humidity (RH) at room temperature. In the latter case, controlled amounts of TCE vapor were passed through the water bubbler until the water reached equilibrium with the flowing TCE vapor. This allowed known concentrations of TCE to be introduced to the chemiresistor polymers under 100% relative humidity conditions. Figure 21 through Figure 24 shows the results of these calibrations.

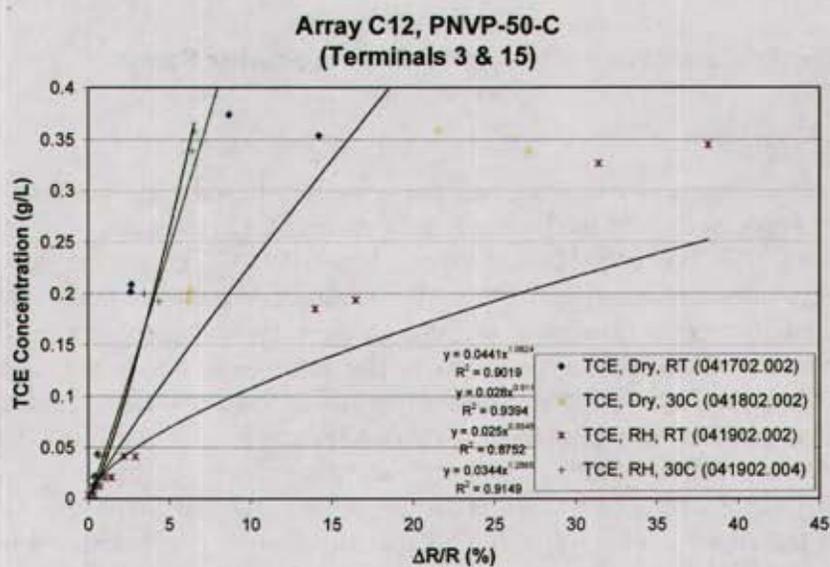
Figure 22. Calibration curves for PNVP polymer on chip C12.

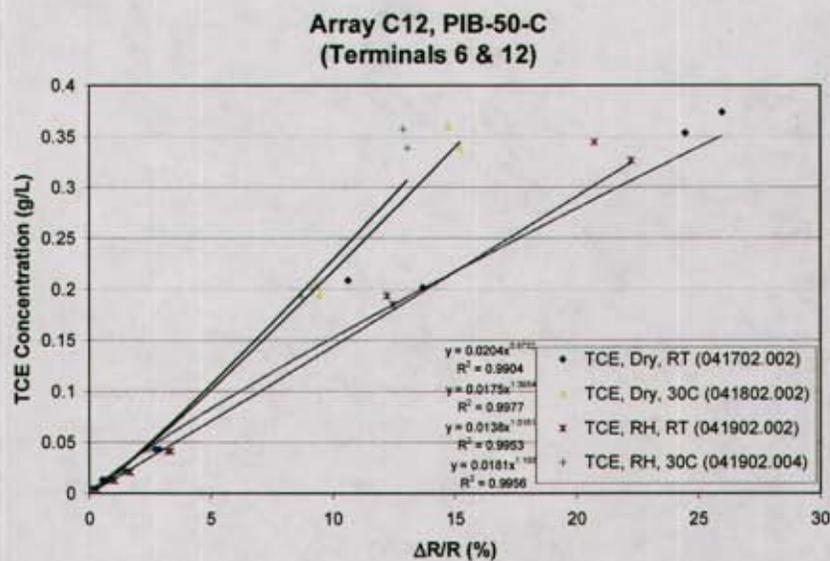
Figure 23. Calibration curves for PIB polymer on chip C12.

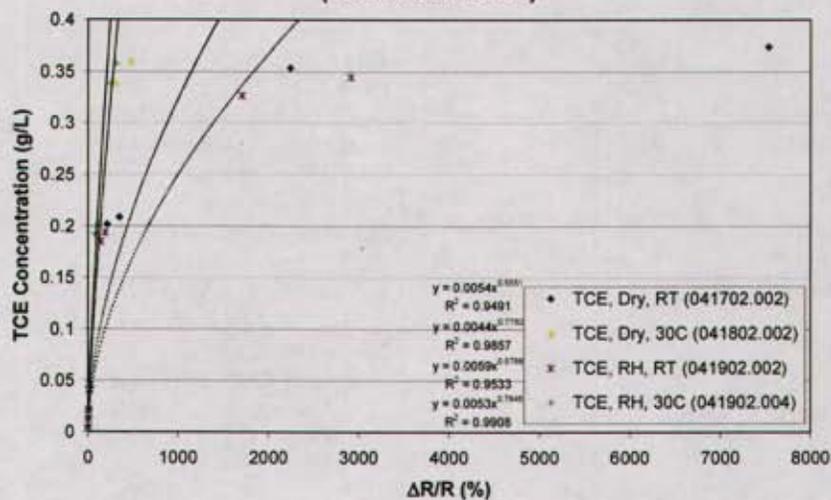
Array C12, PEVA-40-C
(Terminals 6 & 11)

Figure 24. Calibration curves for PEVA polymer on chip C12.
